REPORT OF CURRENT CONDITIONS

Cathedral of the Immaculate Conception

Lake Charles, Louisiana

01/05/2013

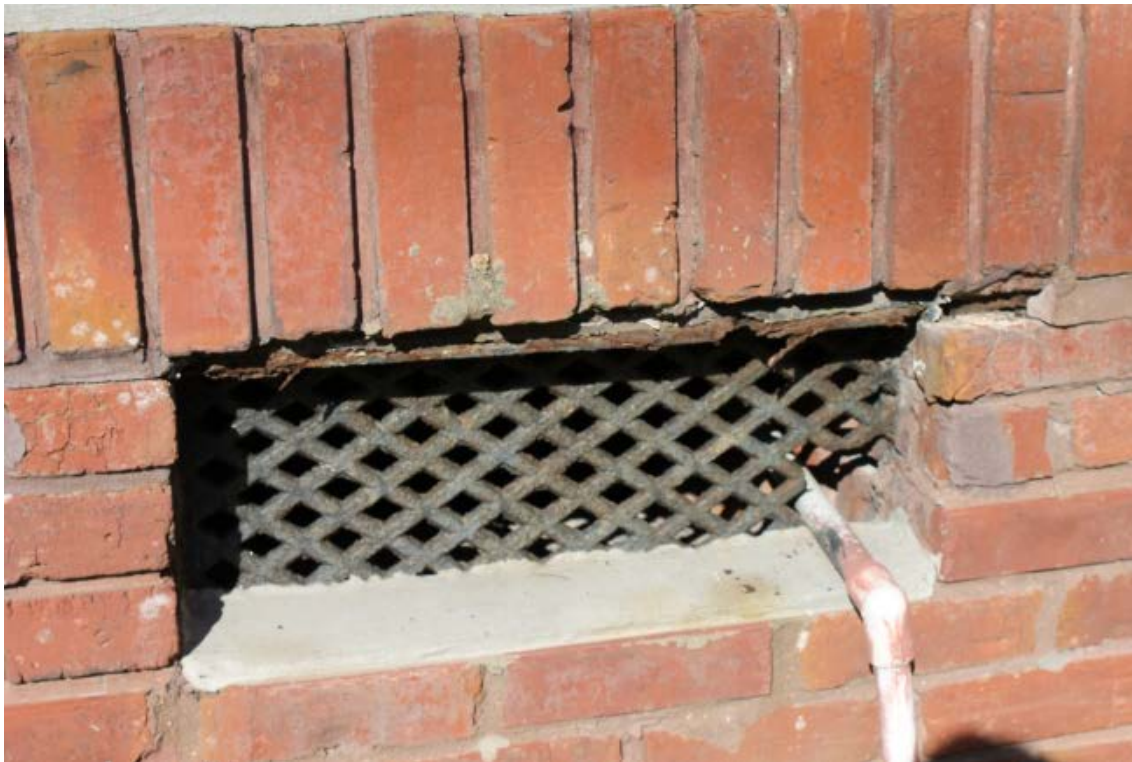
Damaged crawl space grills
and masonry lintel corroded

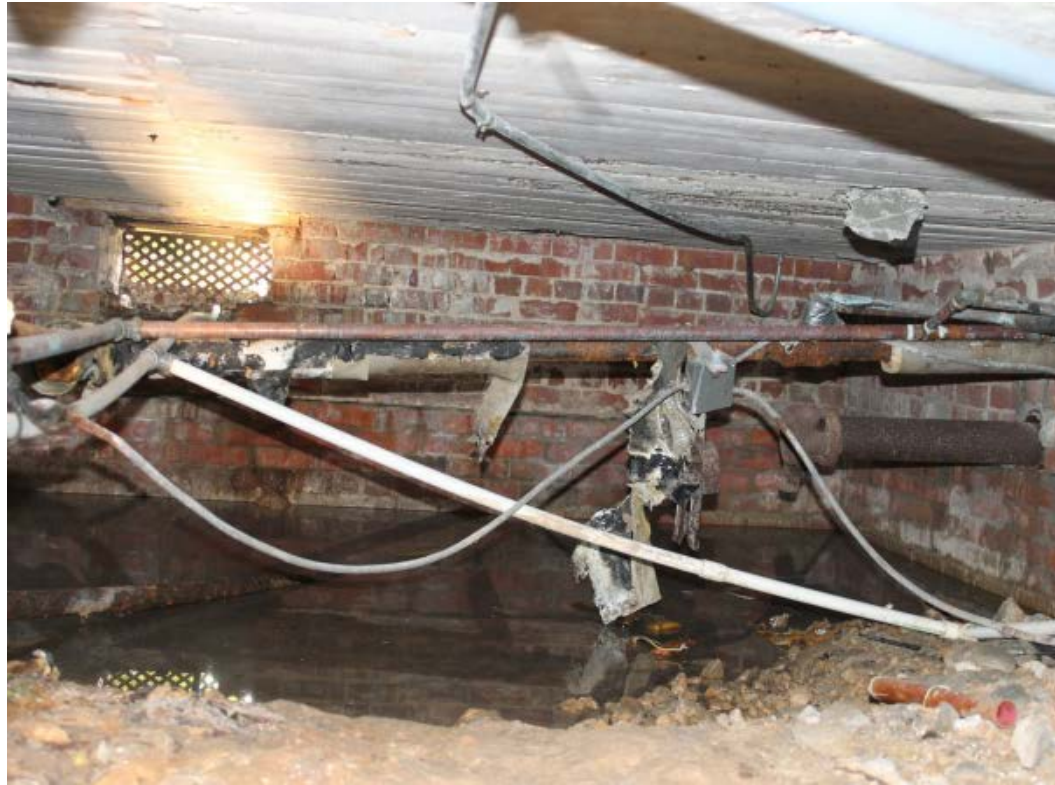
Corroded sewer, water, HVAC & electrical piping in need of replacement or removal & disposal if Abandoned. Water Ponding.

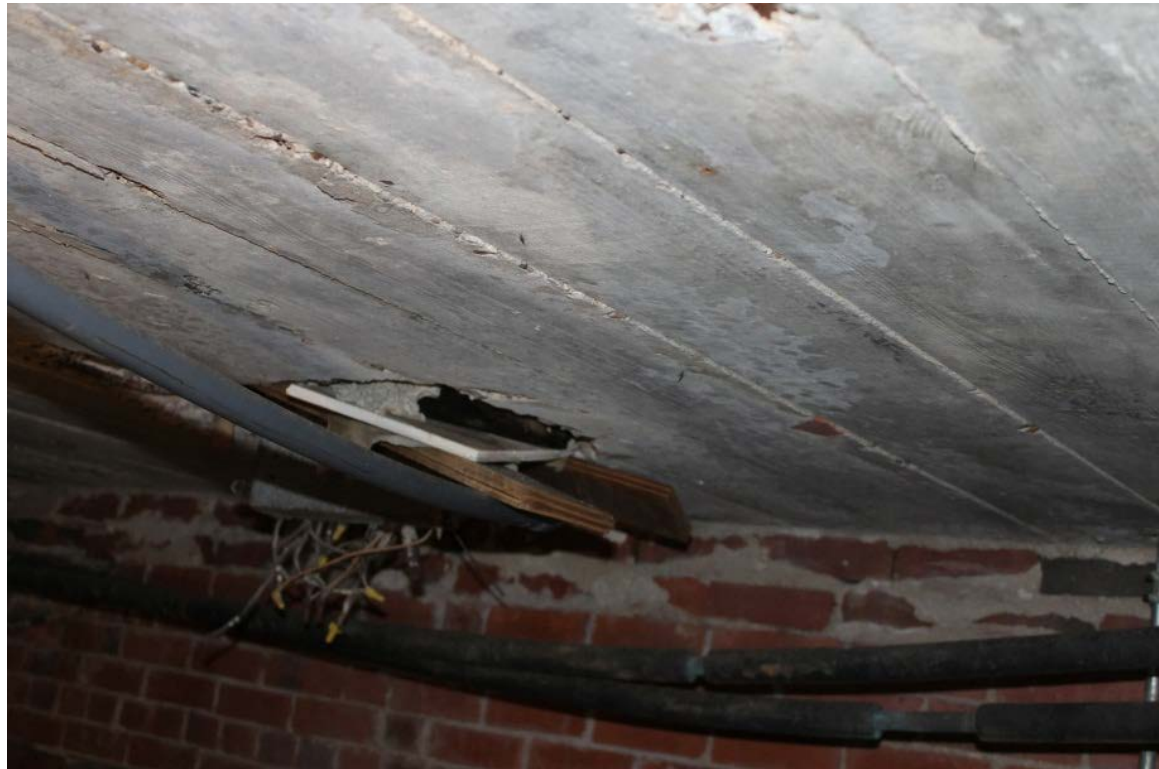
Concrete
spalling,
refrigerant
piping
insulation in
need of
repair. Hole
in floor
system

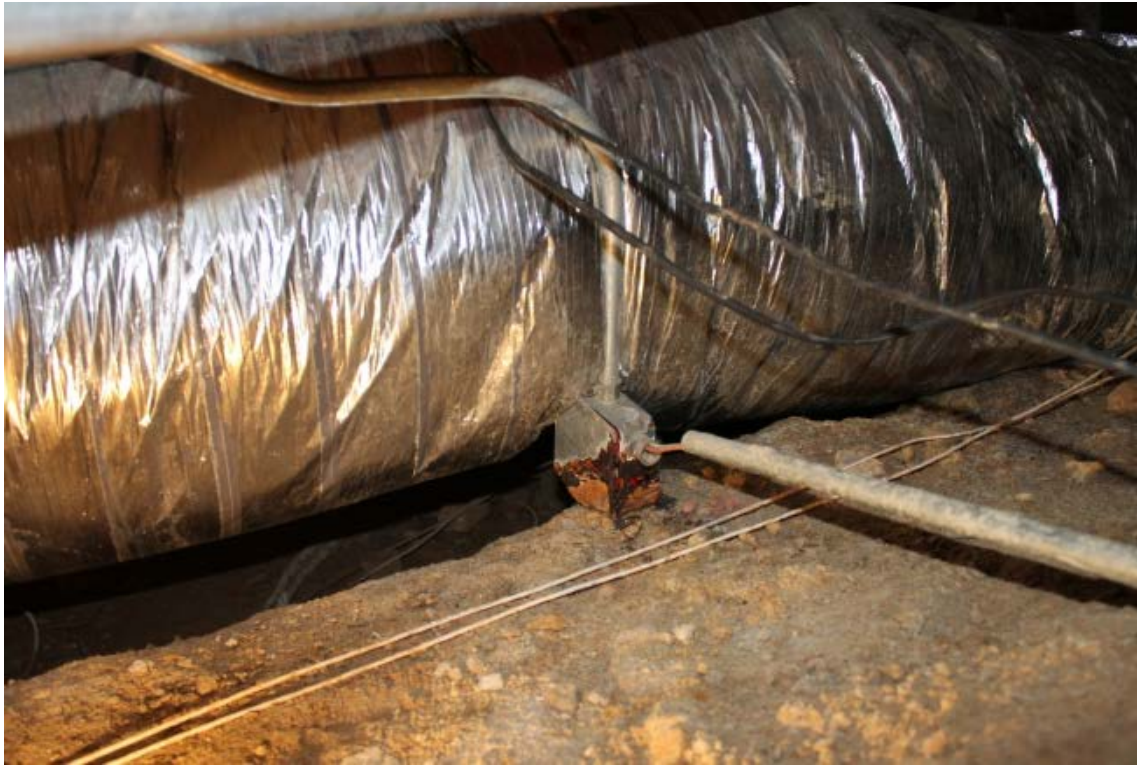
Open electrical
junction box,
corroded electrical
box, exposed
wiring

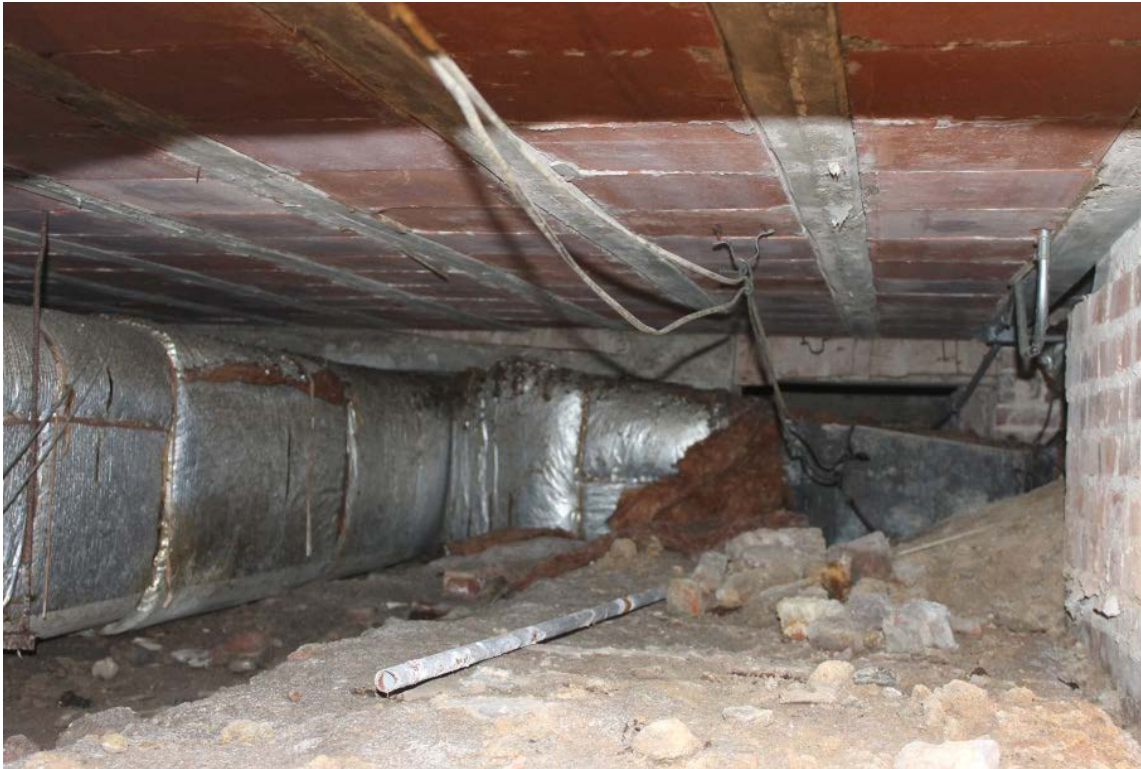
Exposed electrical wiring. Construction debris remnants. HVAC duct insulation displaced from metal ductwork. Soil needs to be spread out and impervious vapor barrier installed to prevent moisture from rising through the soil and affecting the construction materials as well as penetrating into the conditioned interior spaces affecting the design sizing, wear, tear and use of the HVAC systems.

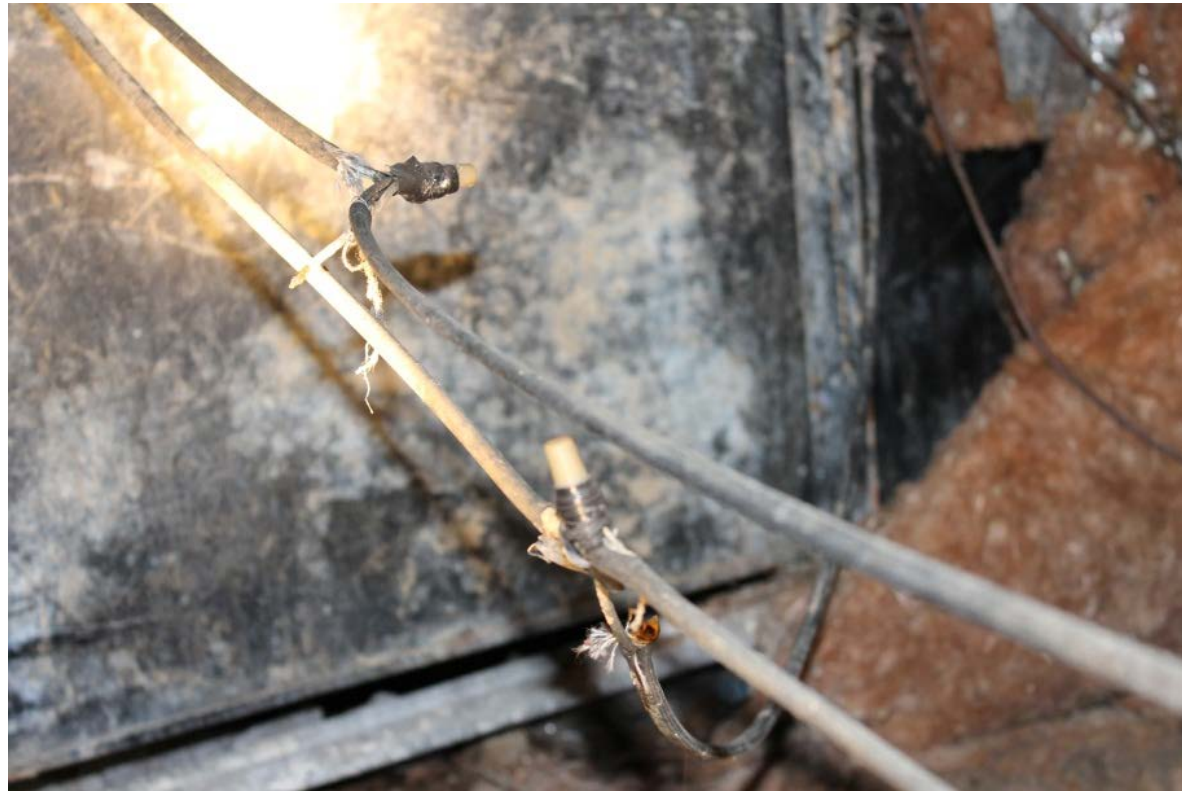
Dangerous and improper exposed electrical wiring connections.

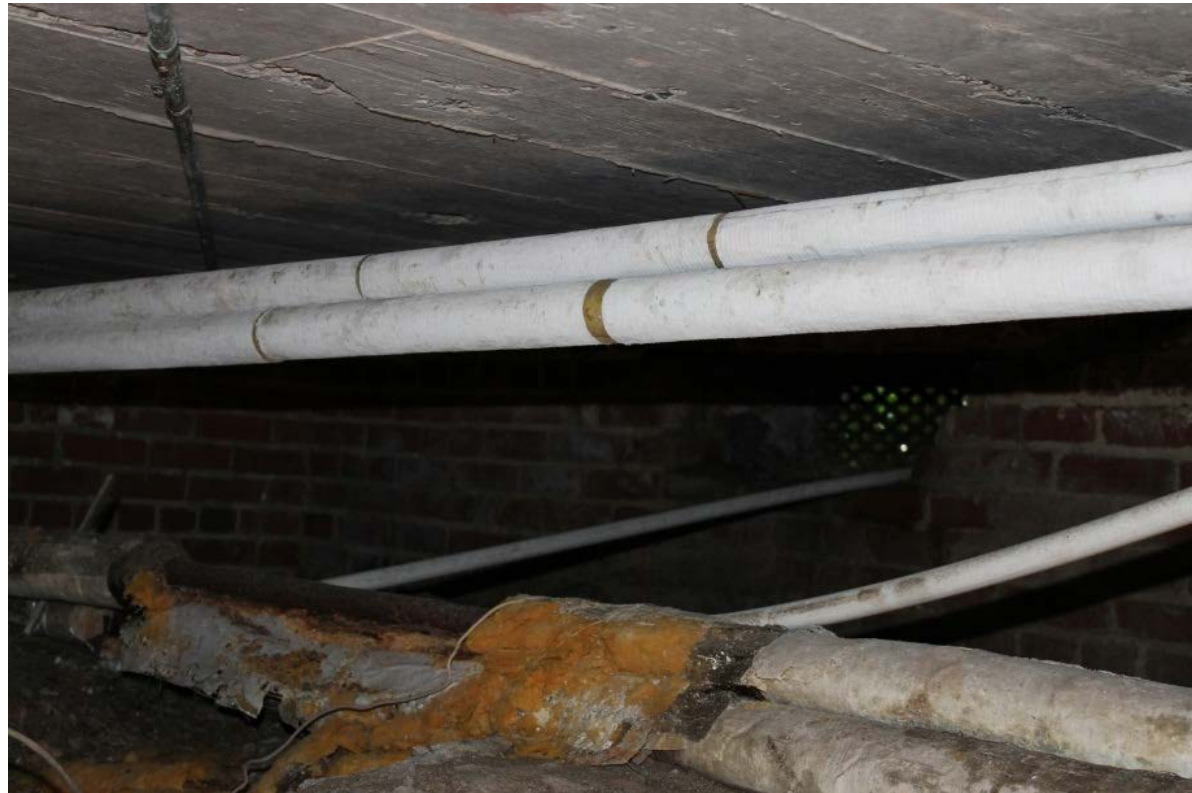
HVAC freon & suction line insulation jacket pulled apart and requires attention.

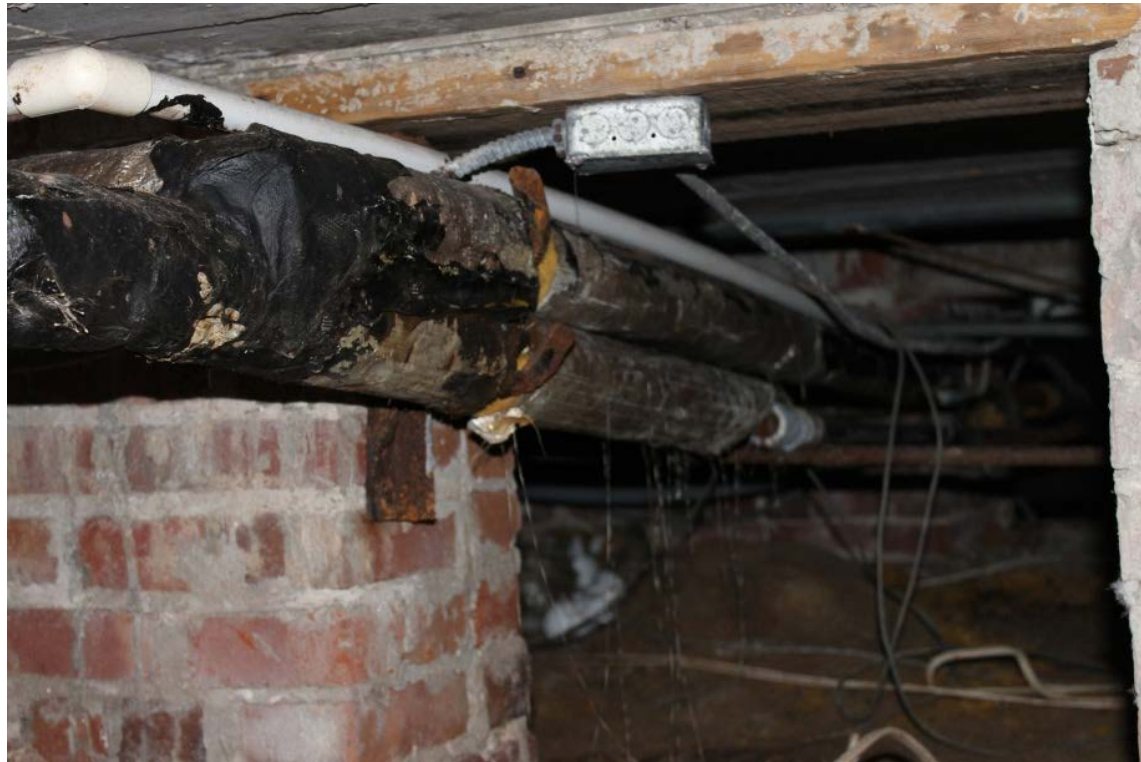
Corroded fastenings & hangers in need of replacement and support system. Exposed romex wiring that should be in electrical conduit.

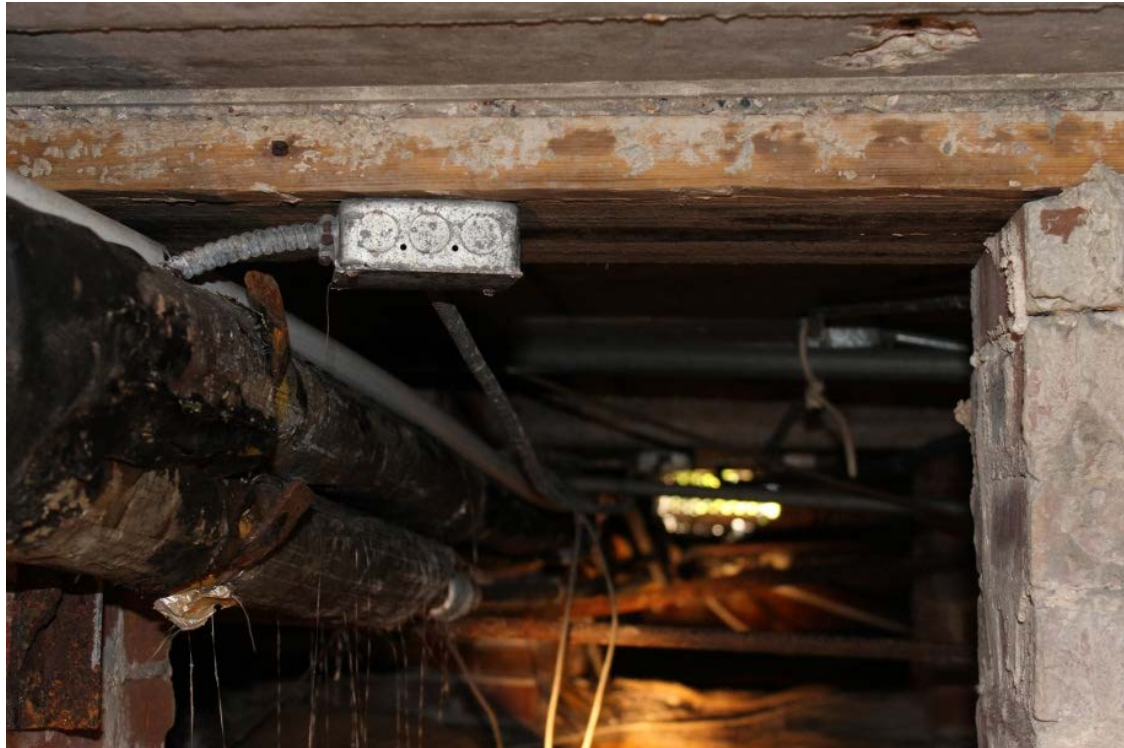
Loose wiring,
spalling concrete at
underside of floor
system. Wet and
damaged ductwork.
Damaged crawl
space vent in
background

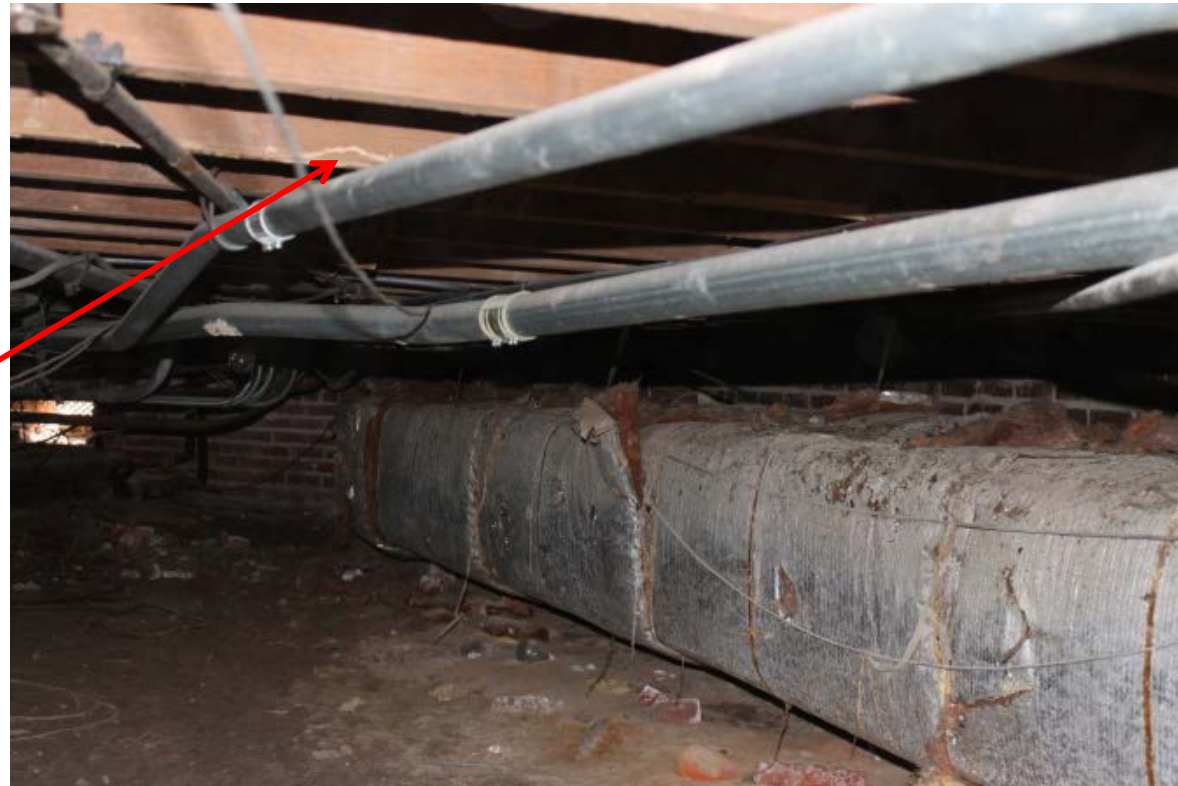
Evidence of
termites.
Note line of
termite travel.

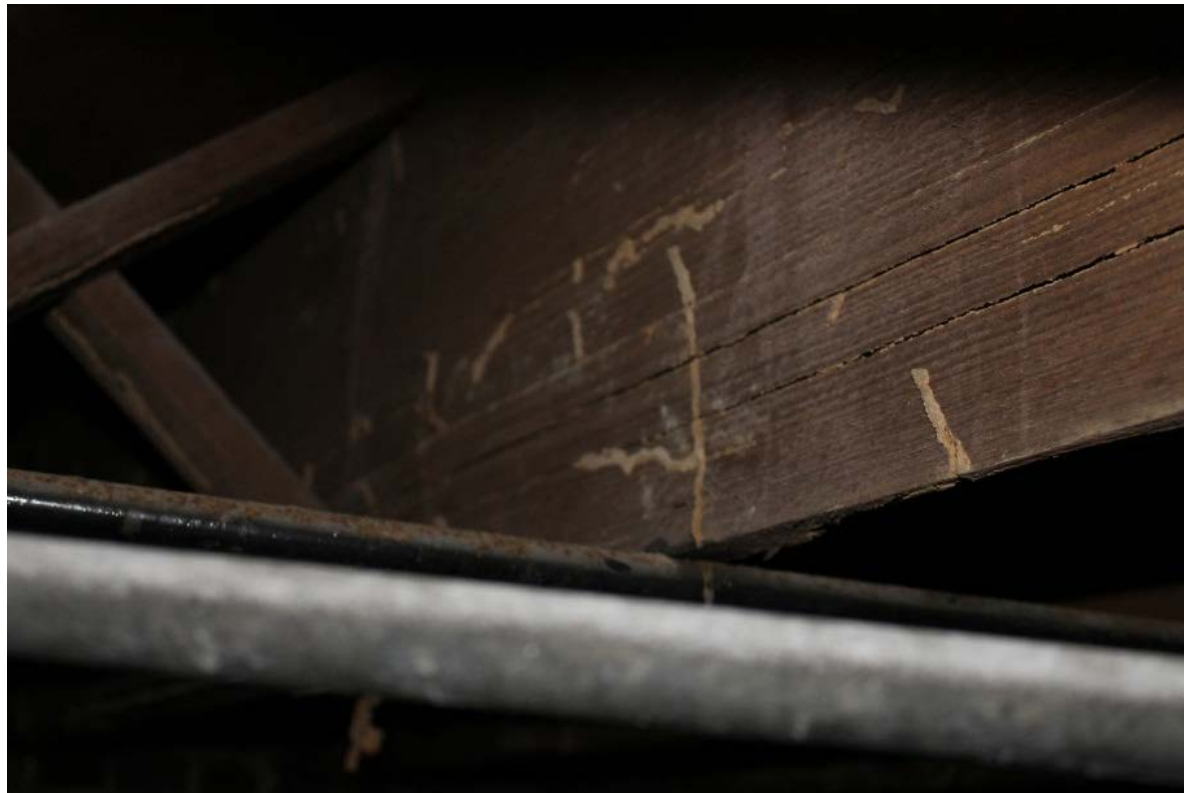
Evidence of termite damage

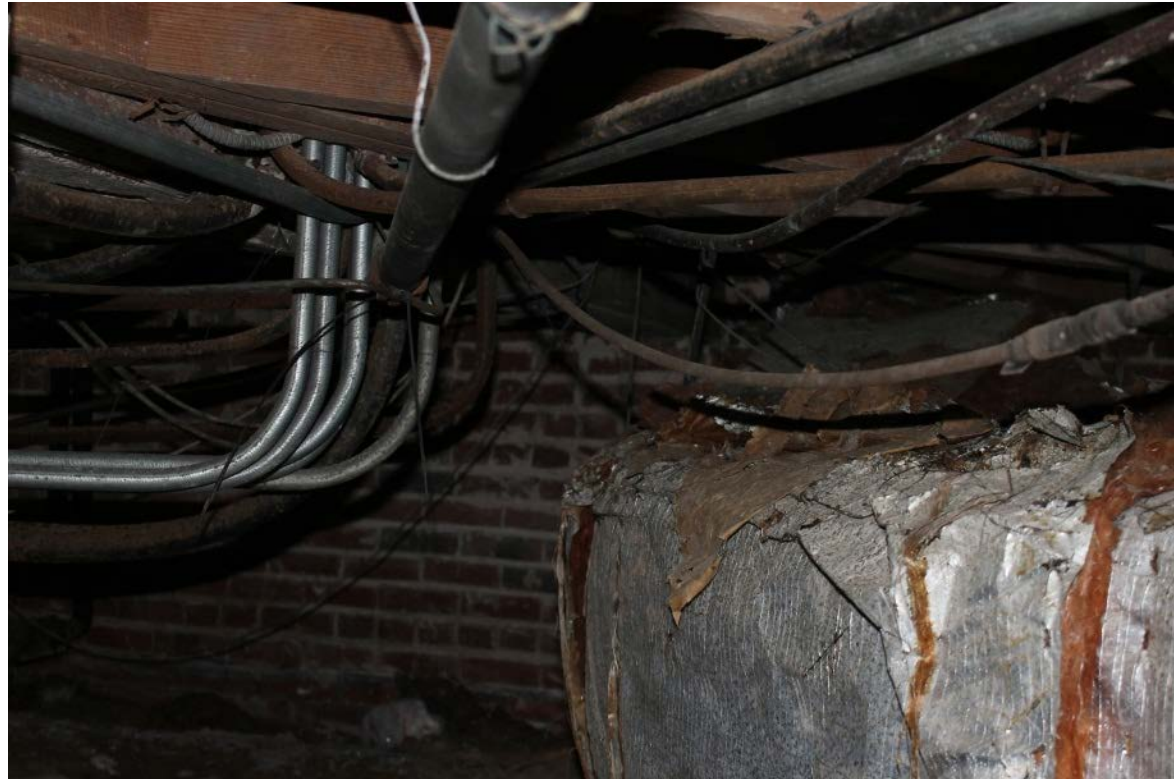
Damaged HVAC
insulation, loose
exposed wiring

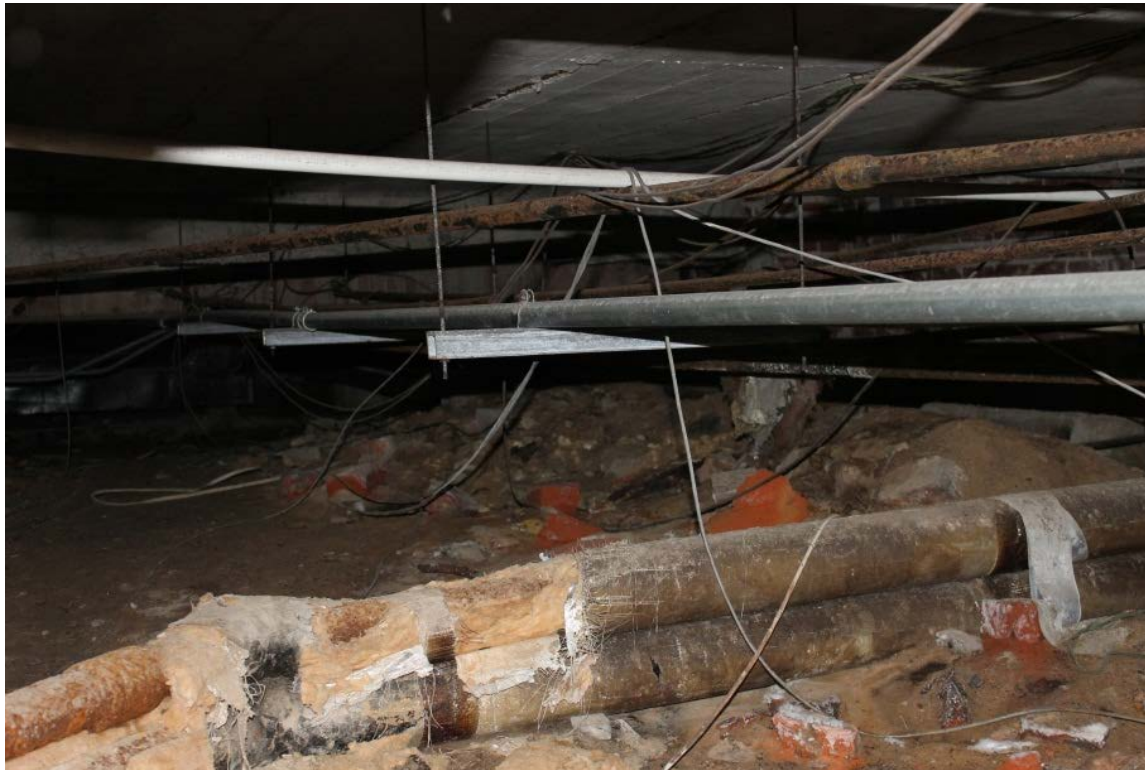
Construction debris requires removal and disposal. Rusted and abandoned piping requires removal & replacement.

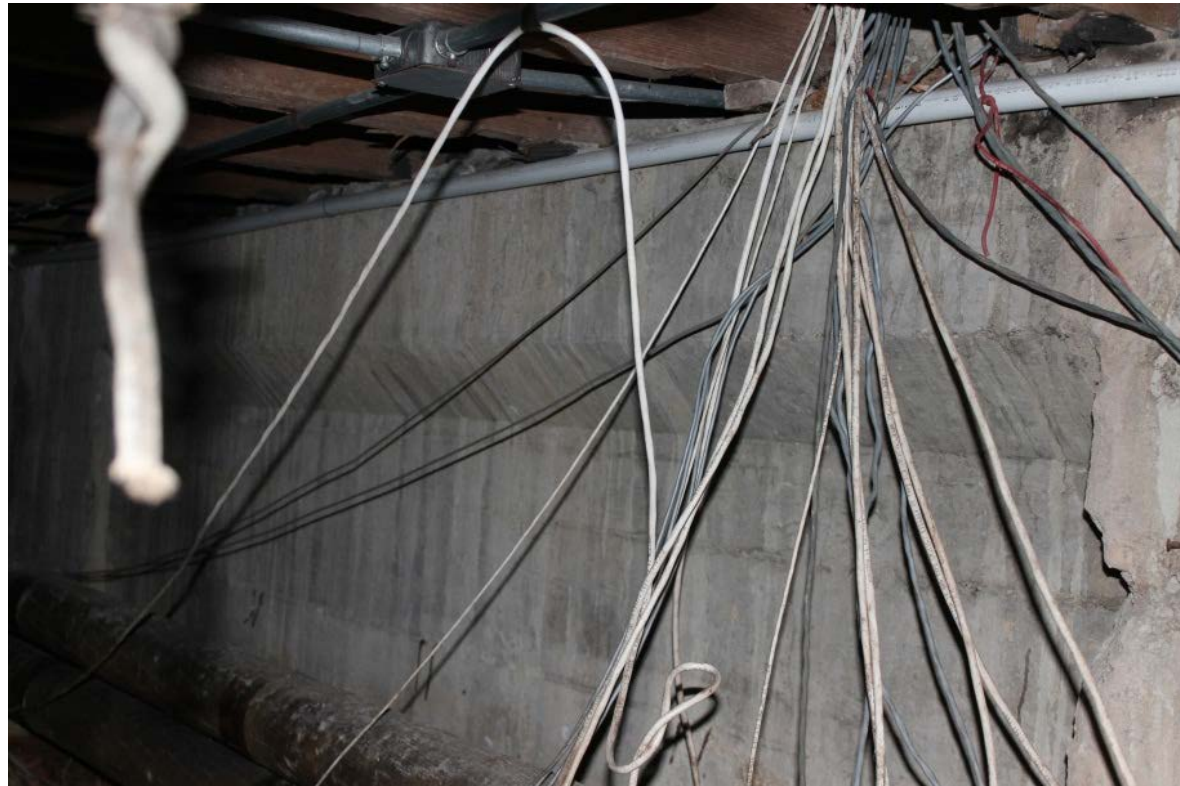
Loose wiring requiring conduit.

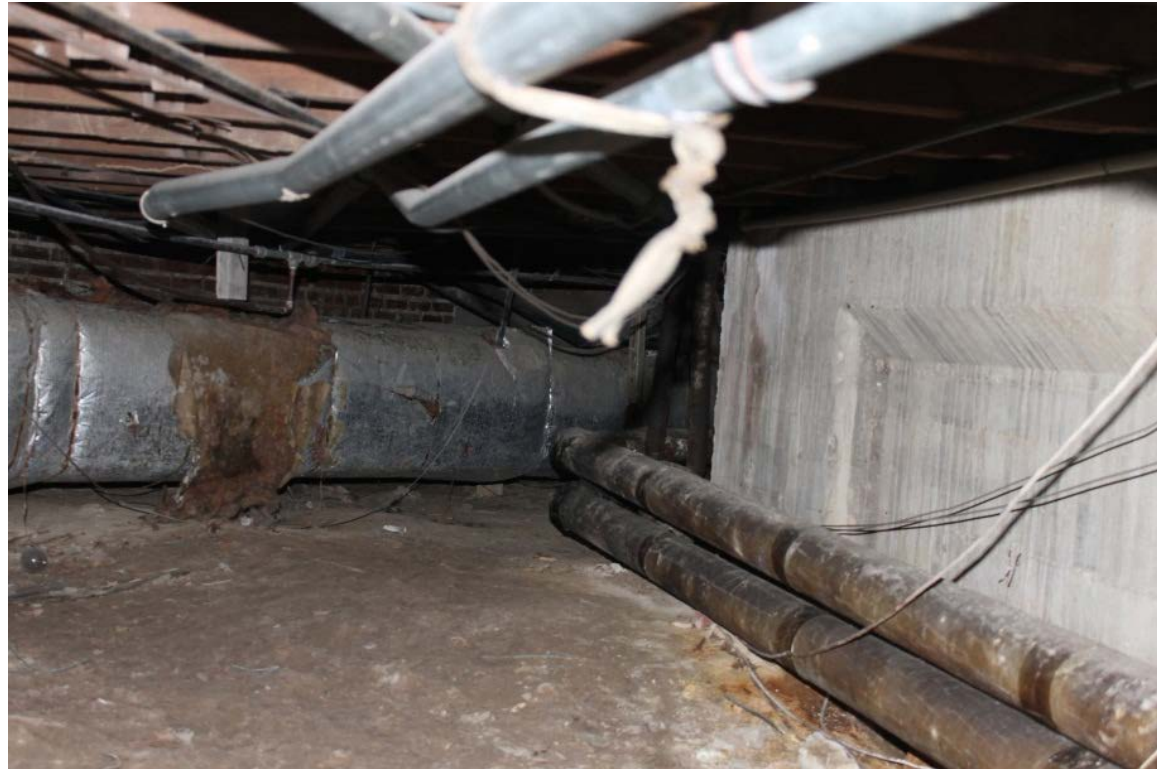
Wet earth, loose exposed wiring, damaged wet HVAC duct insulation. Rusted HVAC piping. Wood joist with evidence of termites.

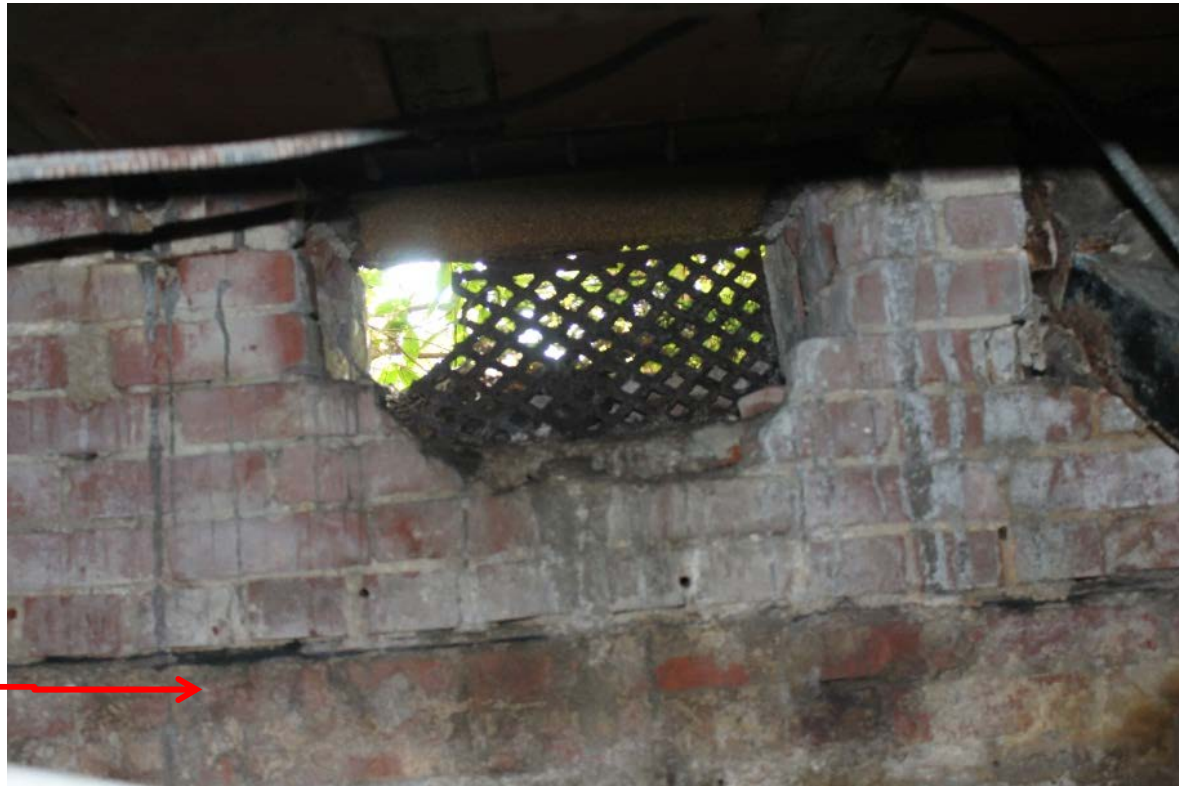
Damaged and corroded crawl space ventilation grill. Steel lintel above supporting brick wall opening is corroded and in need of replacement. This is typical of most vents at perimeter. Note the rising damp from the soil in the masonry.

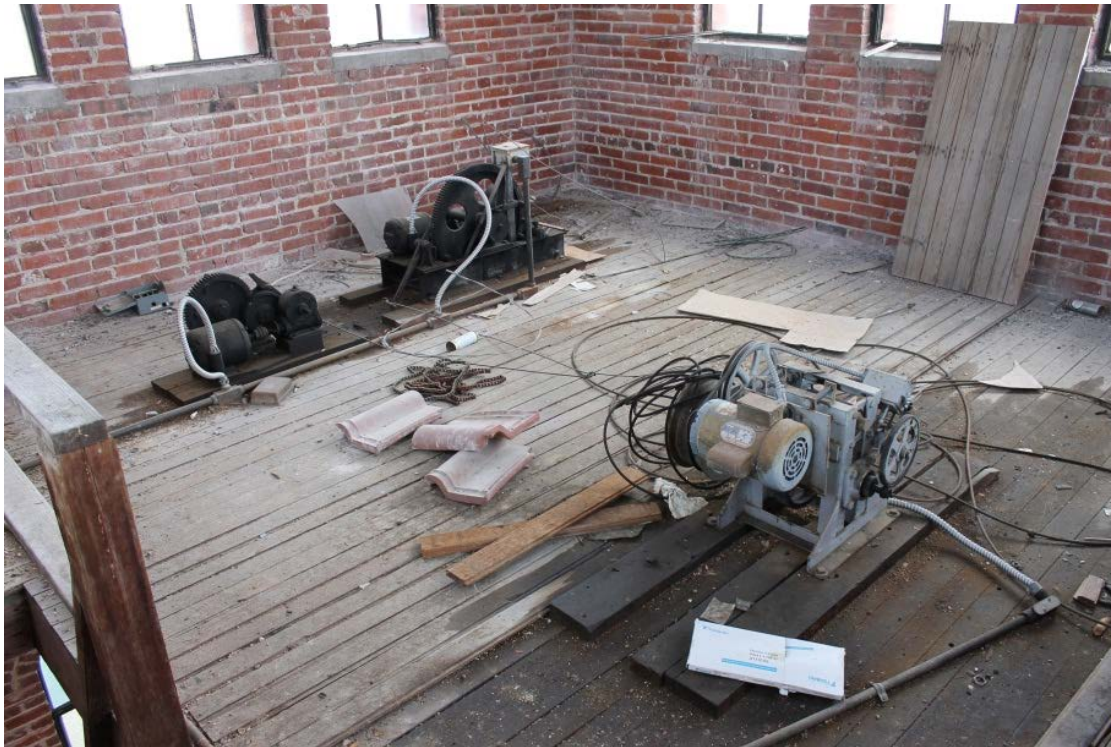
Old bell works are in need of removal as well as cleaning of flammable petroleum products from wood flooring.

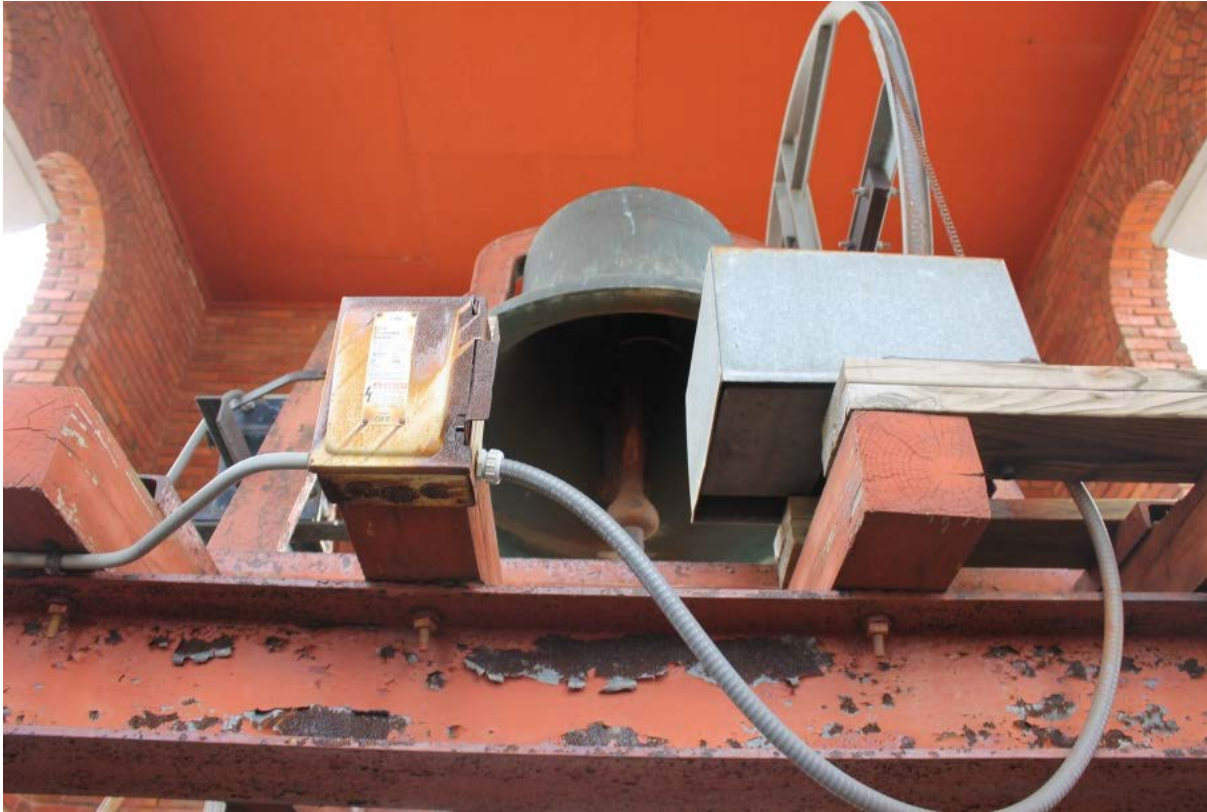
Bell tower bell works structural steel supports in need of cleaning and coating. Electrical gear/disconnects are in need of replacement, wiring and connections should be inspected and repaired/replaced where necessary to protect from environment and to prolong life.

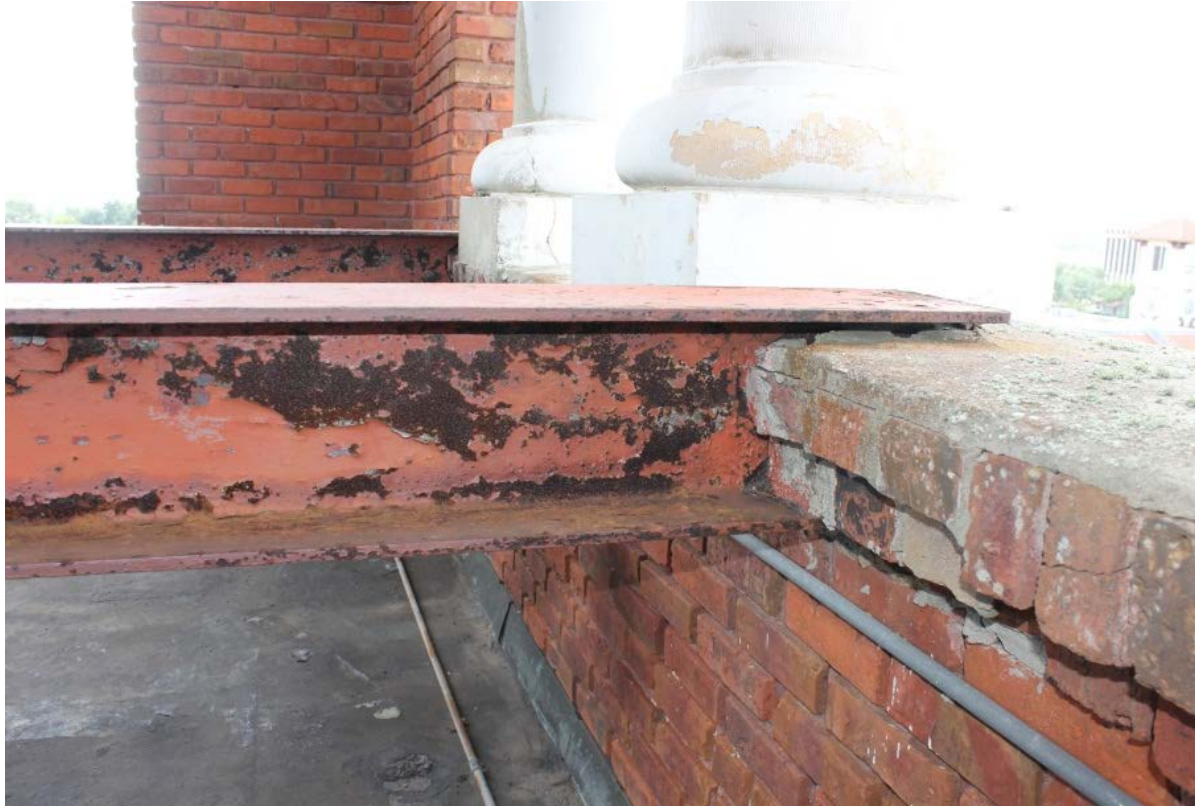
Bell tower bell structural steel supports in need of cleaning and coating. Masonry in need of restoration/repair where damaged. These steel beams were not part of the original construction and were added to support the bell.

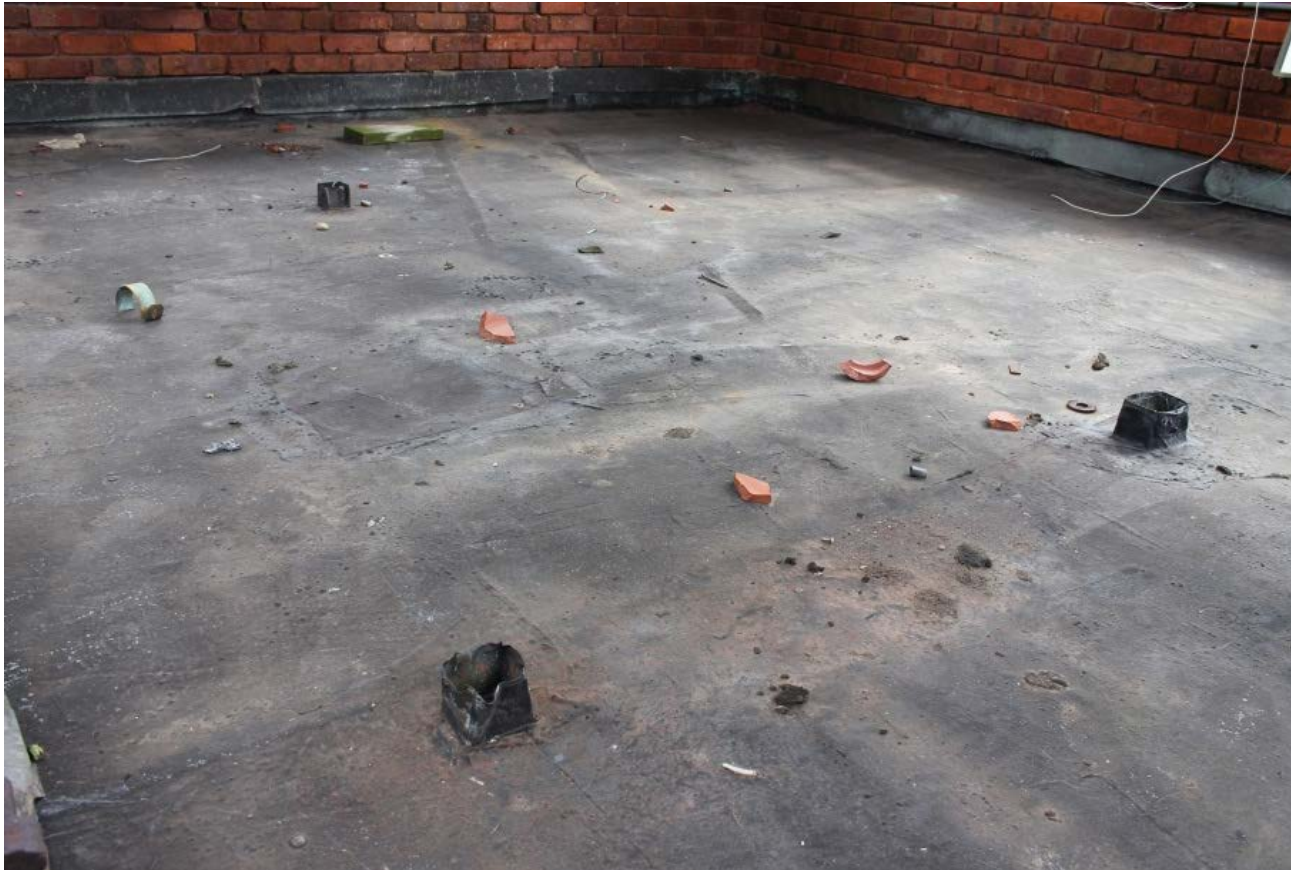
Bell tower floor in need of waterproof membrane replacement and related floor to wall copper flashing. Old supports need attention and a study of whether the bell should be supported by floor or masonry walls.

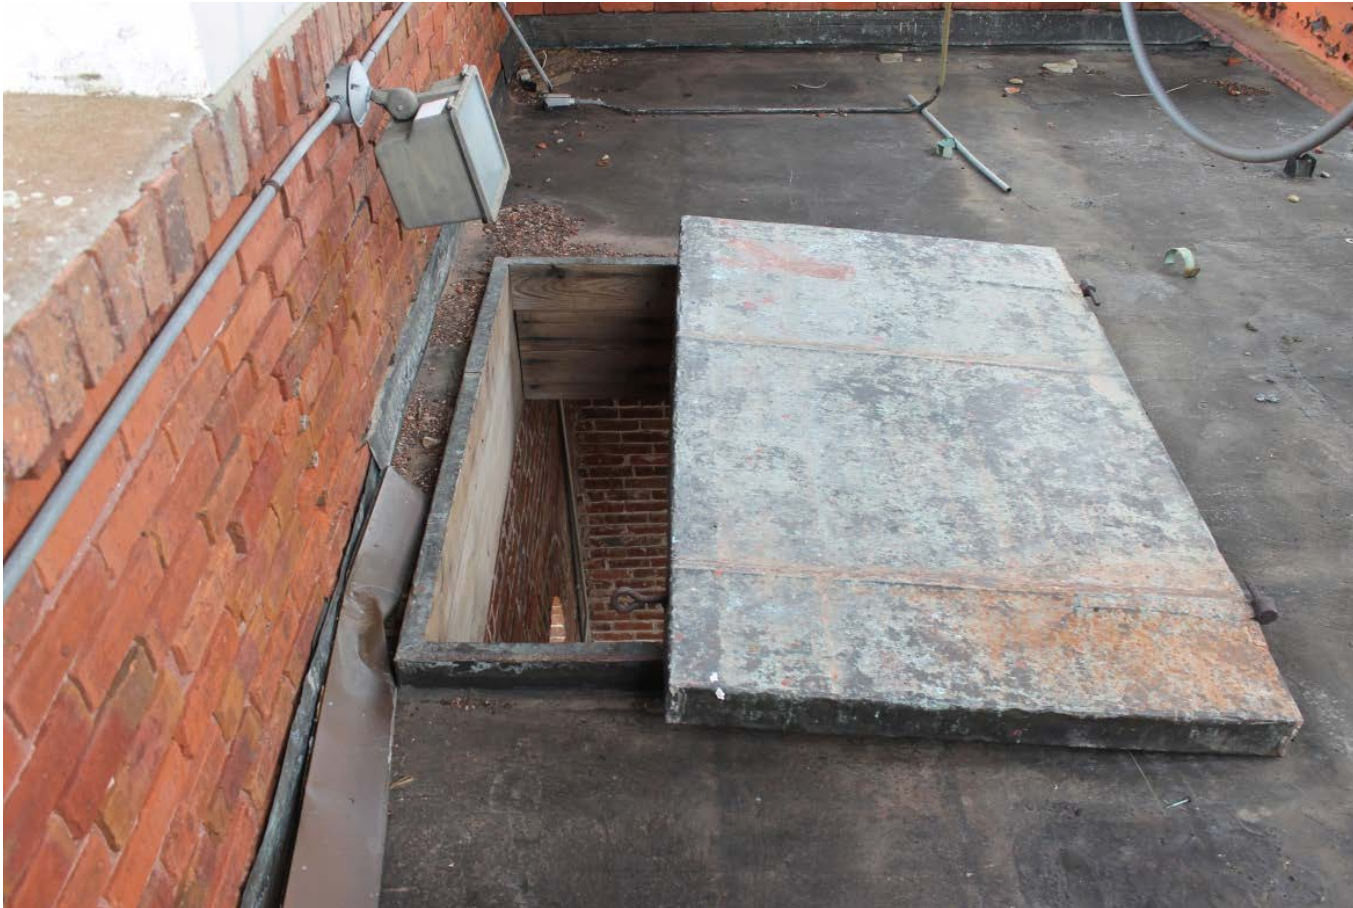
Bell tower top floor in need of new waterproof membrane , flashing and electrical rework.

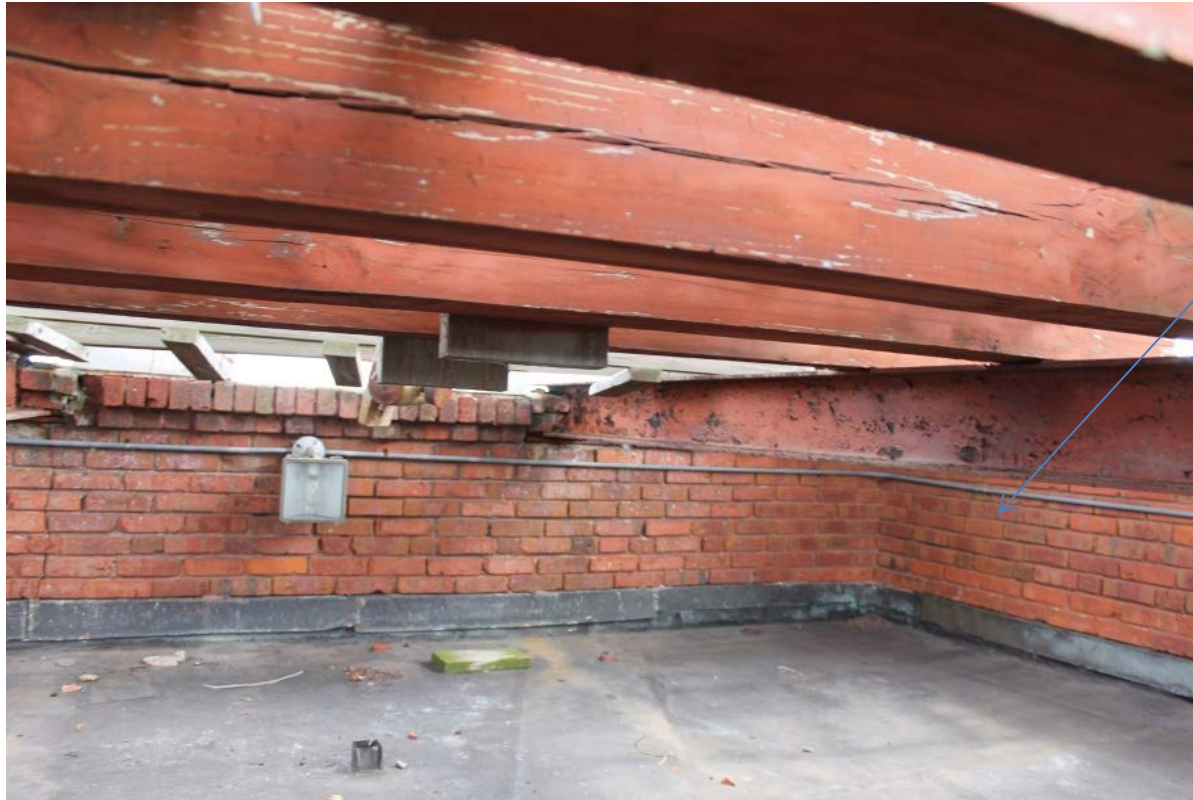
Bell tower top floor. Floor membrane needs replacement, new wall to floor flashing, rework of electrical. Masonry damaged from installation of steel beams to support bell.

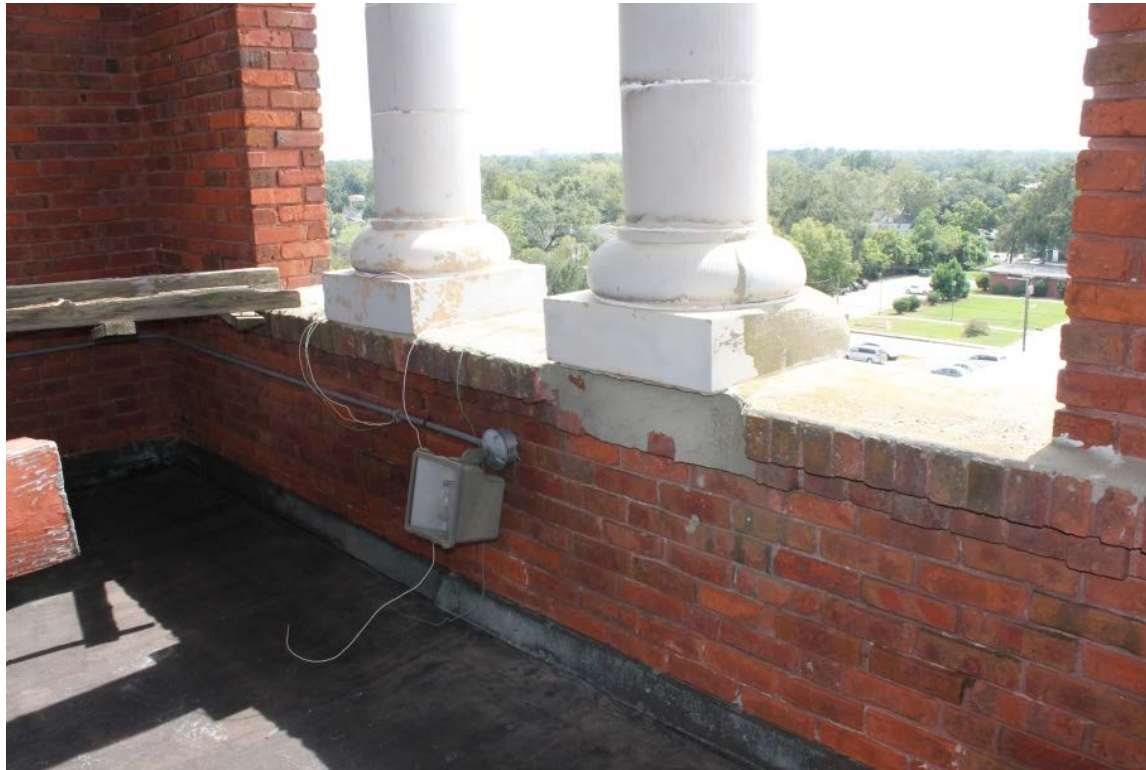
Bell tower
masonry
damaged.
Repairs of poor
quality
workmanship.
Electrical wiring
requires attention.

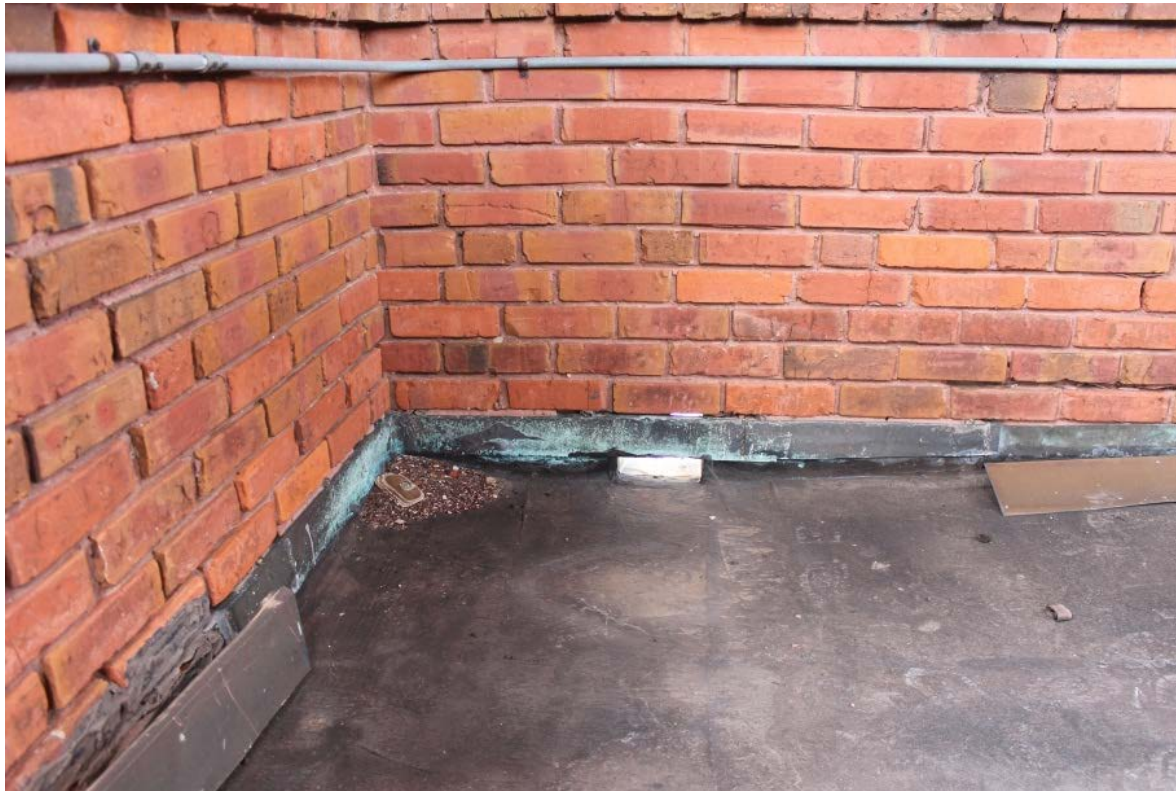
Bell tower floor needs the floor removed and replaced with along with new floor to wall copper flashing. Masonry needs repointing and waterproofing.
