REPORT OF CURRENT CONDITIONS

Cathedral of the Immaculate Conception

Lake Charles, Louisiana

01/05/2013

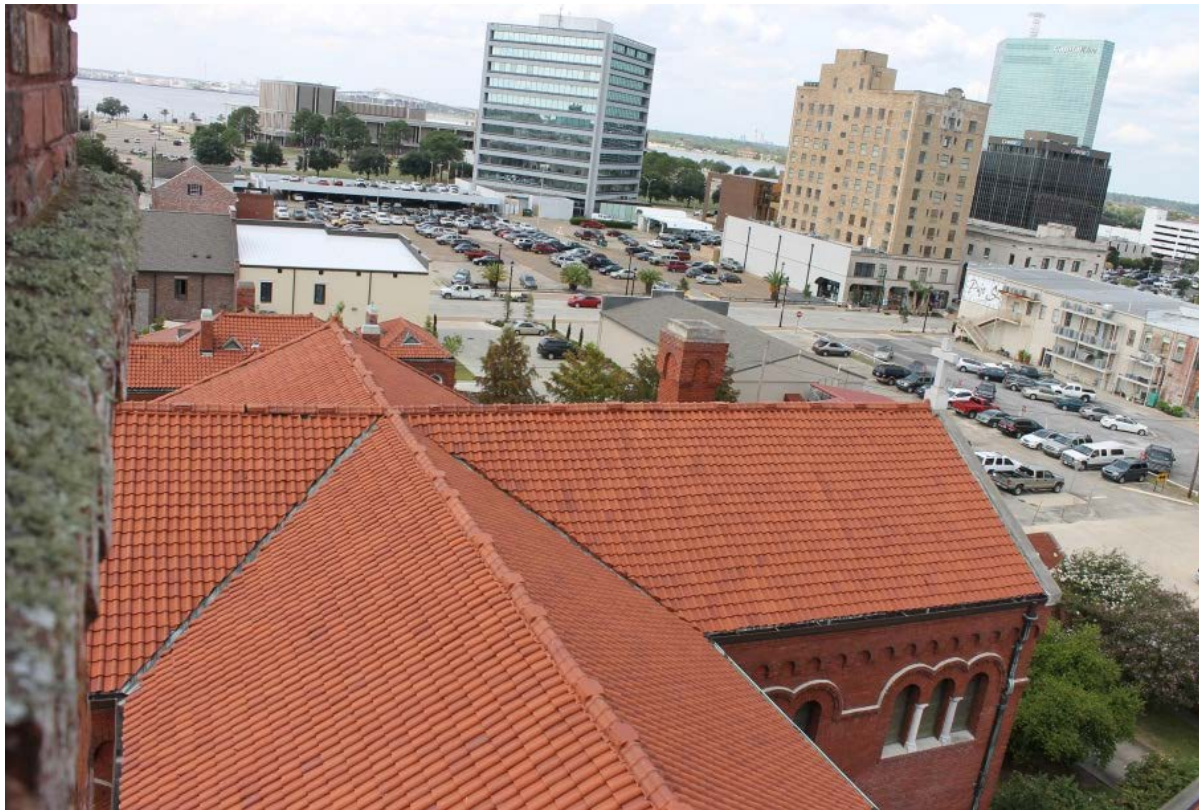
The roof appears to be in good shape. Further inspection of copper flashings, valleys, gutter and downspouts will be necessary. Parapet masonry work and chimney caps need closer inspection and documentation to insure there are no hidden defects.

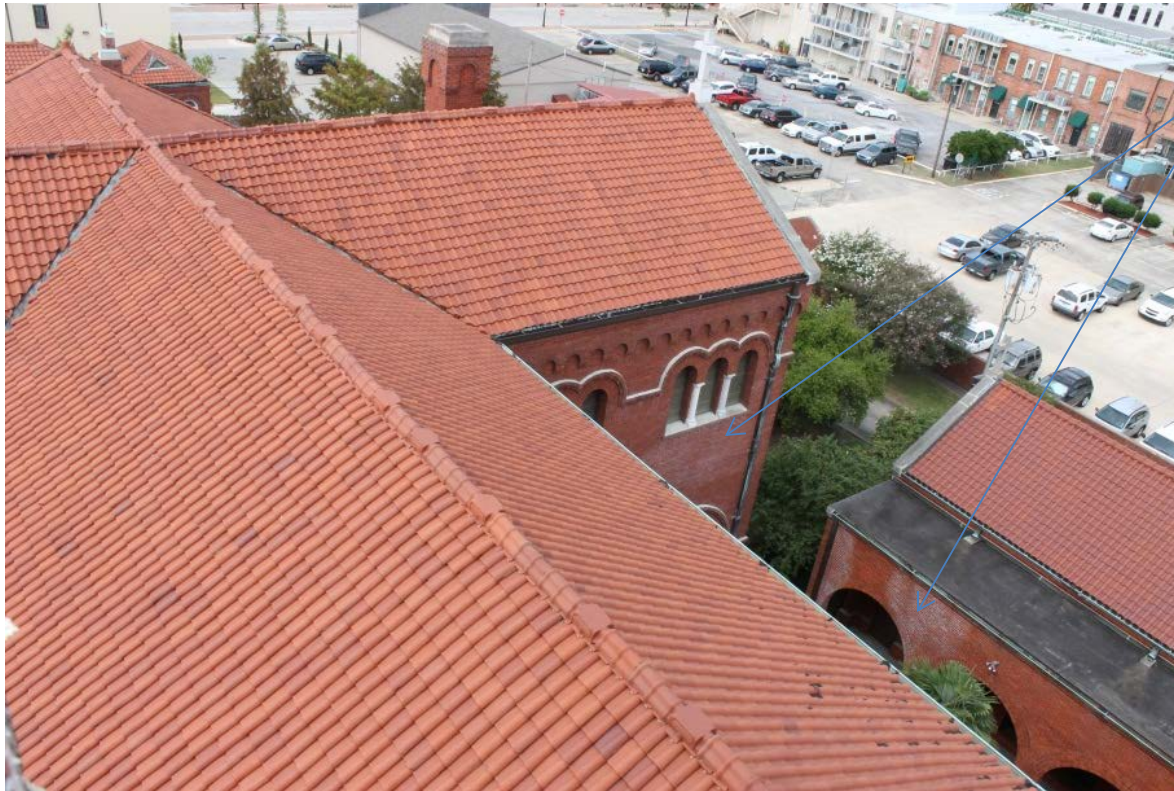
Masonry calcification or
sealer/waterproofing.

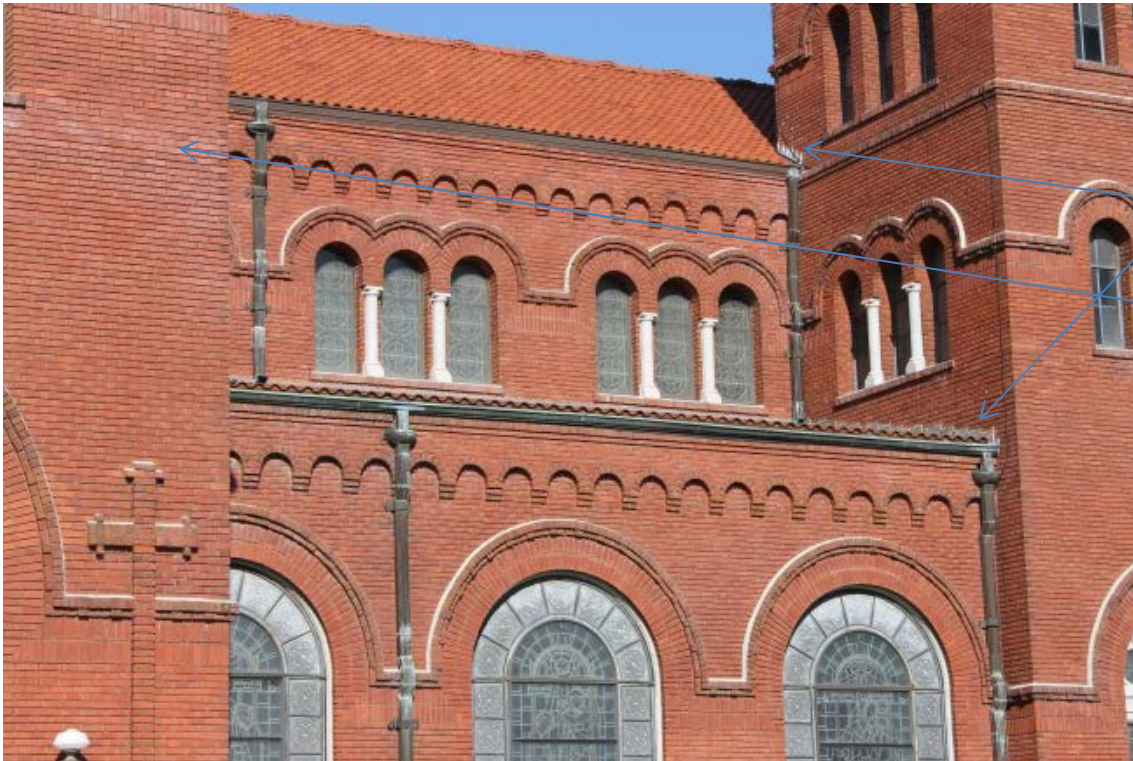
Step roof to wall flashings need close inspections to insure continuity and are without damage.

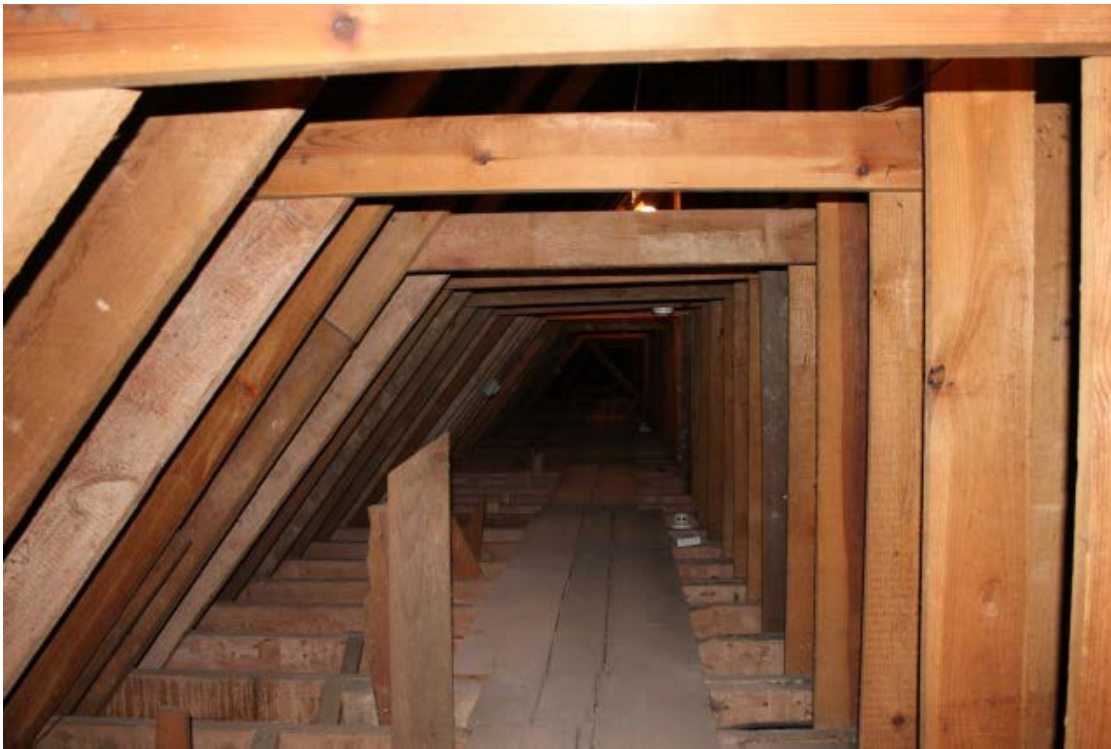
Main roof over Nave.
No issues.

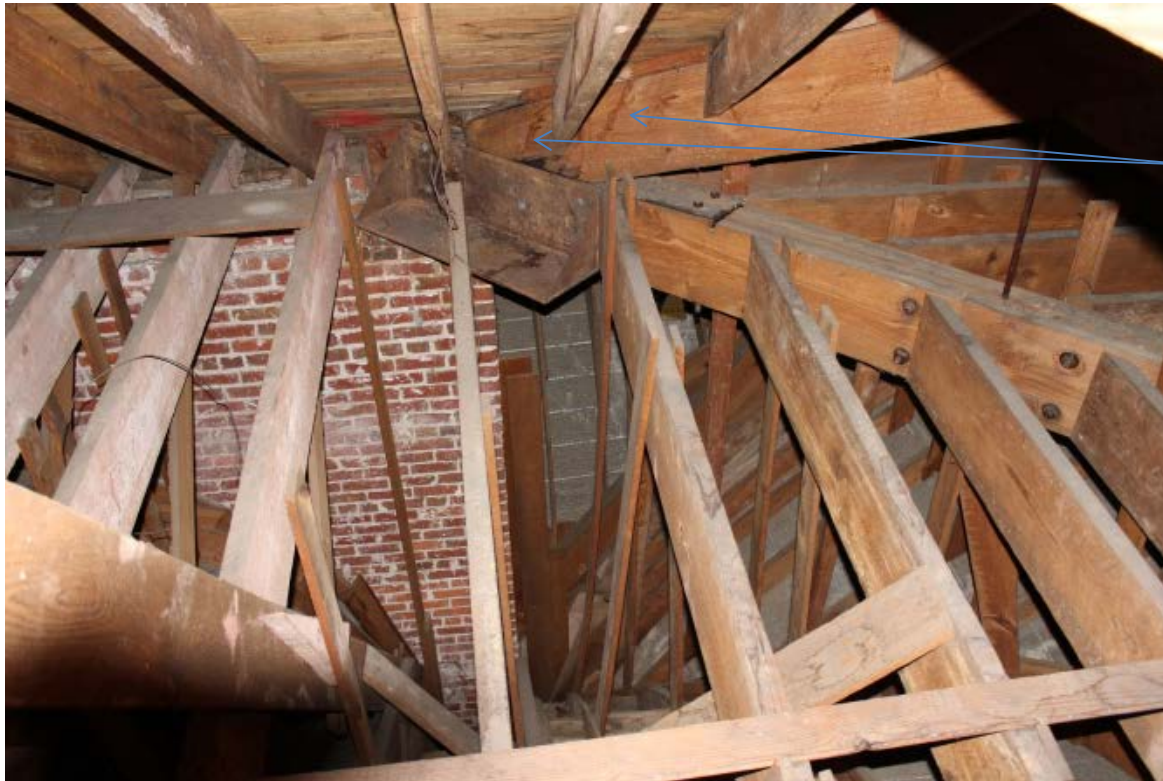
Old water stains.
Wood is not structurally damaged and is still sound.

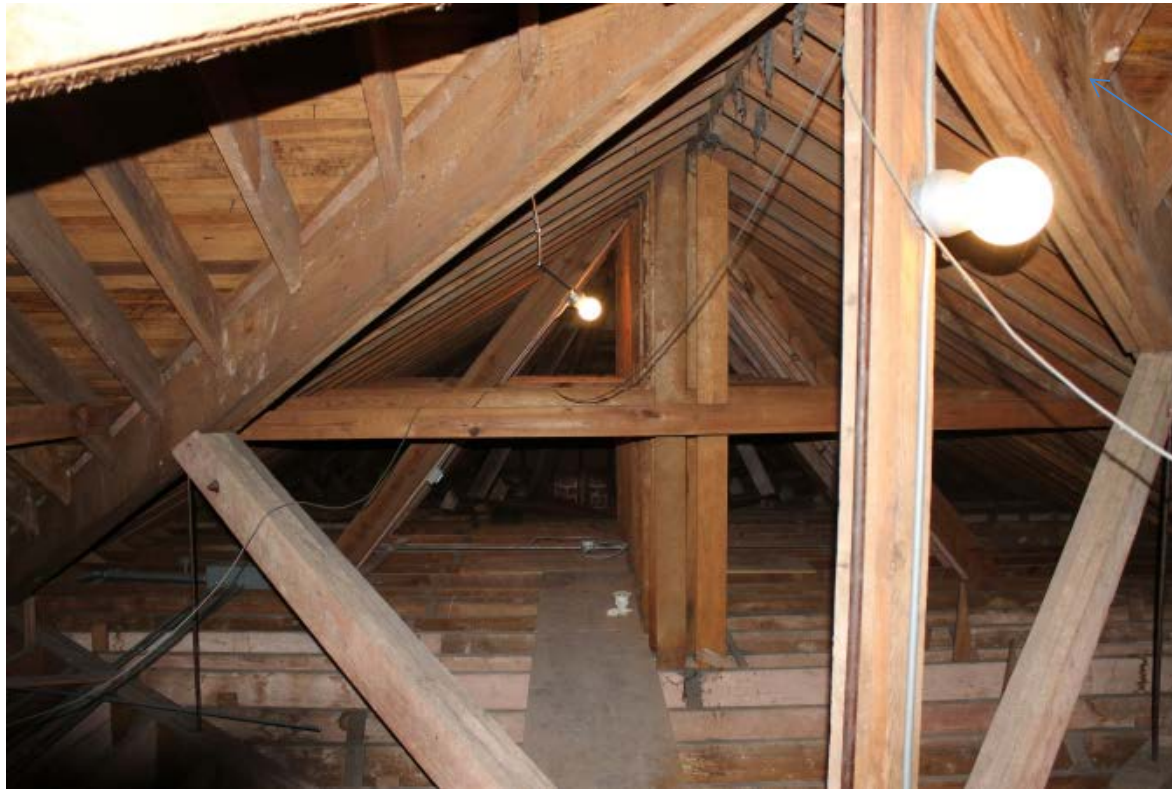
Old water stain.
All framing and
joinery are in
good shape. No
signs of damage
or insect
infestation.

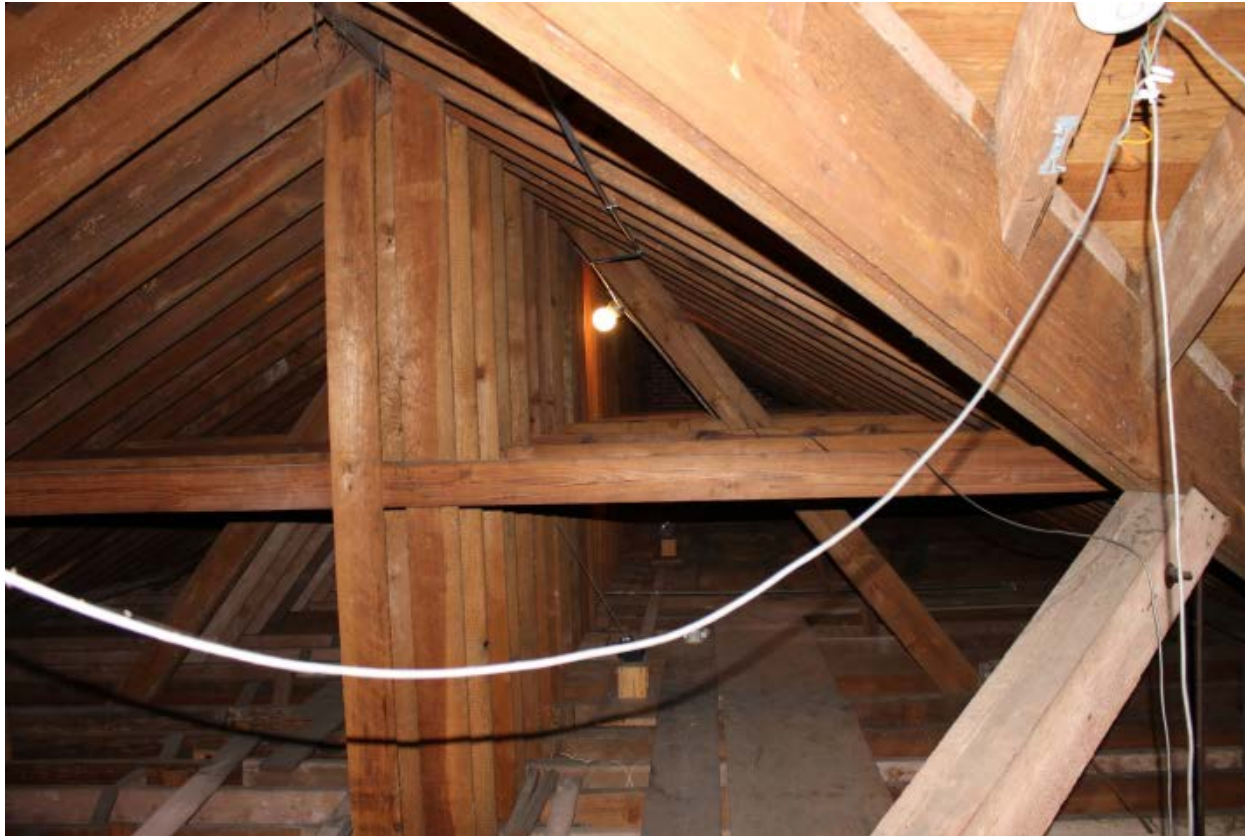
All framing is in very good condition. No problems found. Wiring connections are improper and need to be installed inside an electrical box.

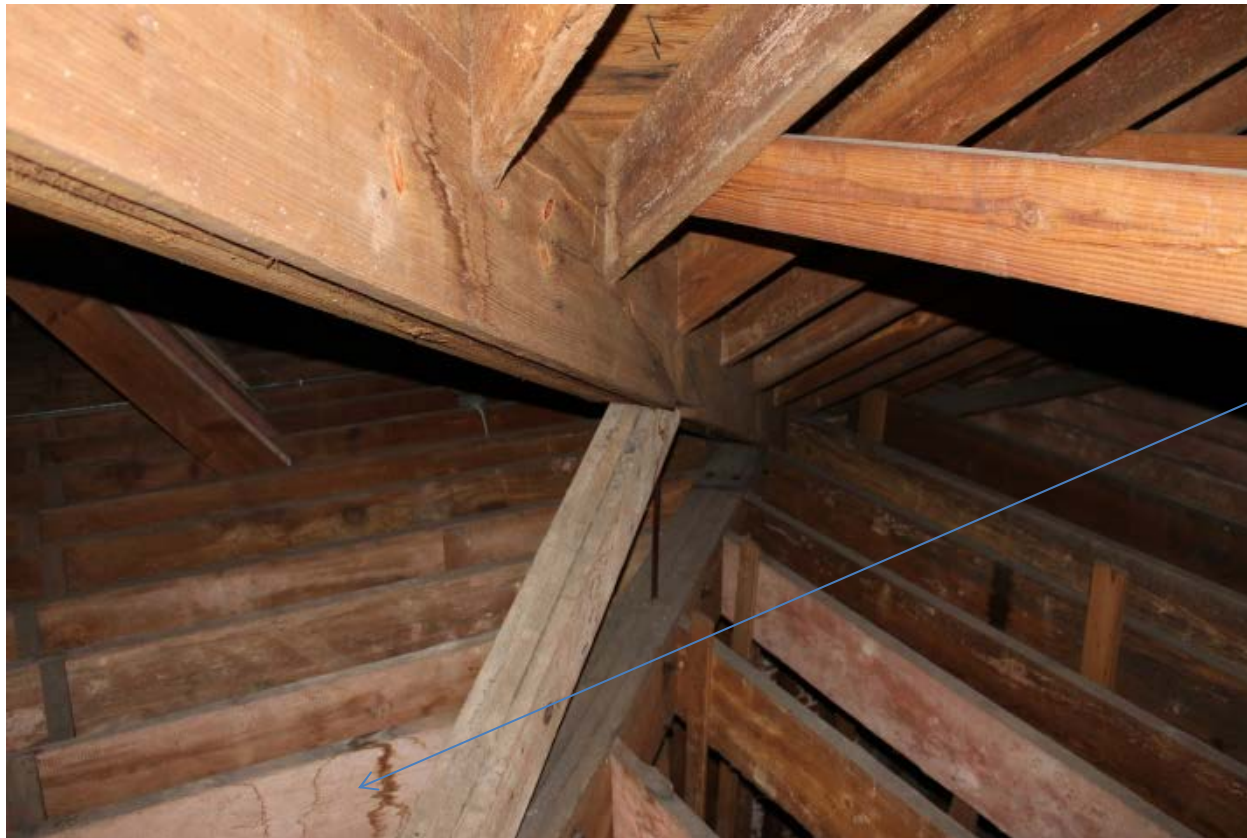
All framing appears to be in good shape. All joinery is tight. No signs of insects or damage.

Old water stain.

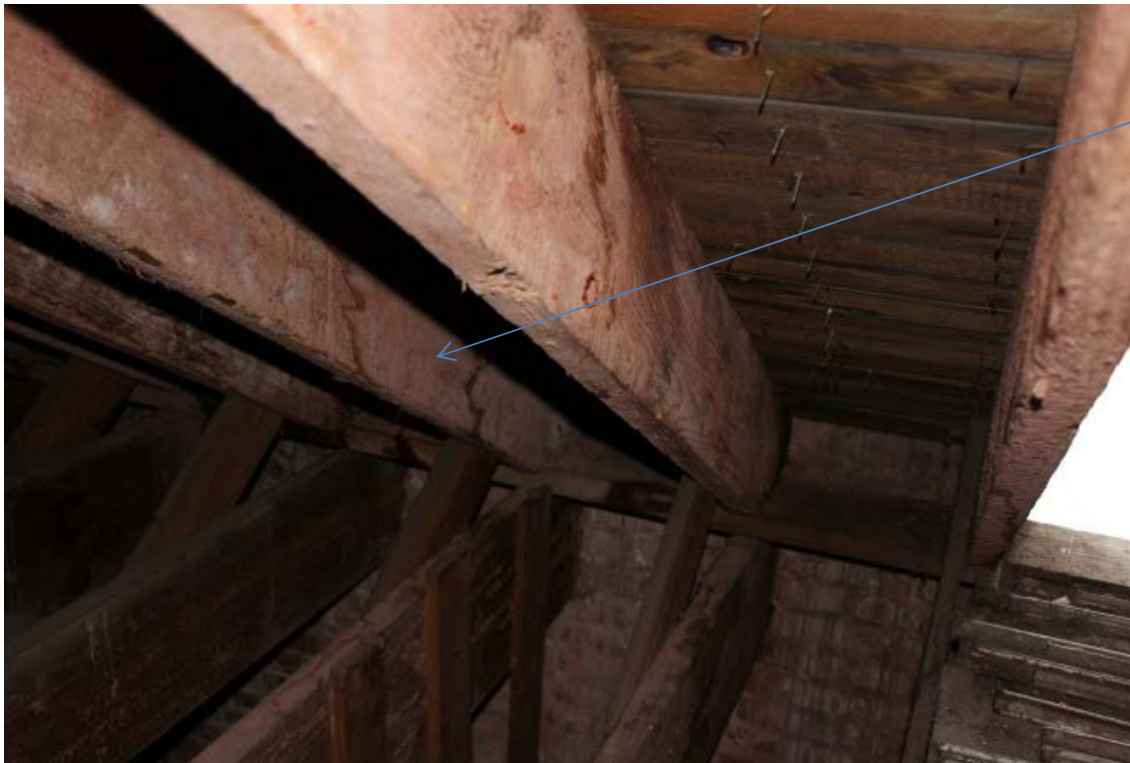
Old water stains
from leaks prior to
re-roofing performed
in 1980.

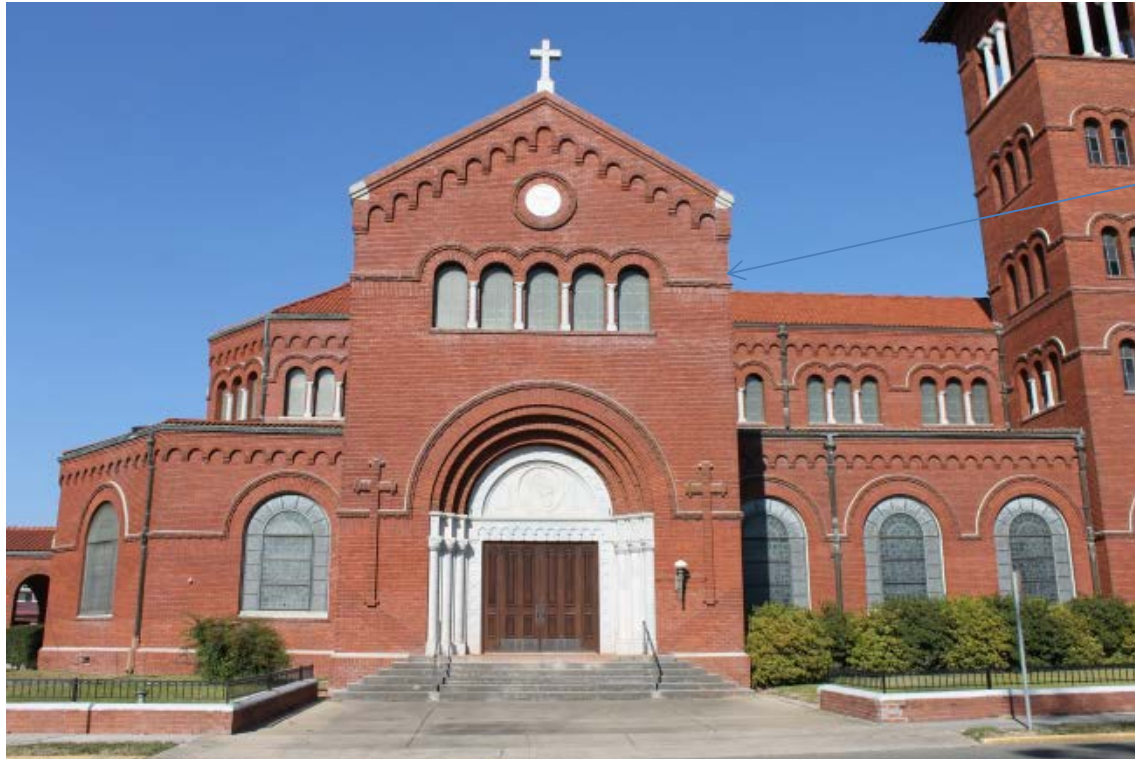
Masonry is in need of cleaning and repointing in areas. Signs of efflorescence and or masonry sealer previously installed is indicative in some areas.

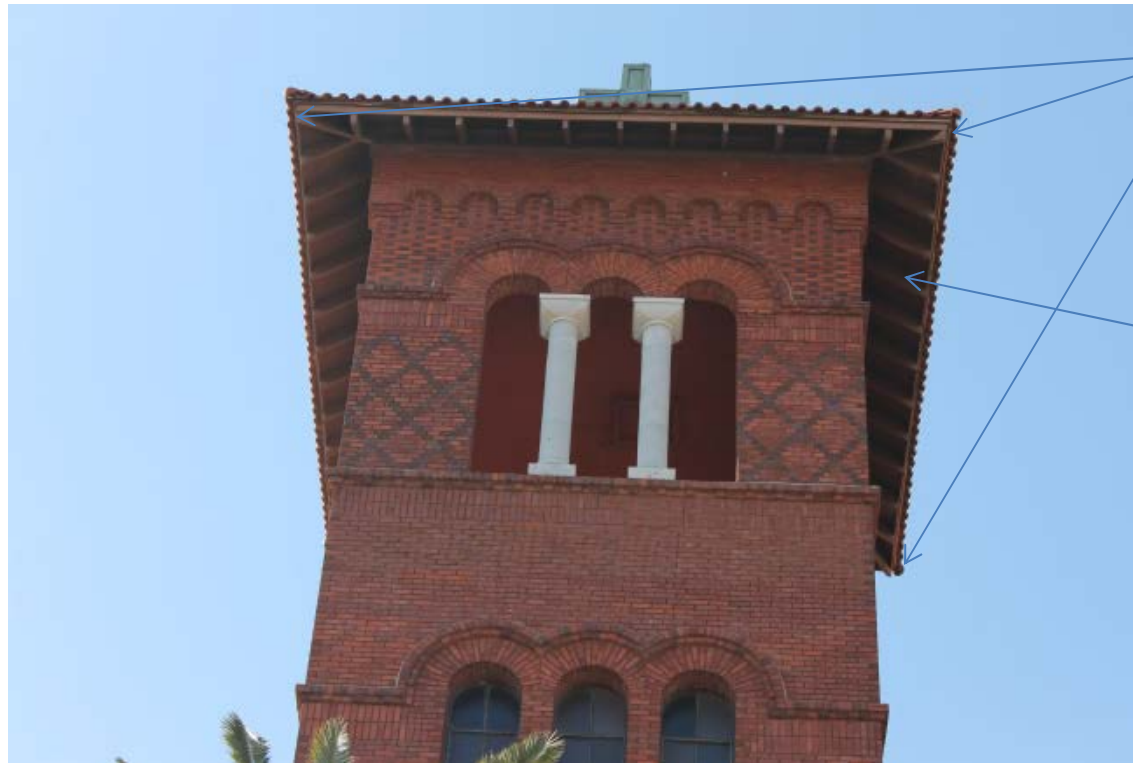
Wood hip rafters at four corners show signs of rot on ends where they are exposed to direct sun and rain. All overhangs are in need of cleaning and recoating.

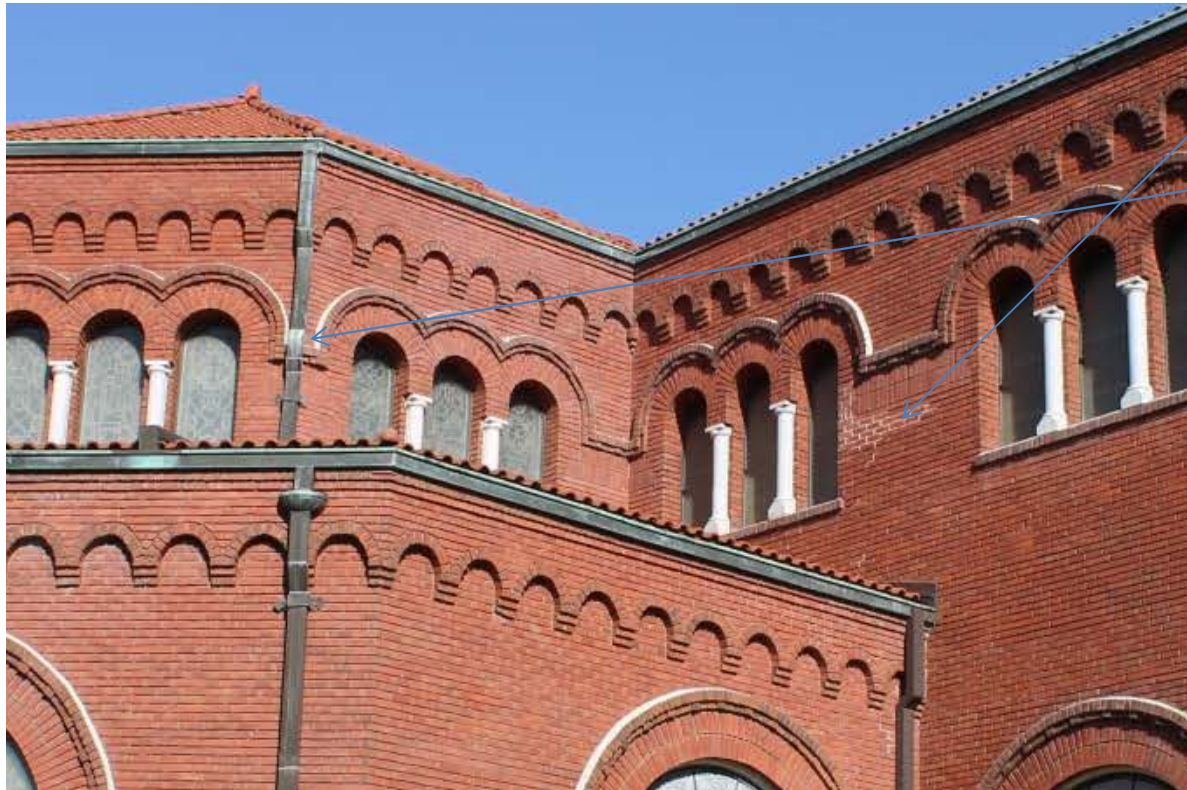
Prior improper masonry repointing requires attention. Signs of gutter leakage at joints are prevalent. Masonry and gutters require proper cleaning. Windows need a thorough detailed investigation and report for rework.

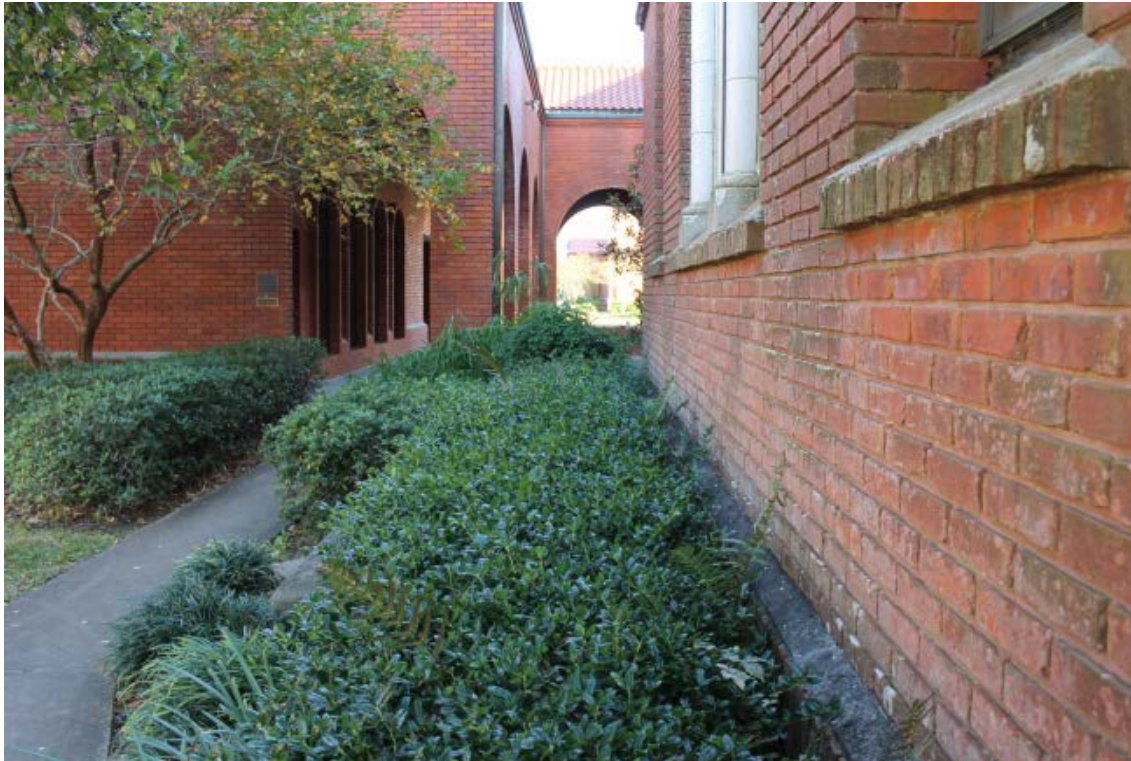
Masonry requiring cleaning.
Landscaping needs to be cut back to allow cross ventilation under building.

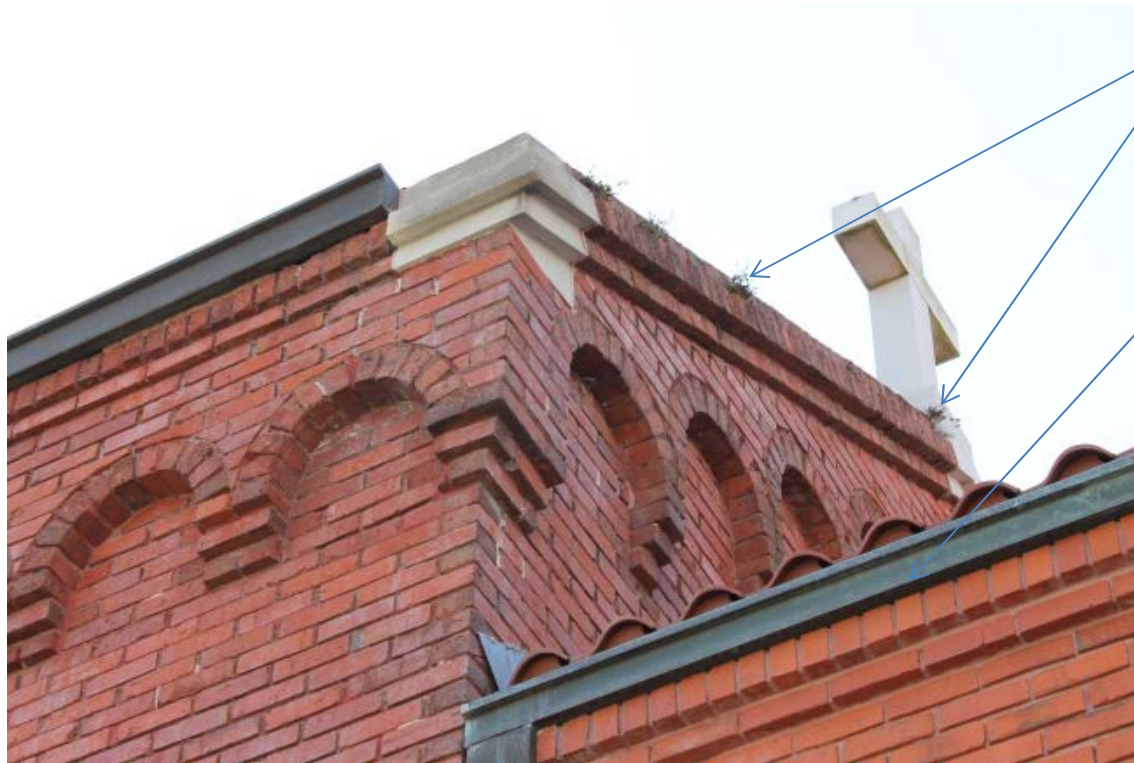
Vegetation growth requires removal. Flashing needs close, thorough inspection including associated sealant. Gutters and downspouts and waterproofing under gutters require thorough inspection for leaks and fastening. Masonry requires cleaning & repointing.

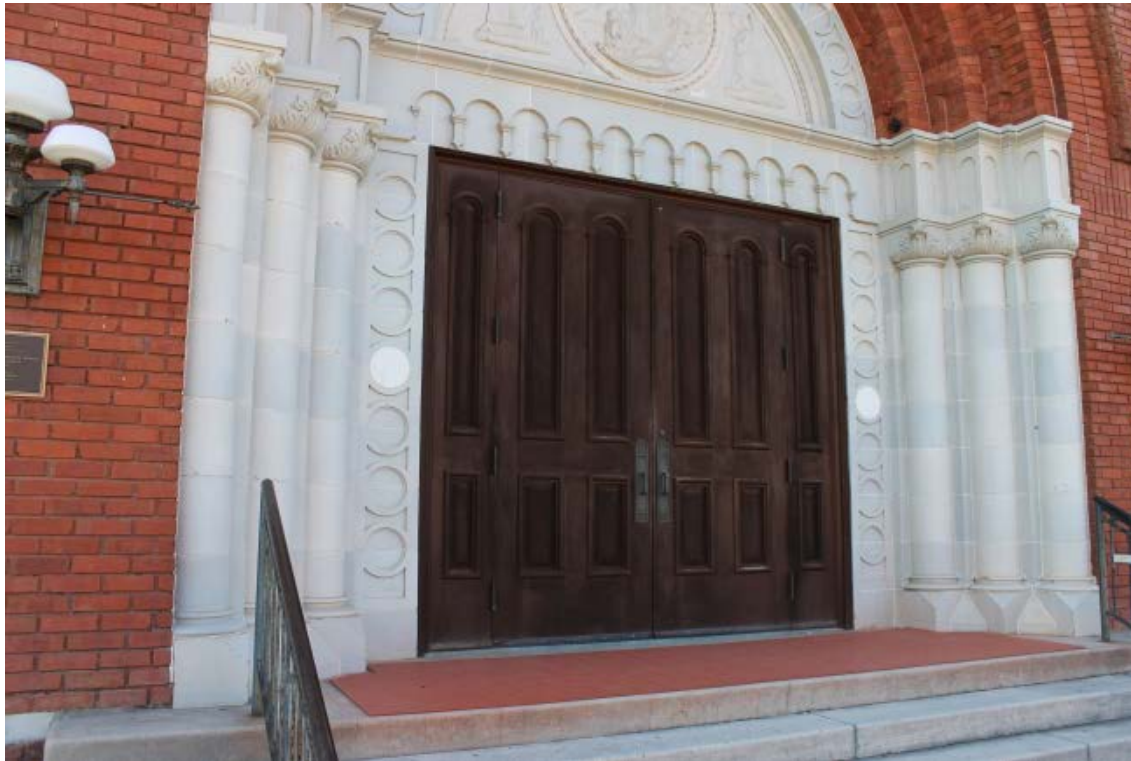
Exterior main doors at Narthex are in need of cleaning and proper coating, including all perimeter edges.

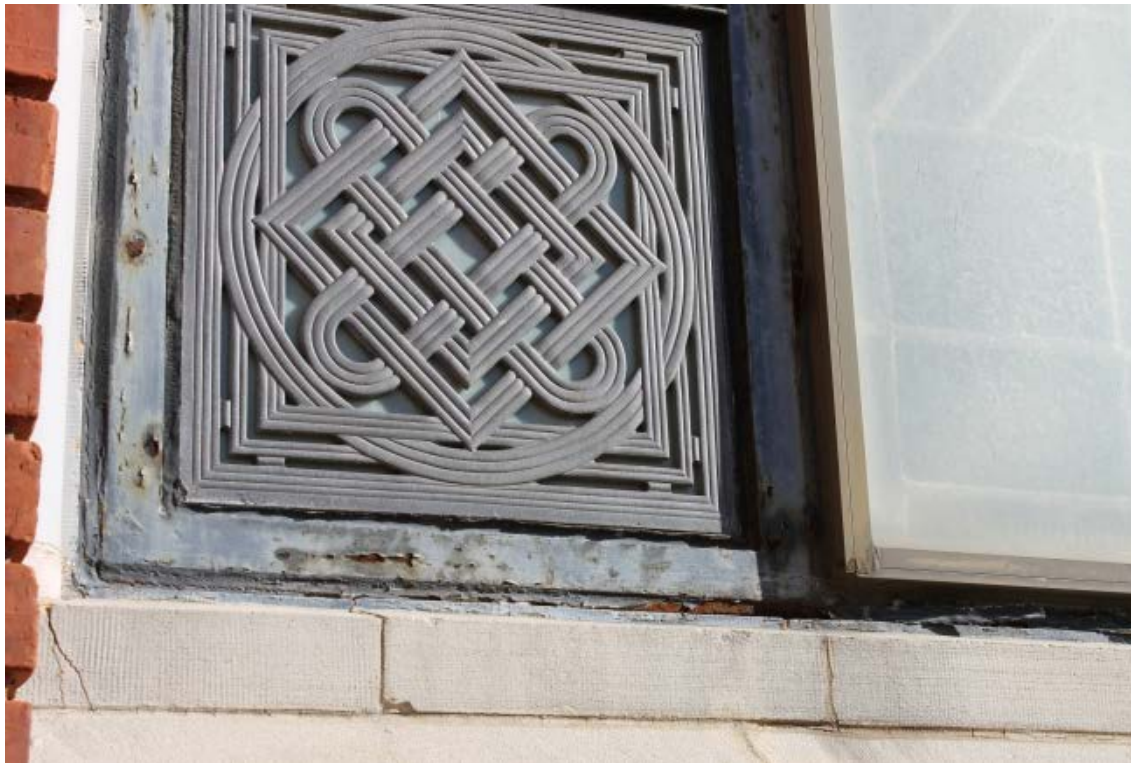
Original iron windows. Some windows pieces are beyond repair and parts will require exact replacement. A detailed written report and scope will be required of each and every window.

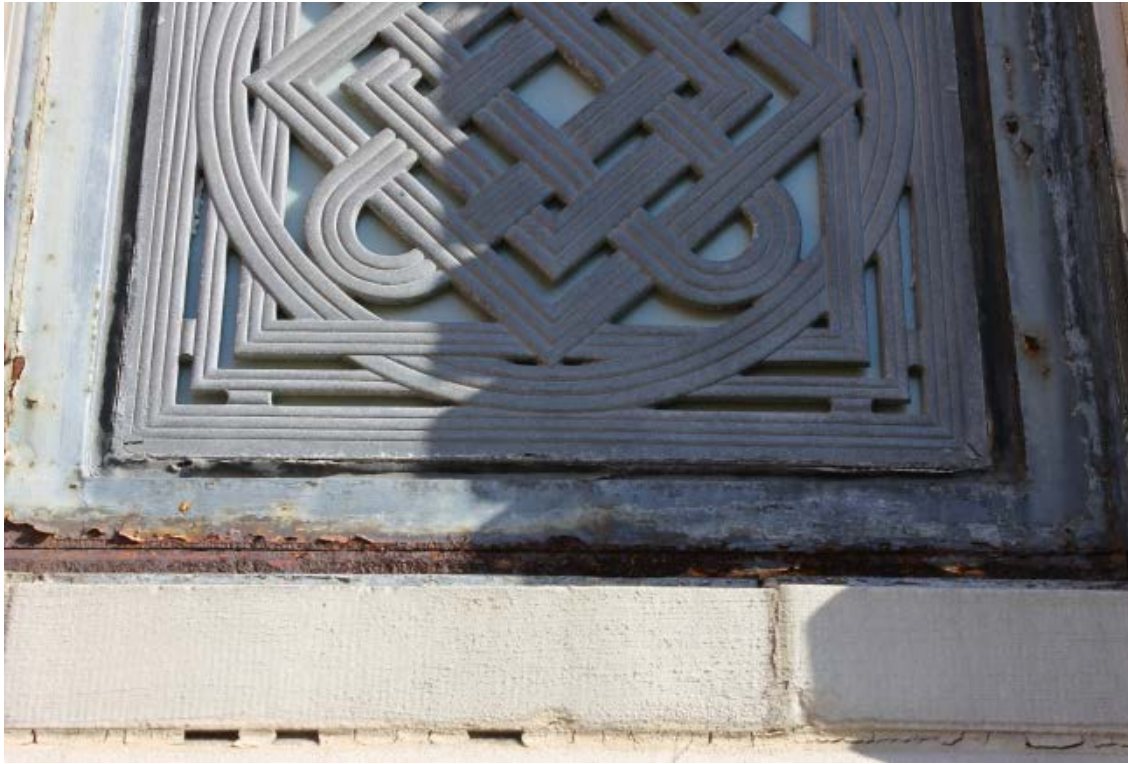
Rust and corrosion is prevalent on most all windows. A detailed inspection and report on each window is required with a corrective scope of work defined.

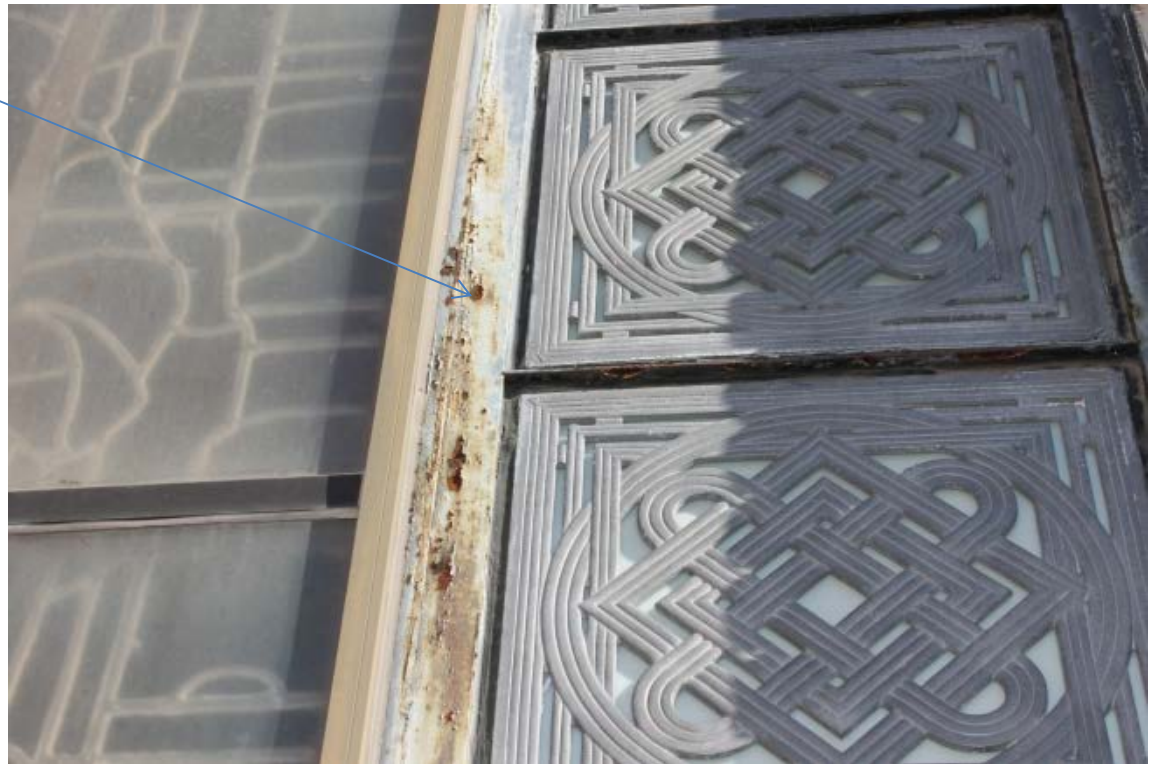
Rust and corrosion

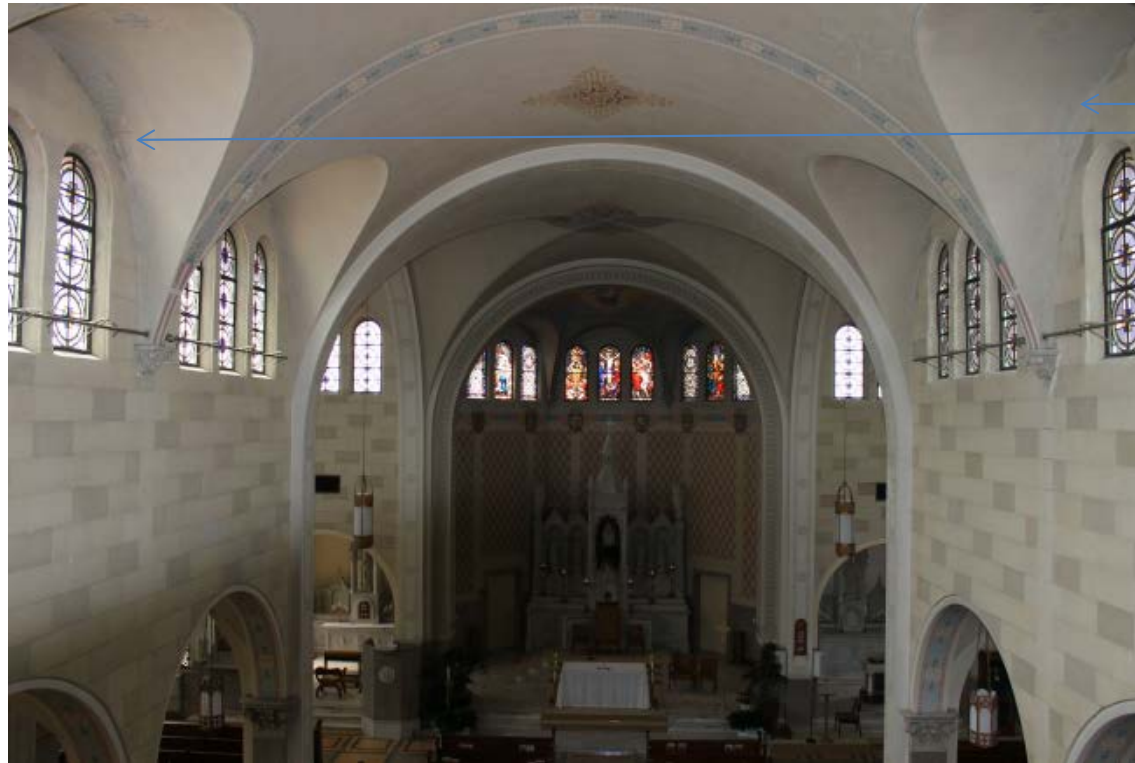
Signs of
moisture
penetration

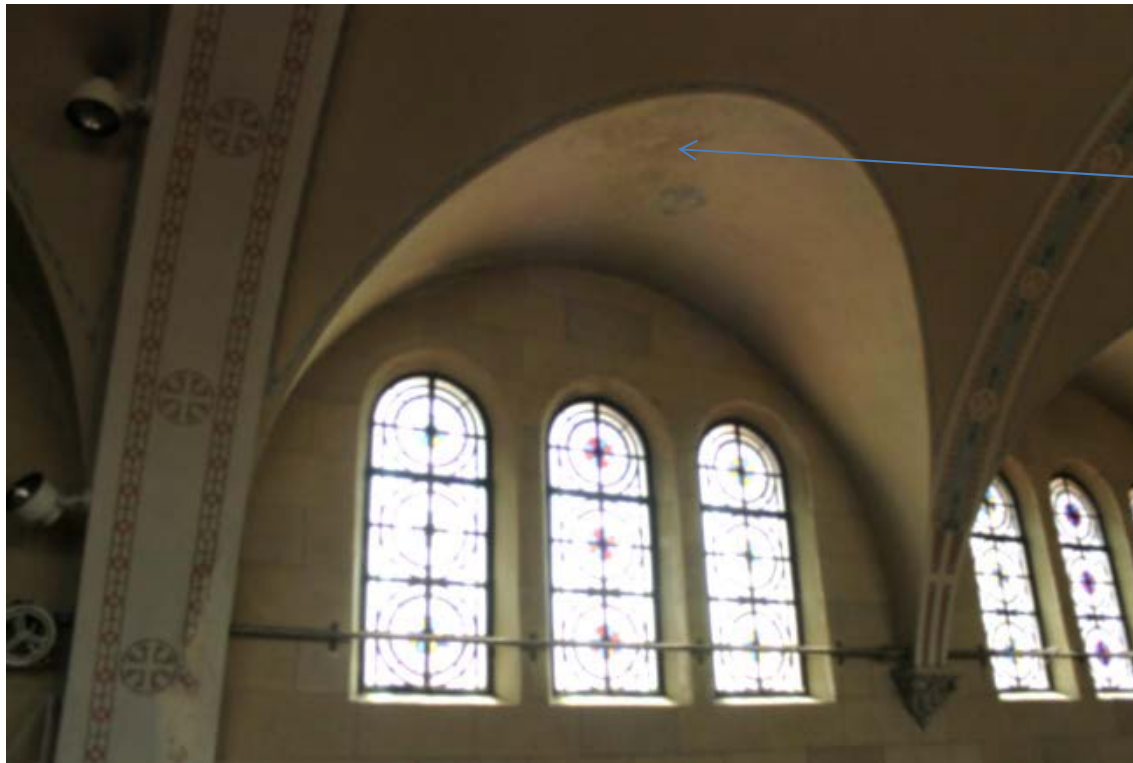
Plaster damaged from is believed to be old roof leaks that were previously repaired.

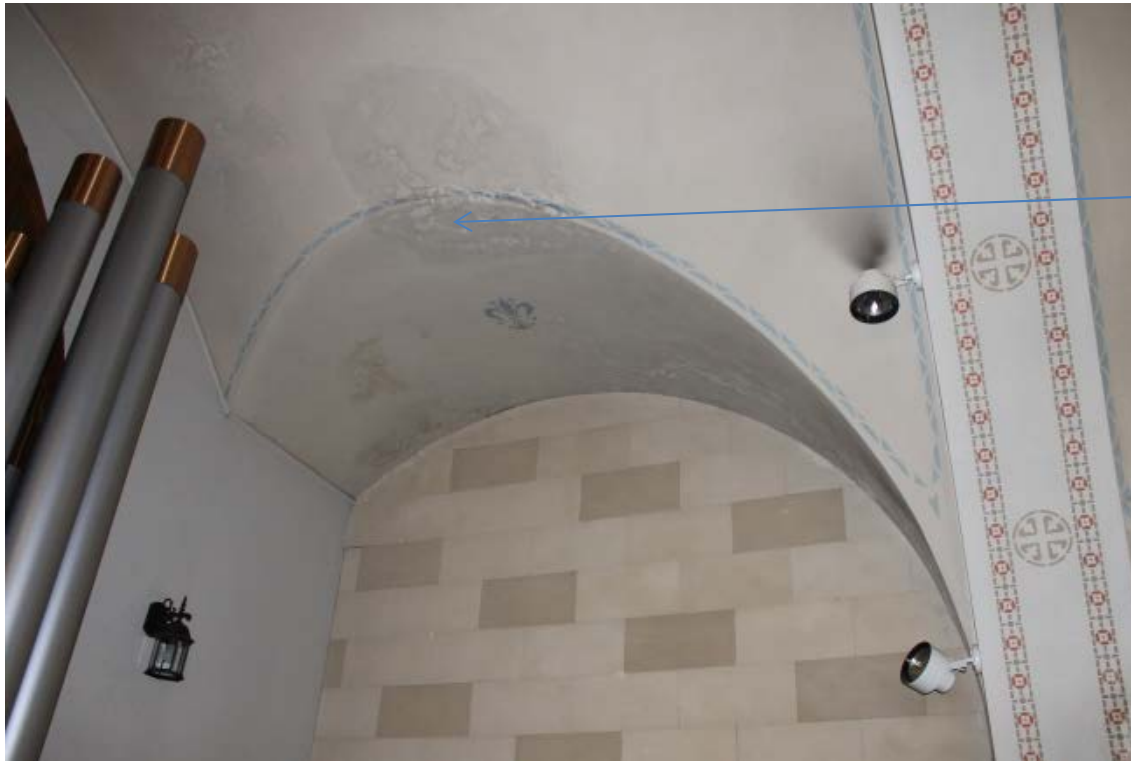
Damaged plaster from water leakage. Plaster will need to be analyzed and a final determination of a detailed scope of work should be established. This is very prevalent at all of the arches. This photo is in the choir loft.

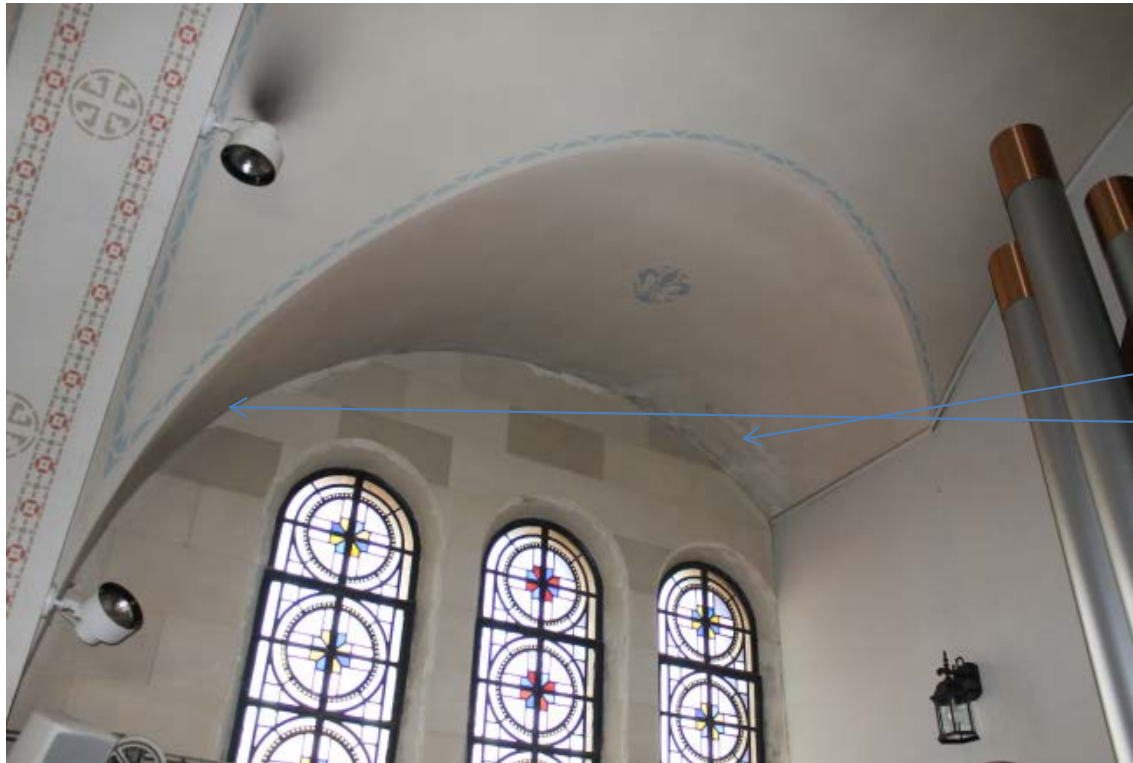
Damaged plaster from water leakage. Plaster will need to be analyzed and a final determination of a detailed scope of work should be established. This is very prevalent at all of the arches. This photo is in the choir loft.

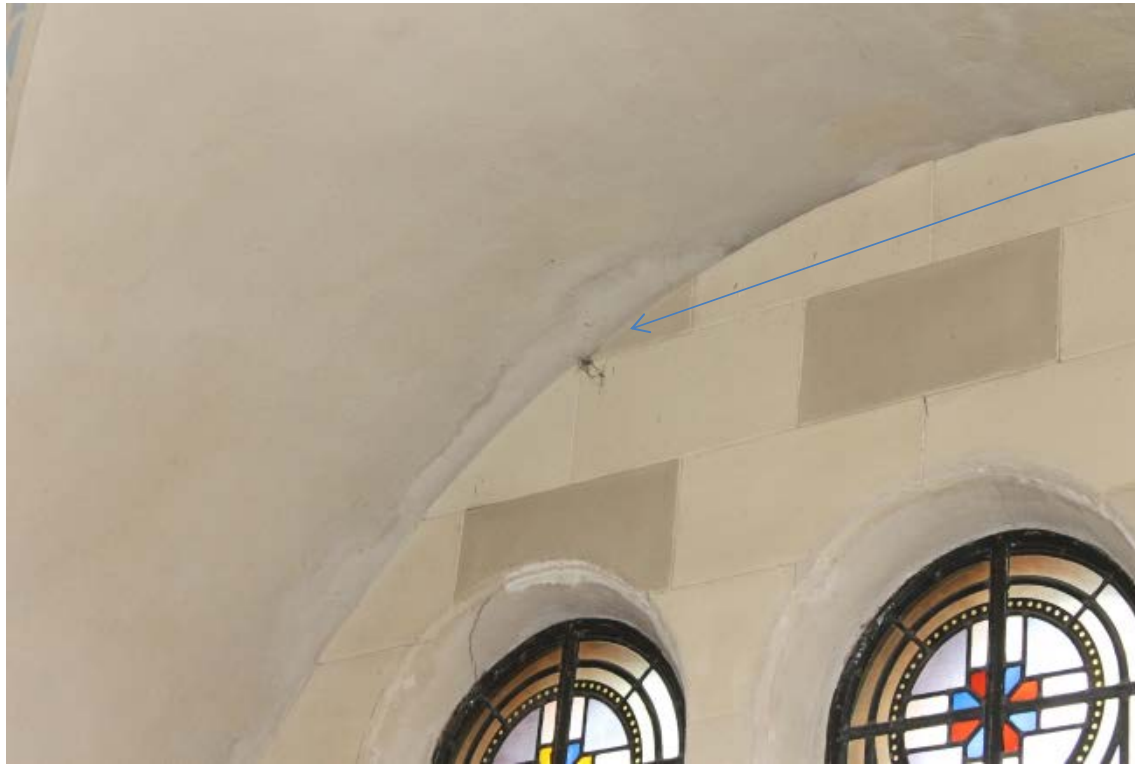
Plaster that has become wet and stained. Scaffolding will need to be set and sampling made to determine assessment.

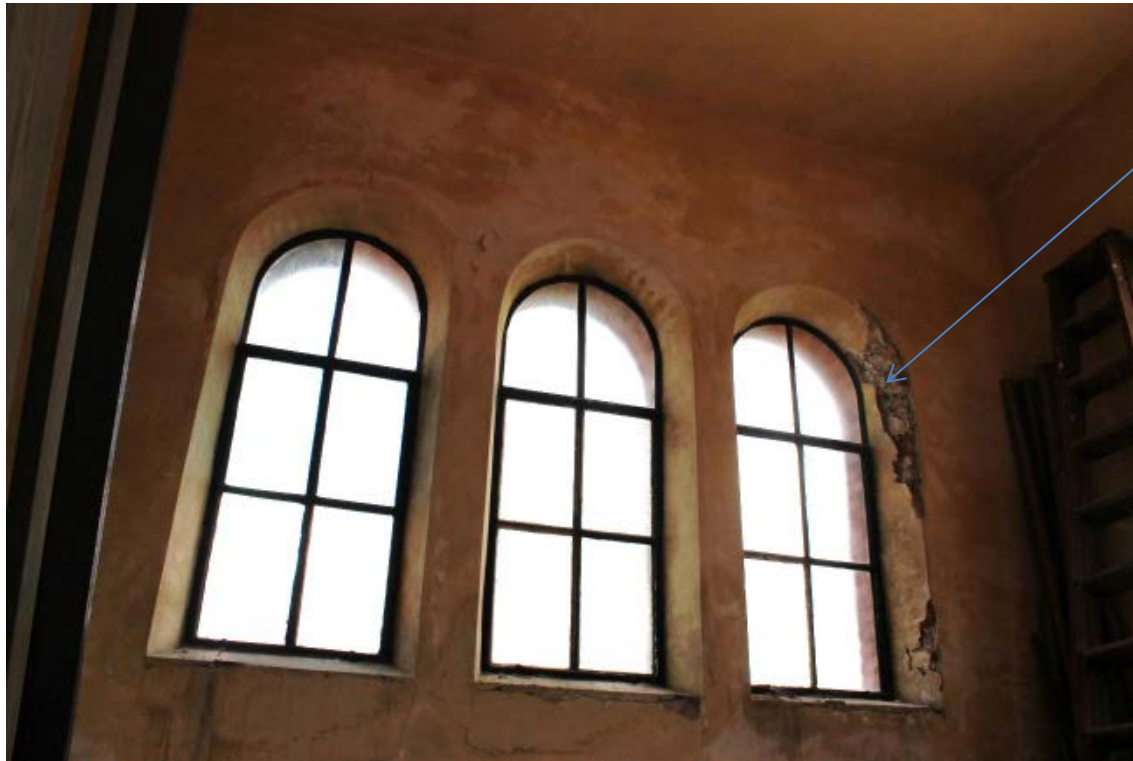
Interior plaster rotted and missing from water intrusion. This is prevalent throughout building and especially in bell tower.

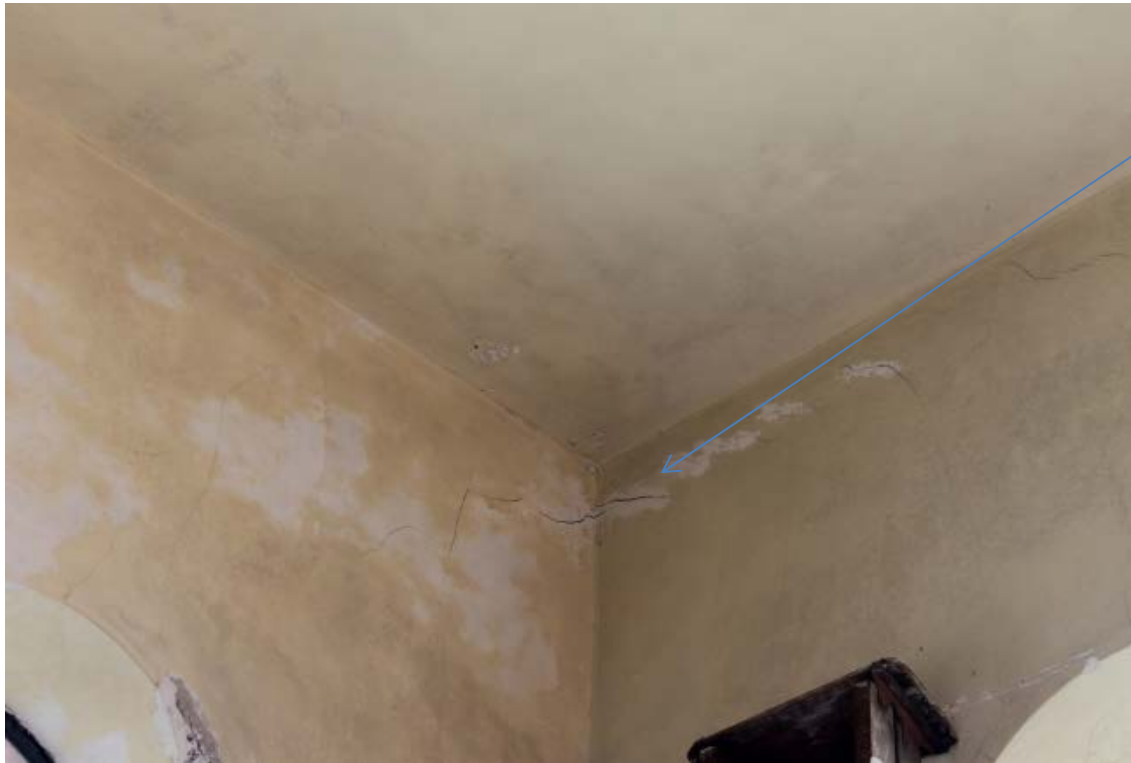
Stress cracks in
plaster at bell
tower at 2nd
floor.
