REPORT OF CURRENT CONDITIONS

Cathedral of the Immaculate Conception

Lake Charles, Louisiana

01/05/2013

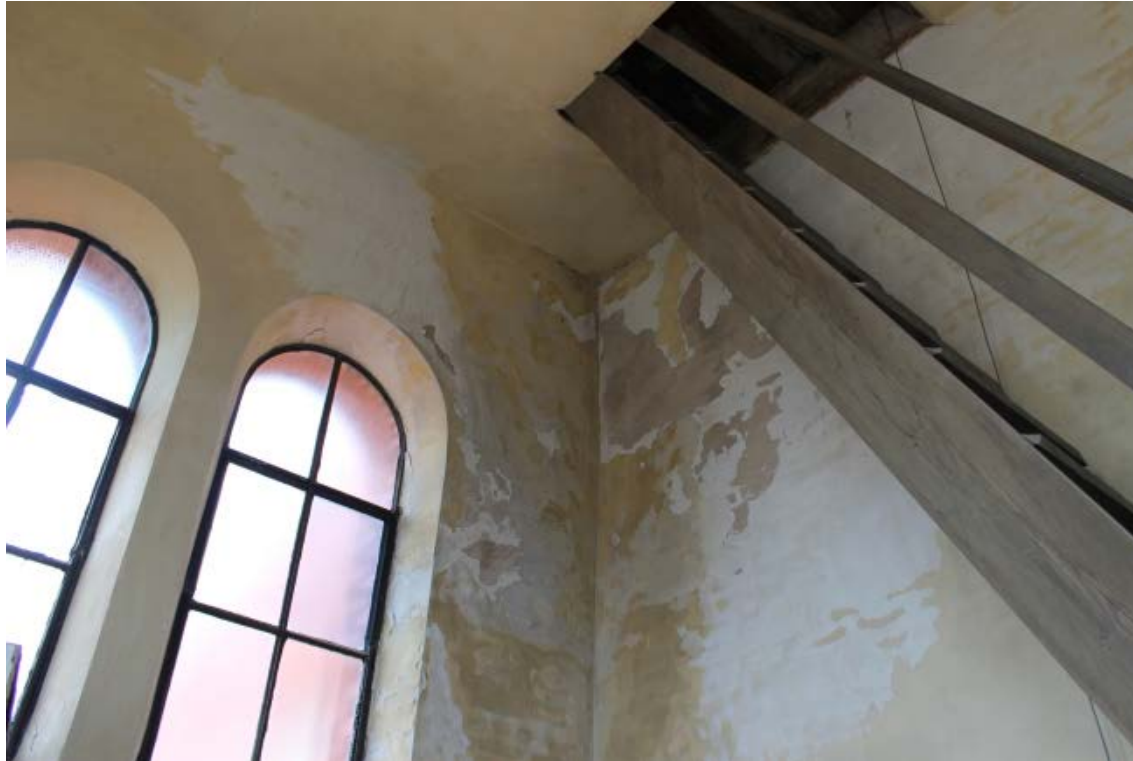
Plaster in bell tower from moisture migration through walls and roof/wall intersection leaks.

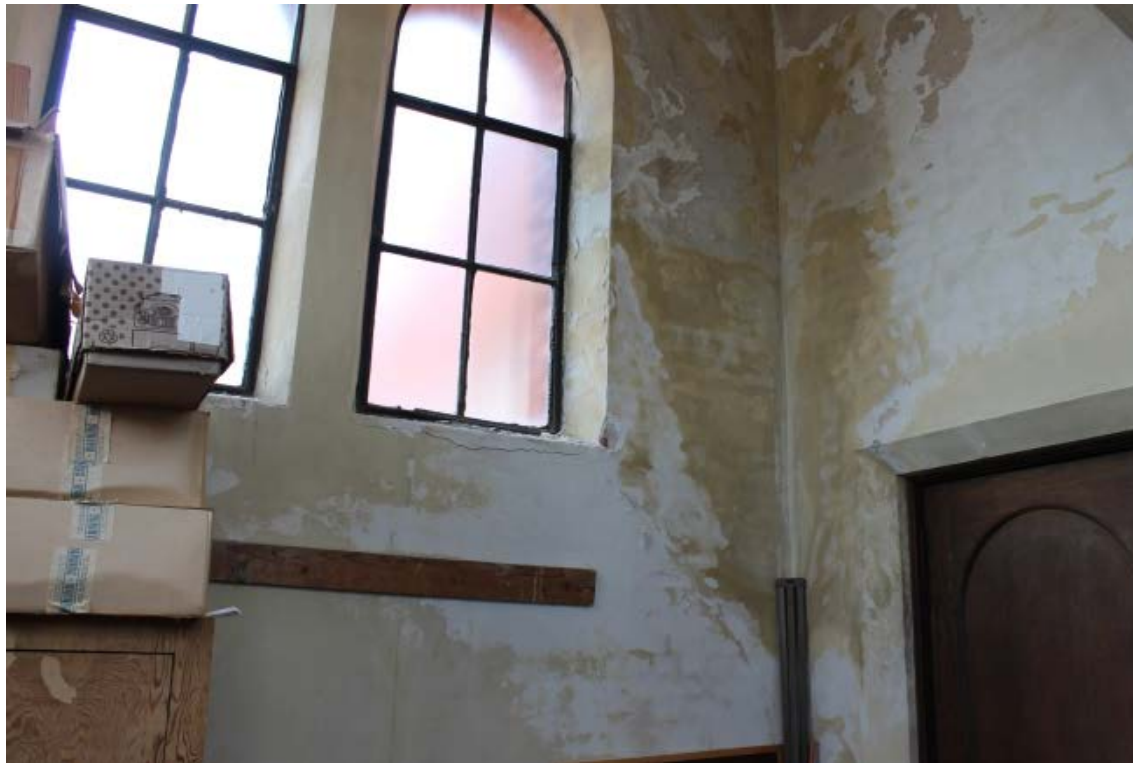
Plaster in bell tower from moisture migration through walls and roof/wall intersection leaks.

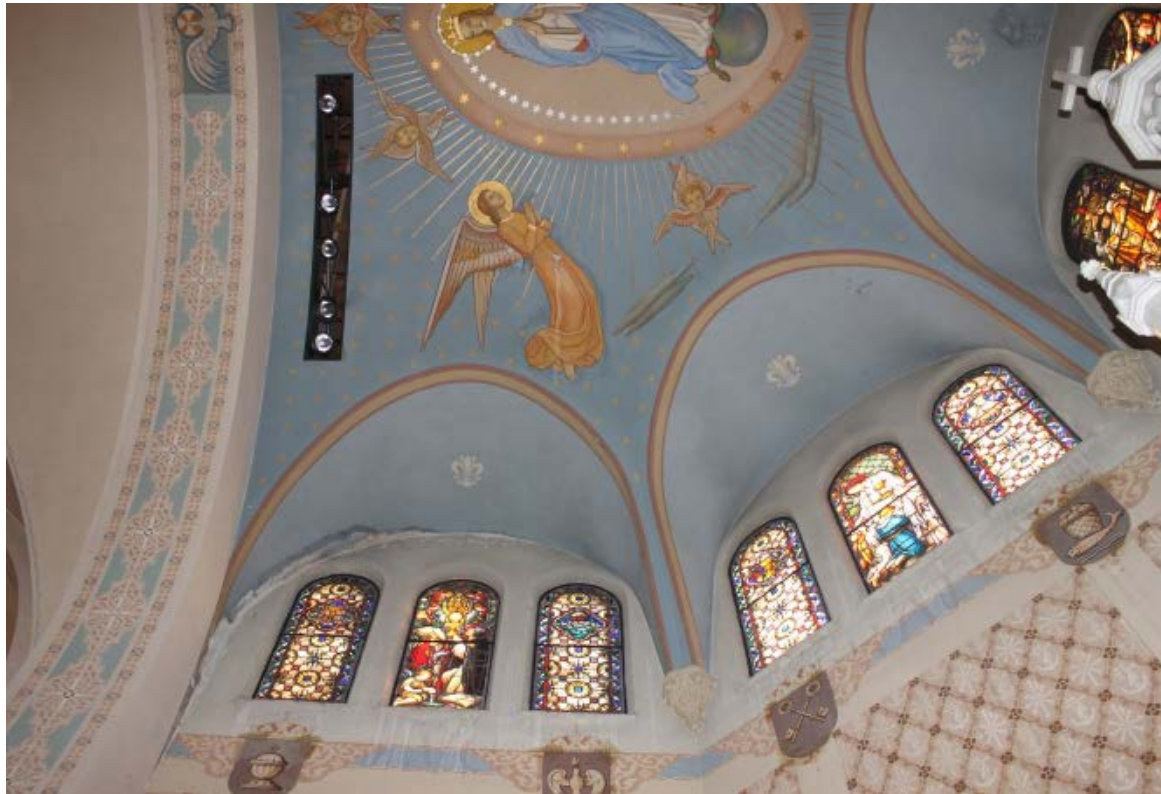
Water leaks are substantial at Apse at both roof and windows. The reader should review the digital photos provided in the back of this report to enlarge and obtain a clearer picture of the issues and problems with moisture penetration throughout the church.

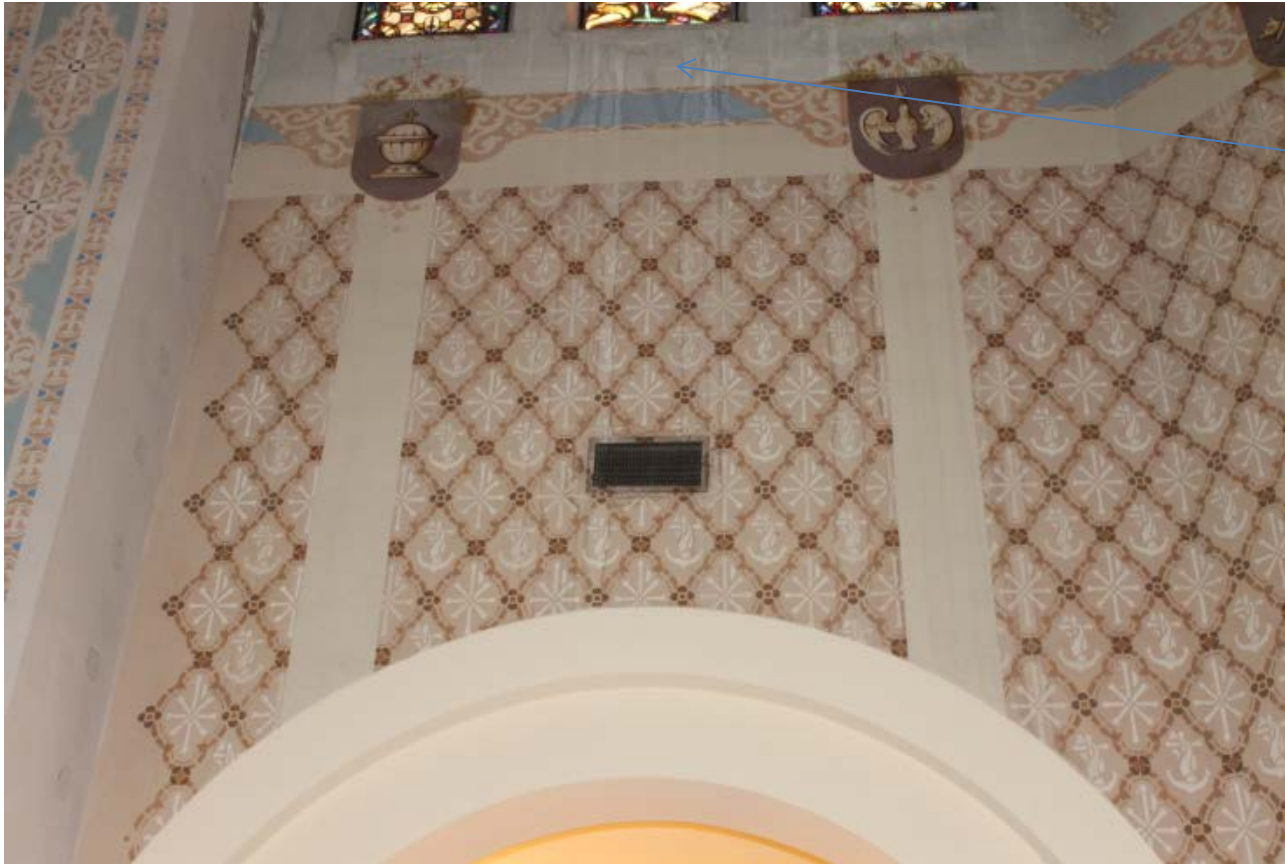
Water and moisture penetration at upper Apse.

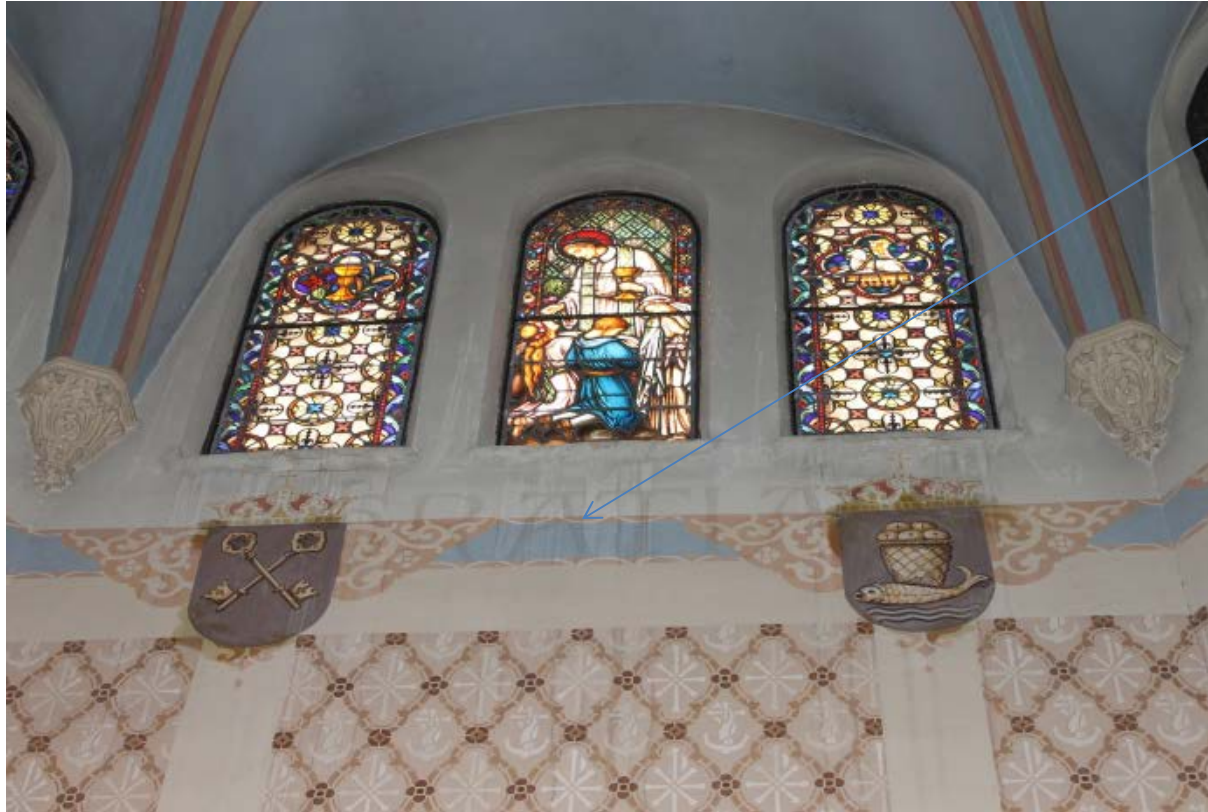
Original wall painting bleed through.

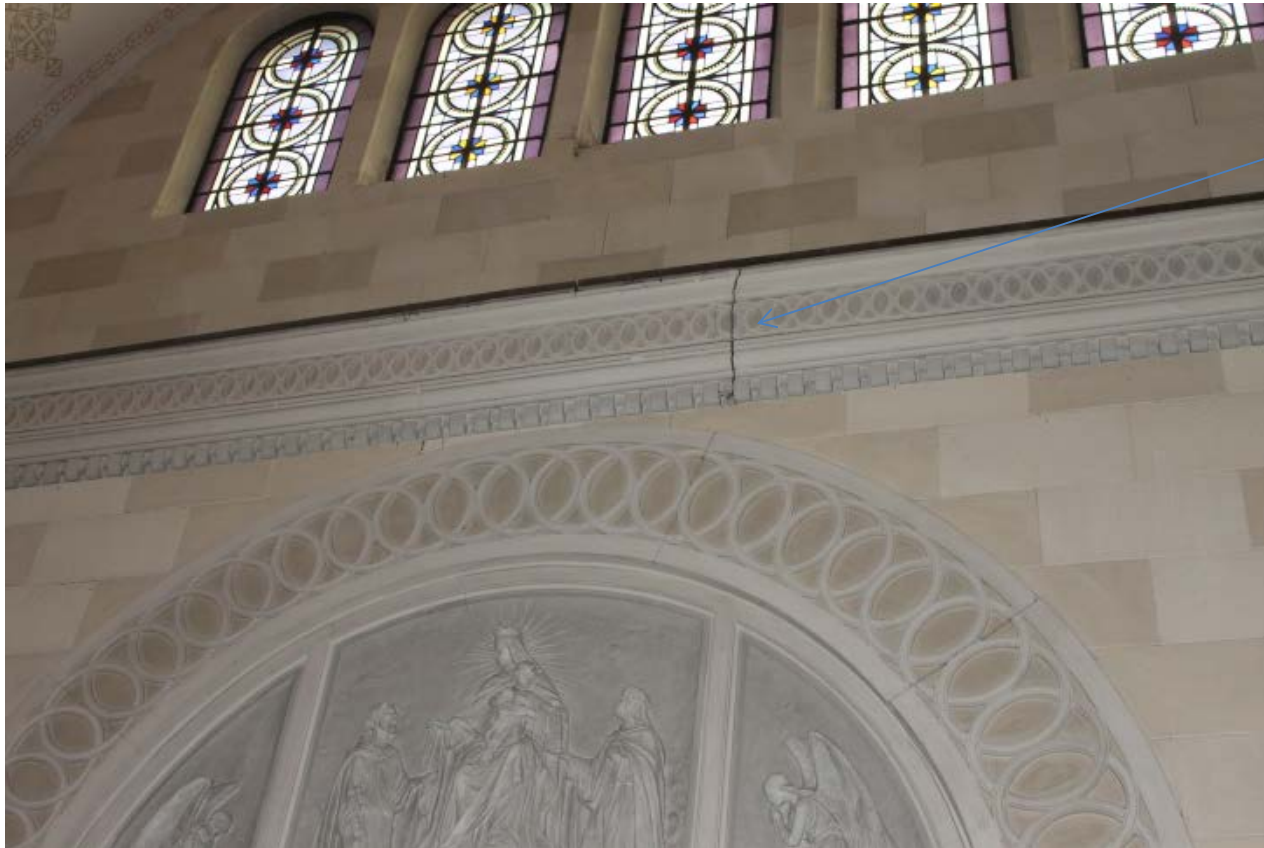
Stress crack in plaster molding. Repair required. Does not appear to emanate from the exterior masonry. Once acoustical panels are removed further investigation can be performed to determine exact cause and solution for repair.

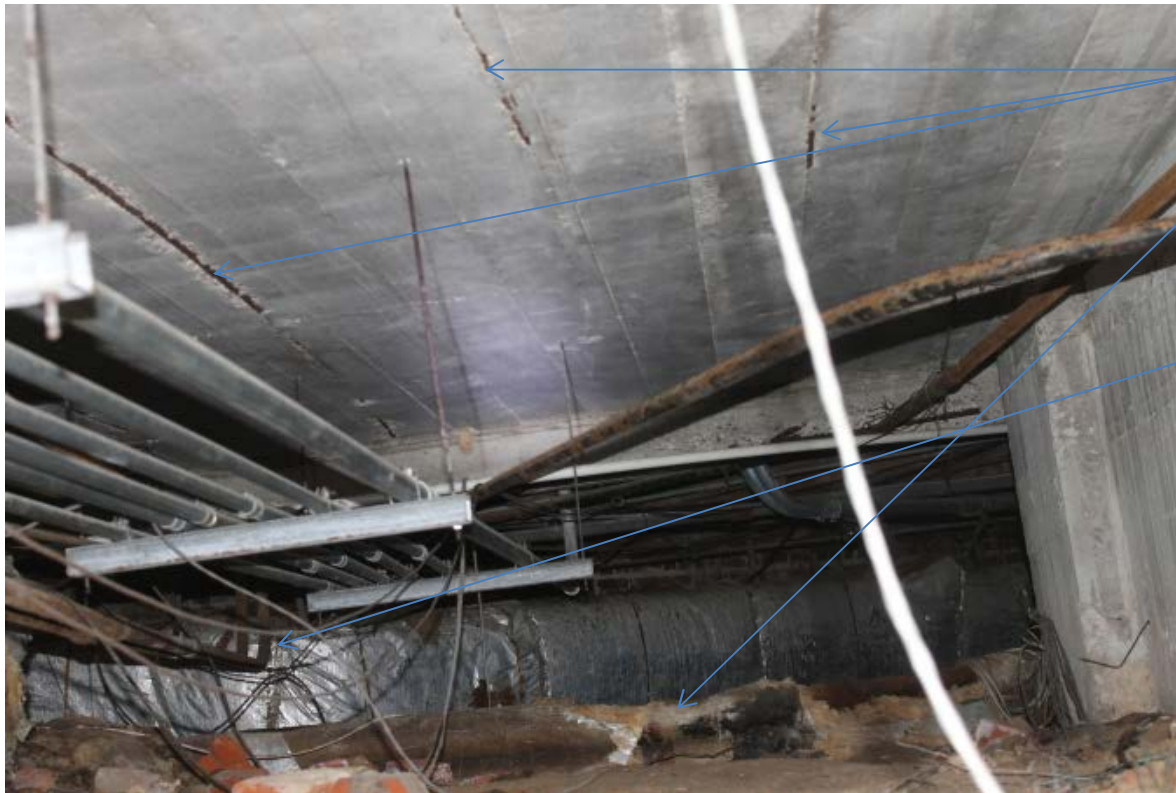
Spalled concrete & exposed reinforcing.
