REPORT OF CURRENT CONDITIONS

Cathedral of the Immaculate Conception

Lake Charles, Louisiana

01/05/2013

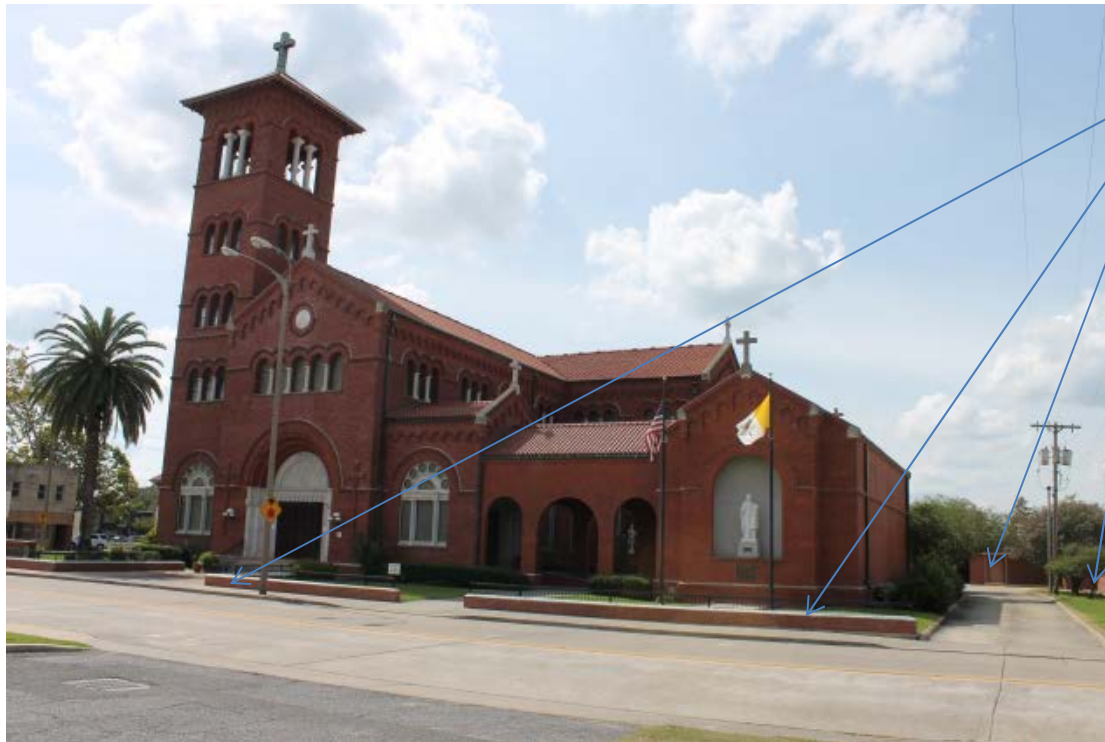
Masonry perimeter fencing and drainage obstacles.

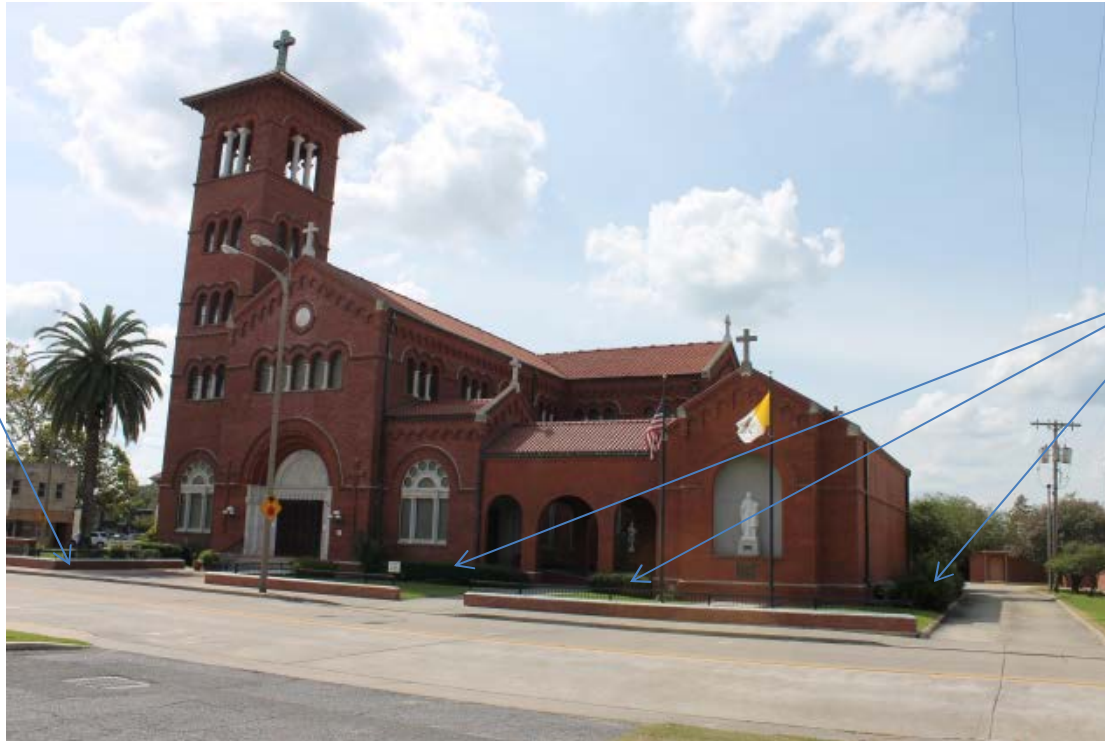
Perimeter plants that
can affect
Foundation, drainage
&
Circulation of outside
air between the floor
and
Ground.

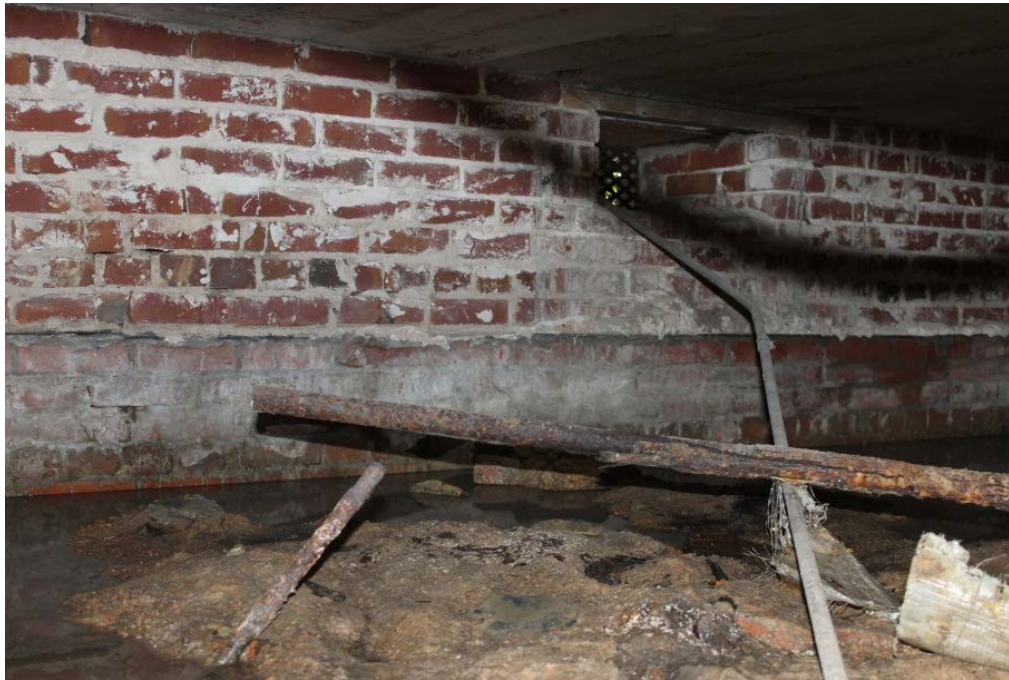
Corroded sewer,
water, HVAC &
electrical piping in
need of replacement or
removal if abandoned

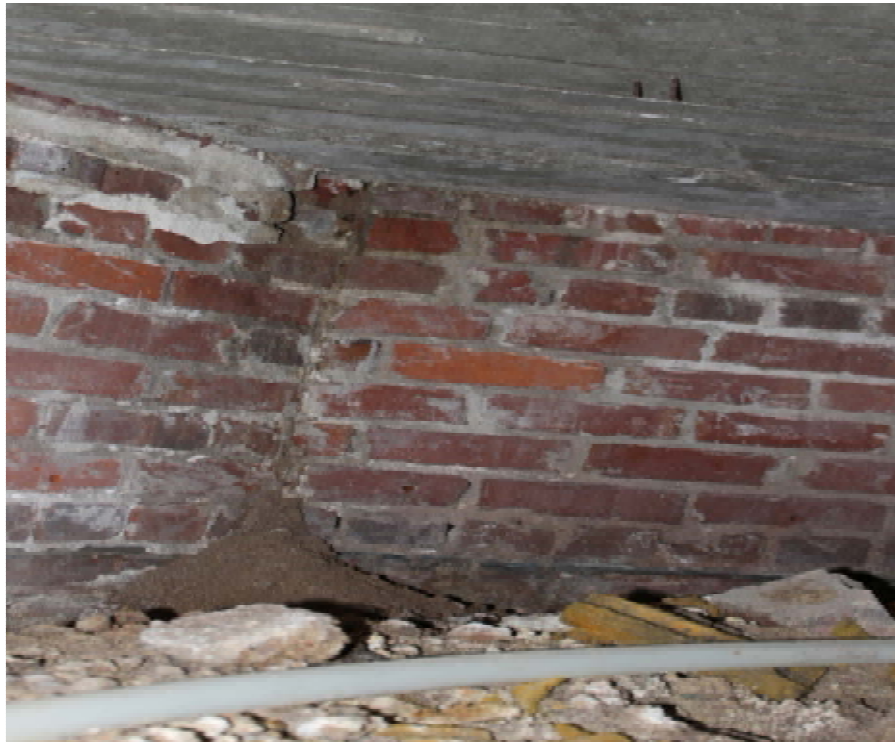
Evidence of termite and or ant
Insect dirt piles. Construction
Debris in need of removal for
Placement of moisture barriers
directly on ground.

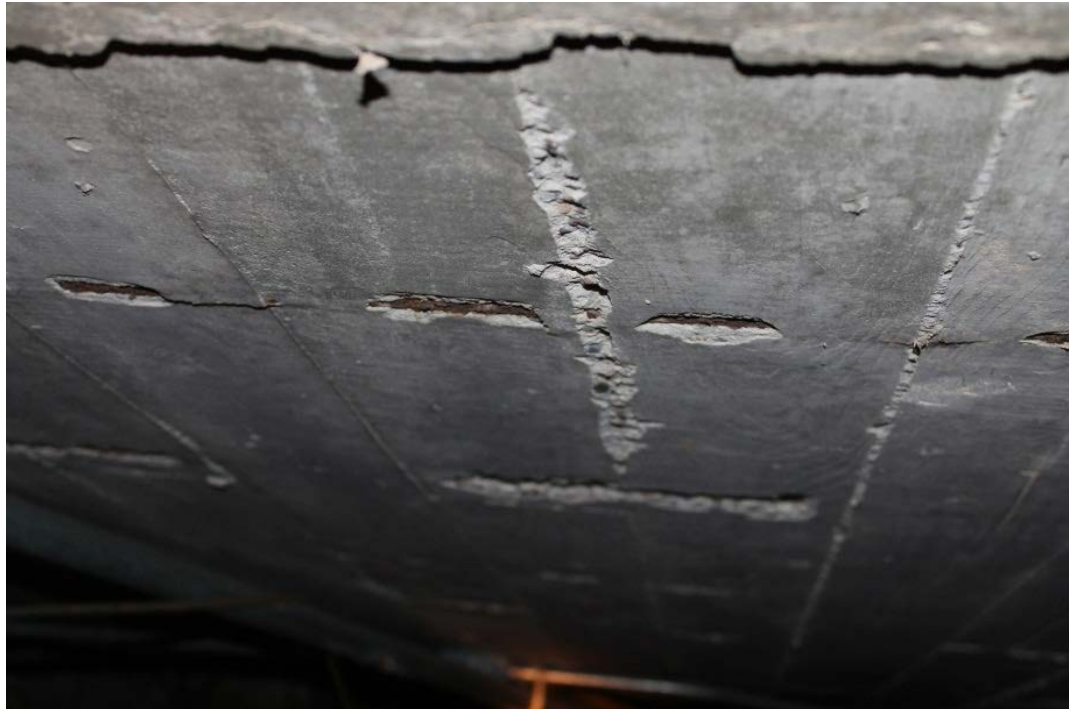
Spalling concrete at the underside of the floor exposing the concrete reinforcing. The reinforcing is exposed to the moisture from the ground causing corrosion and eventual structural concrete failure.

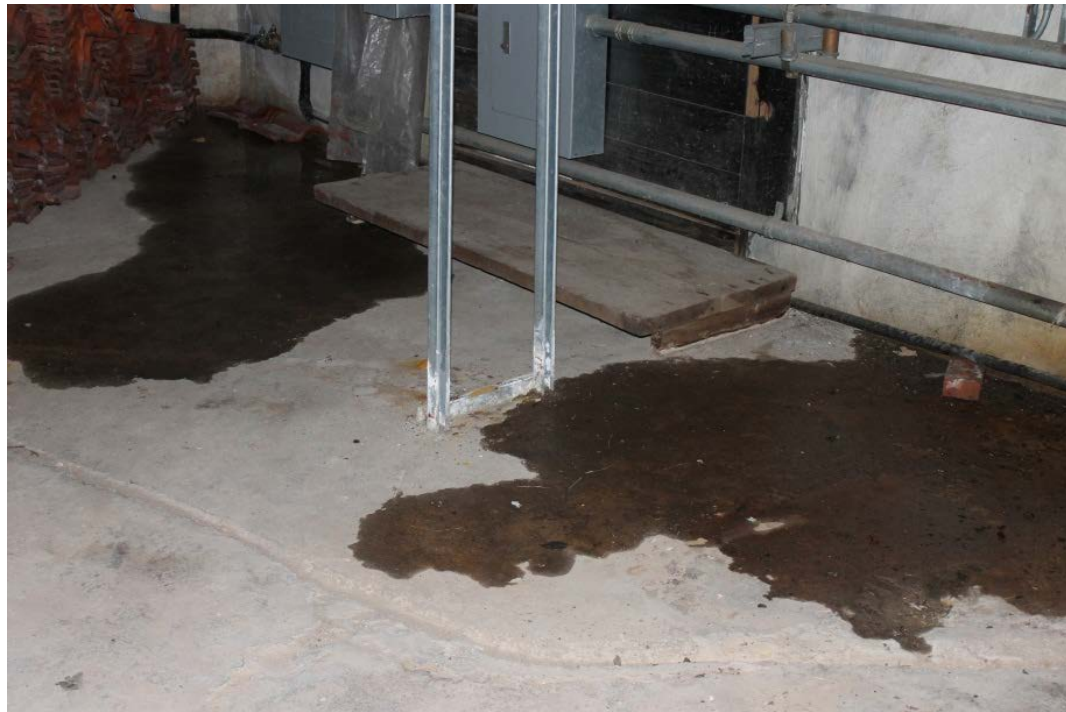
Water intrusion at
basement through
foundation walls.
waterproofing
required

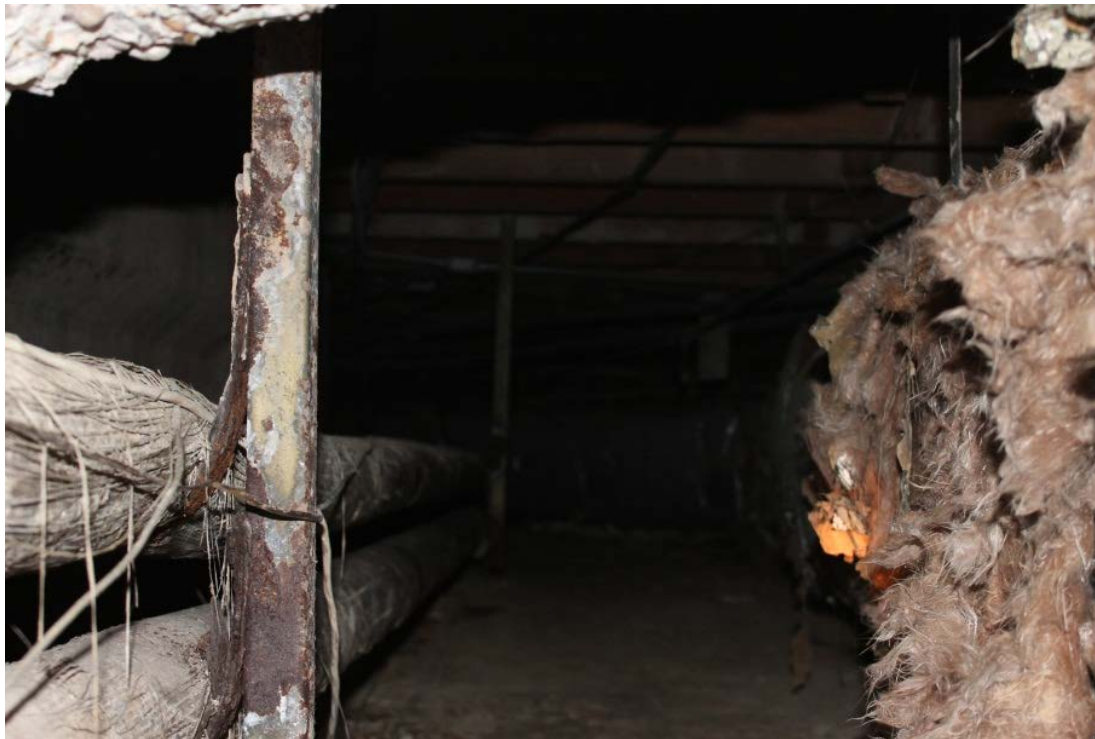
Damaged insulation, rusted and corroded piping and support system.

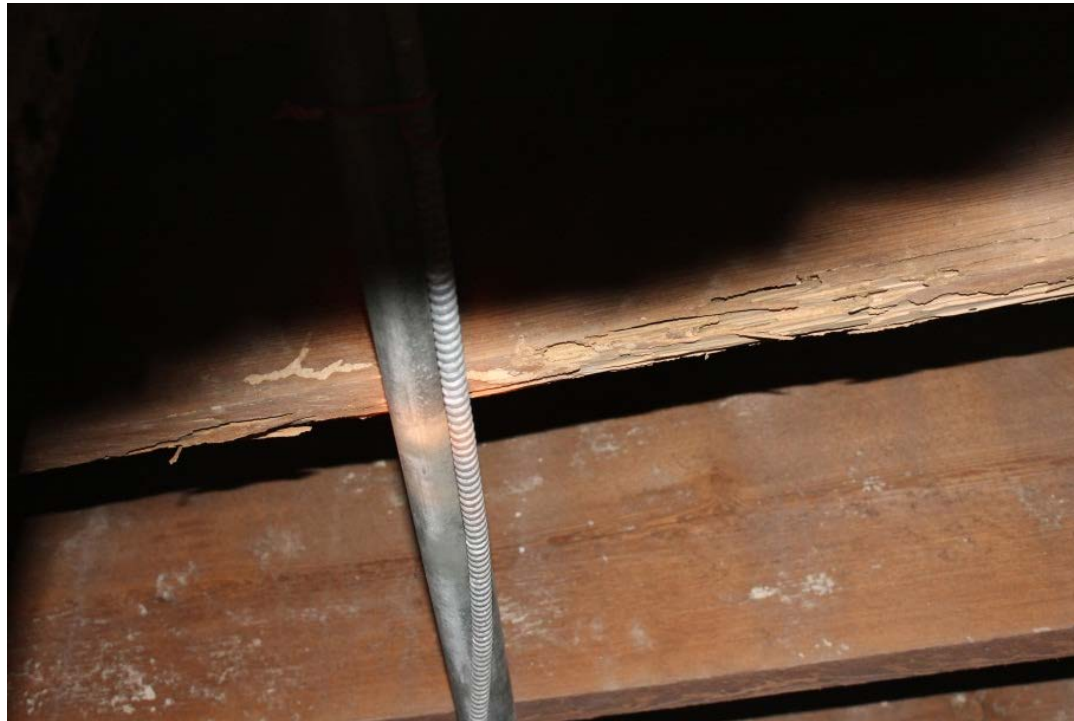
Evidence of
termites and
termite damage.

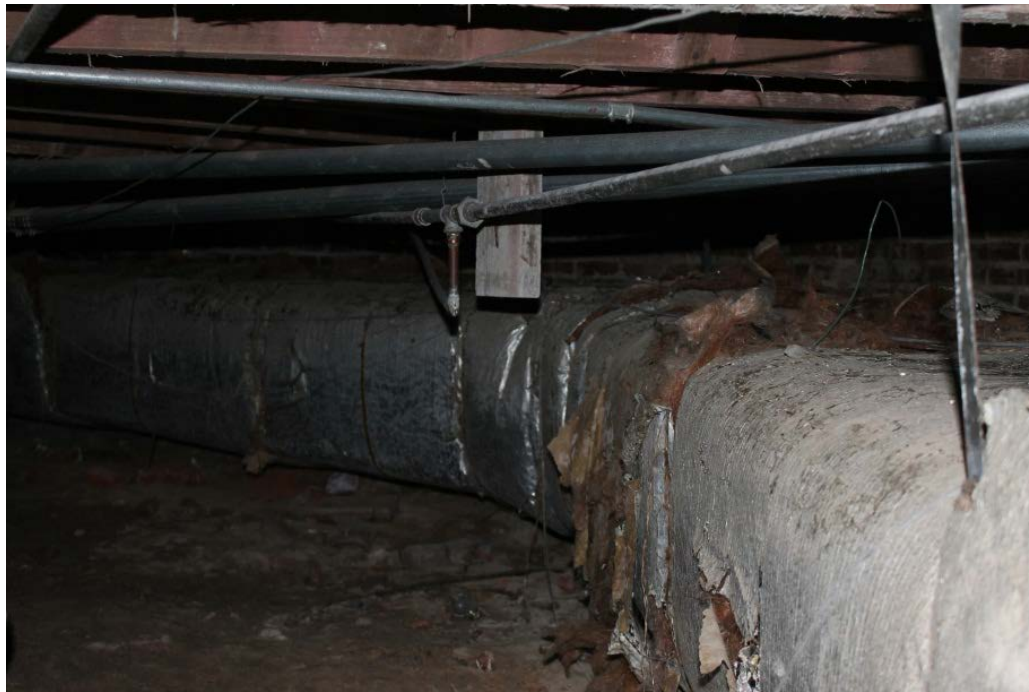
Foil facing on ductwork insulation damaged. Wet earth. Damaged and broken duct support system.

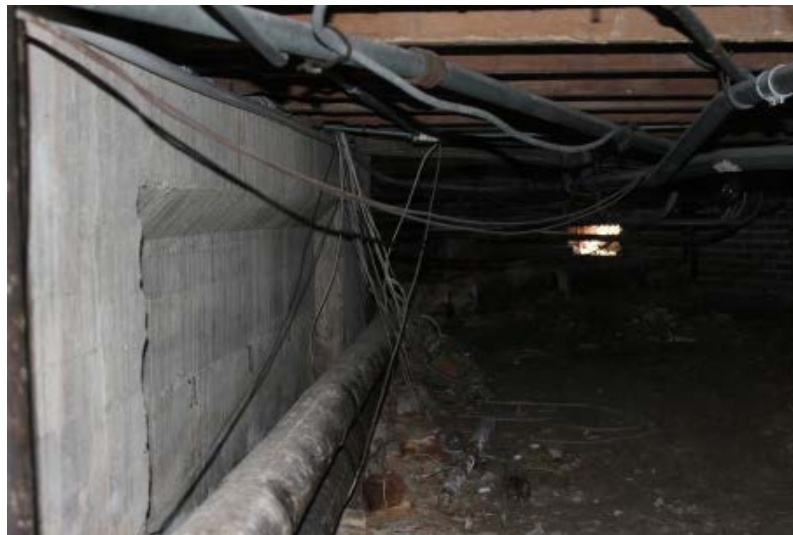
Loose exposed wiring.
Wet earth. Damaged
crawl space vent grill.
Construction debris.

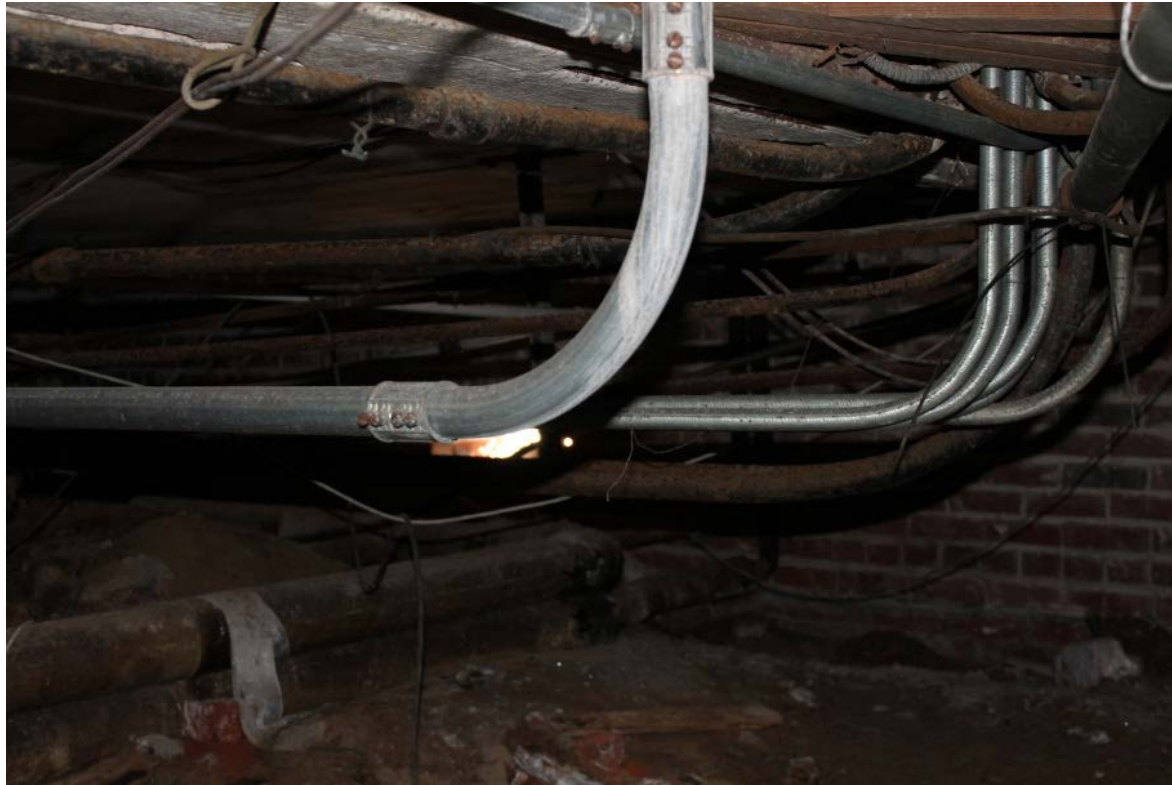
Construction debris requires removal and disposal. Rusted and abandoned piping requires removal & replacement.

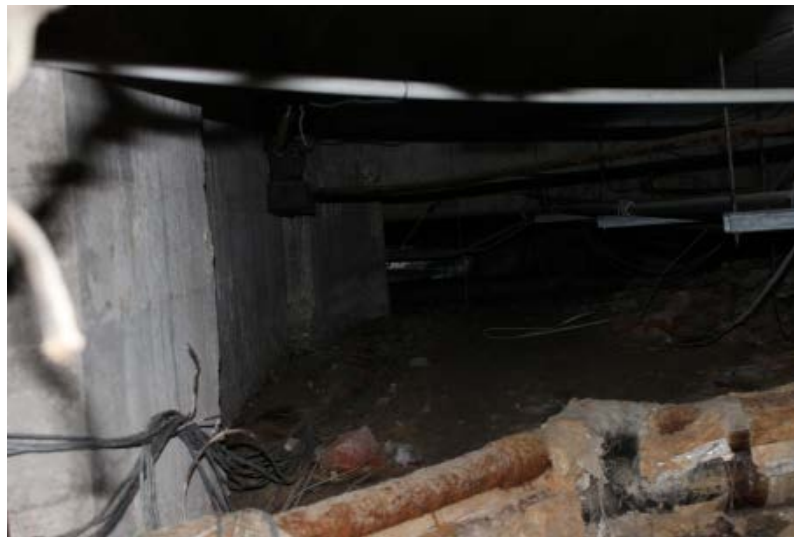
Loose wiring requiring conduit.

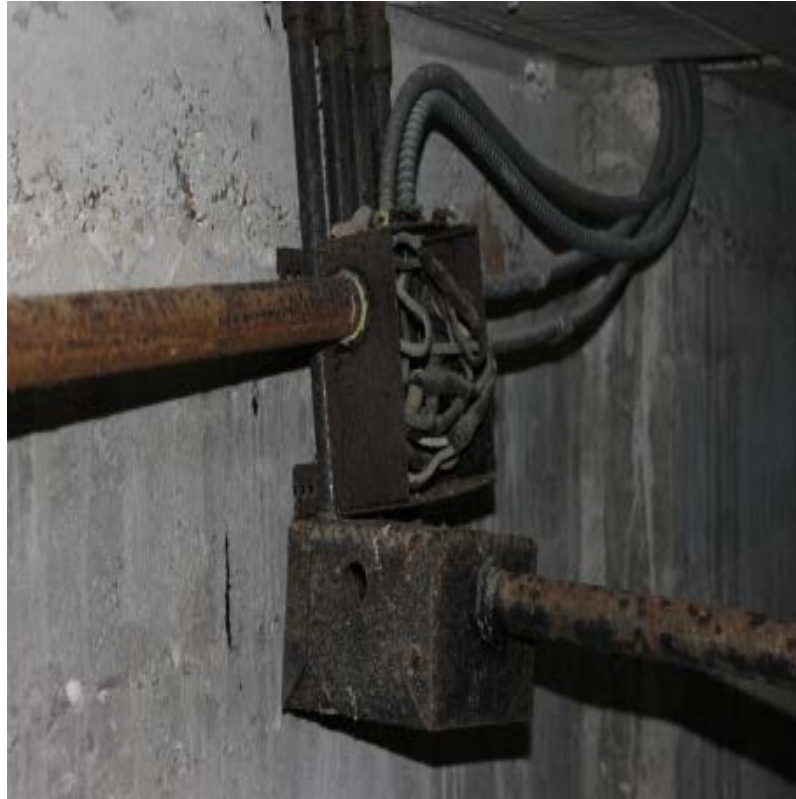
Strewn debris,
rusted and
corroded piping,
un-insulated
HVAC ductwork.
Exposed wiring,
wet earth
creating
moisture
problems.

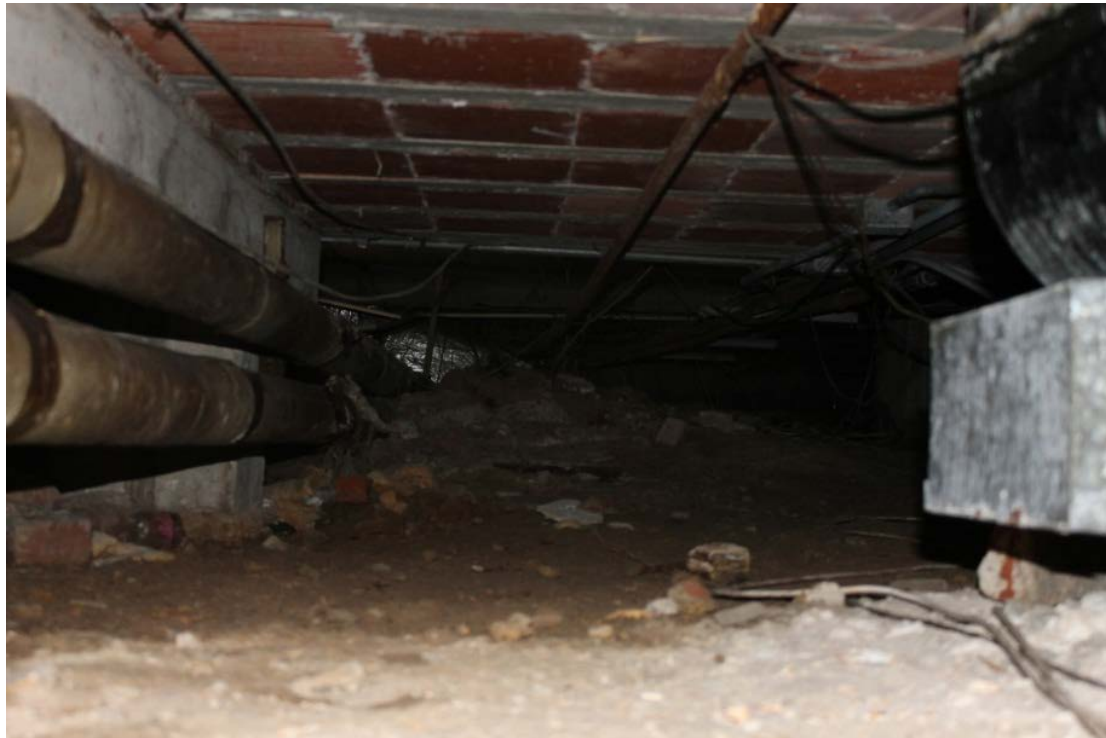
Damaged and corroded crawl space ventilation grill. Steel lintel above supporting brick wall opening is corroded and in need of replacement. This is typical of most vents at perimeter. Note the rising damp from the soil in the masonry.

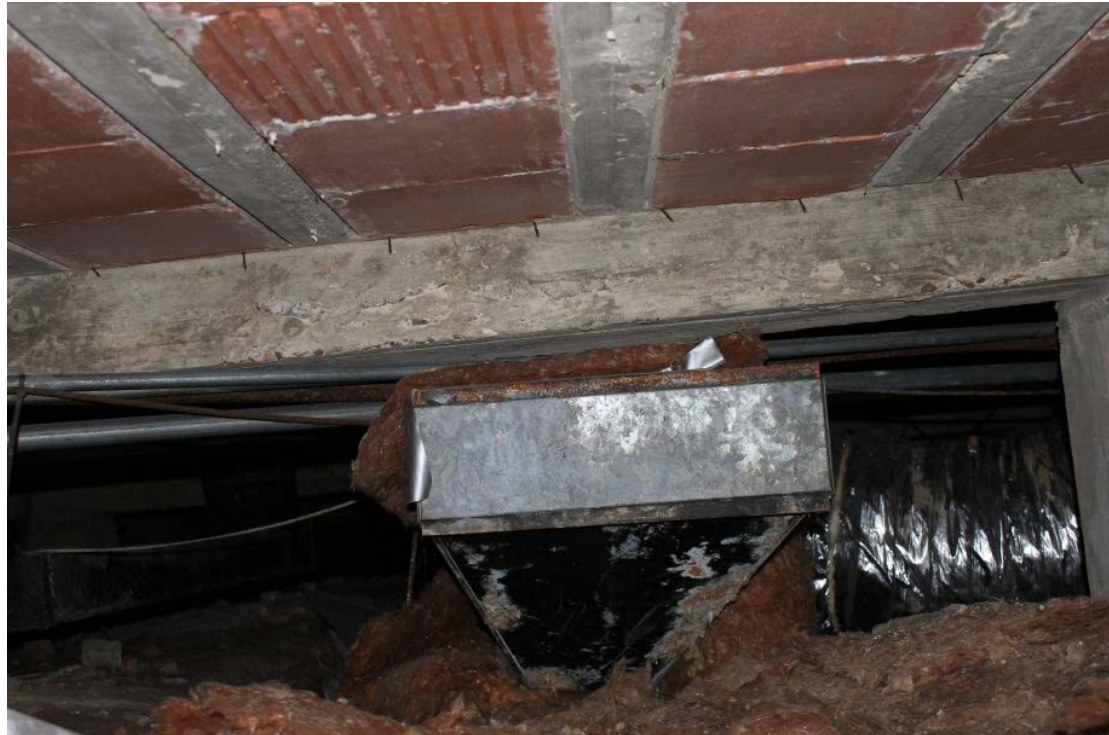
Mounded wet/damp soil that should be knocked down to allow coverage and access through to other areas of crawl Space. Termite damaged wood beam at underside of elevated concrete floor slab system. Loose wiring should be in conduit.

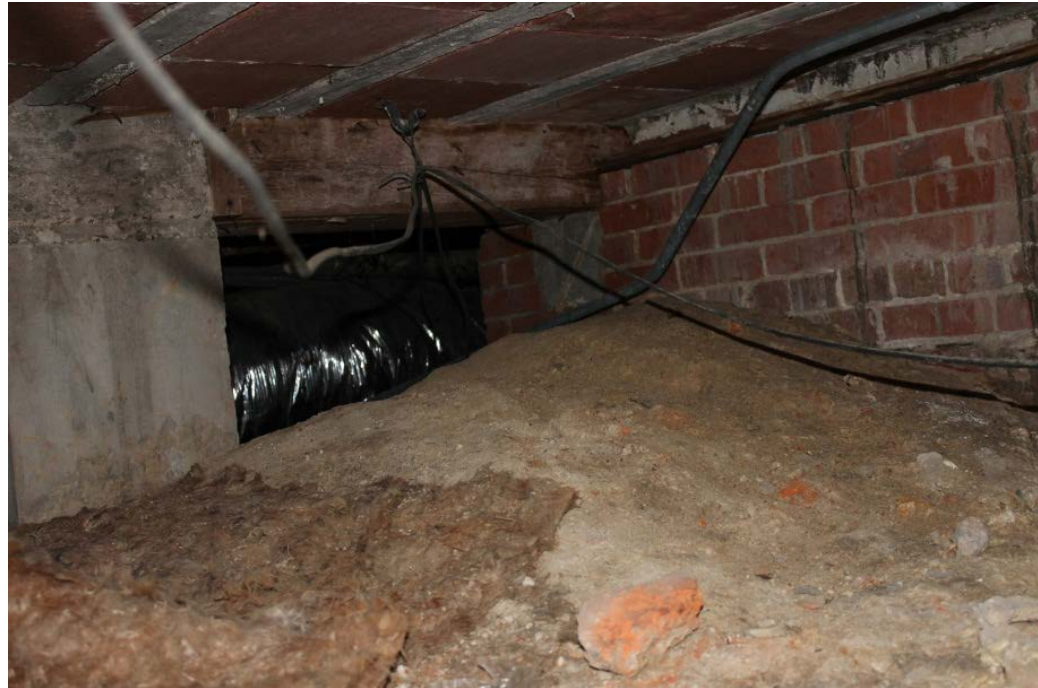
Spalling concrete, exposed concrete reinforcing steel at underside of floor system. Rusted and deteriorated conduit. Crawl space ventilation grills broken and in disrepair. Electrical wiring left exposed. Mechanical supports rusted and corroded. Wet and damp earth in need of coverage.

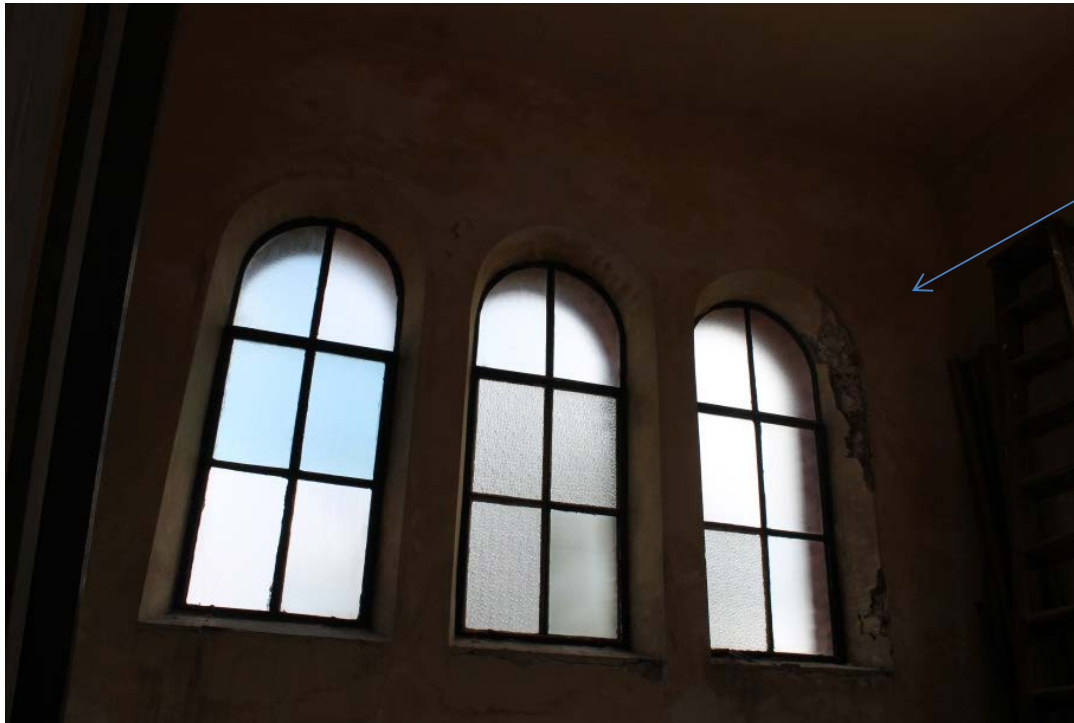
Plaster at bell tower windows spalling due to moisture penetration.

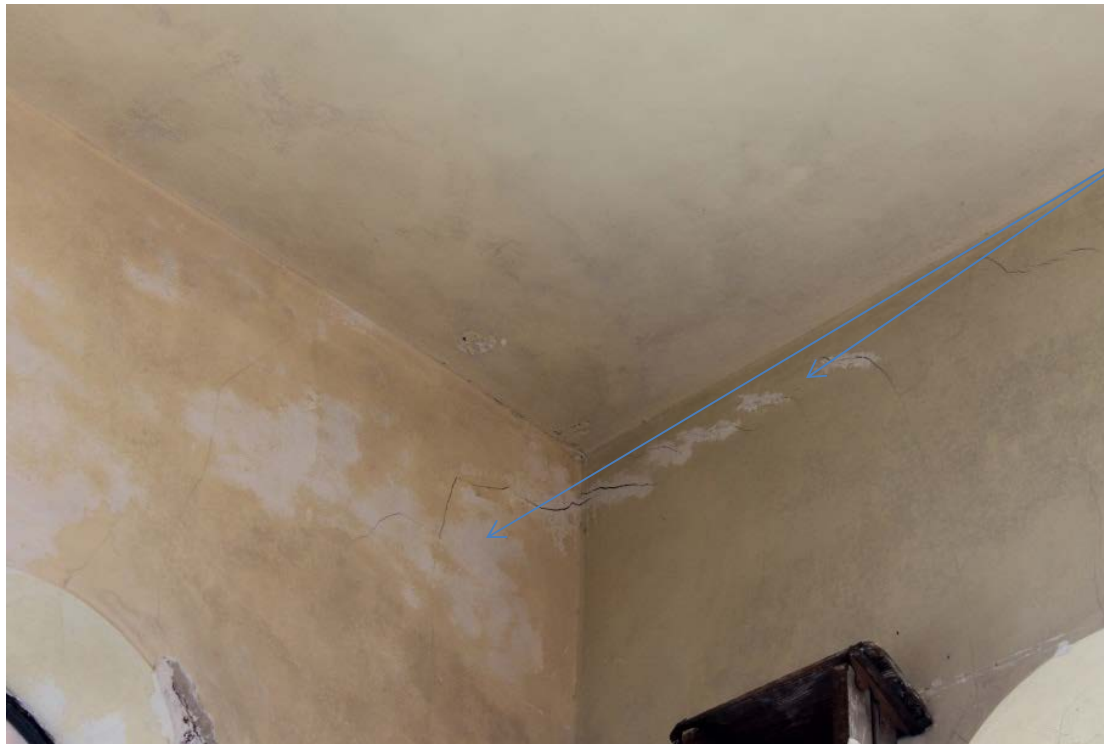
Plaster stress crack at bell tower. Spalled plaster at windows.

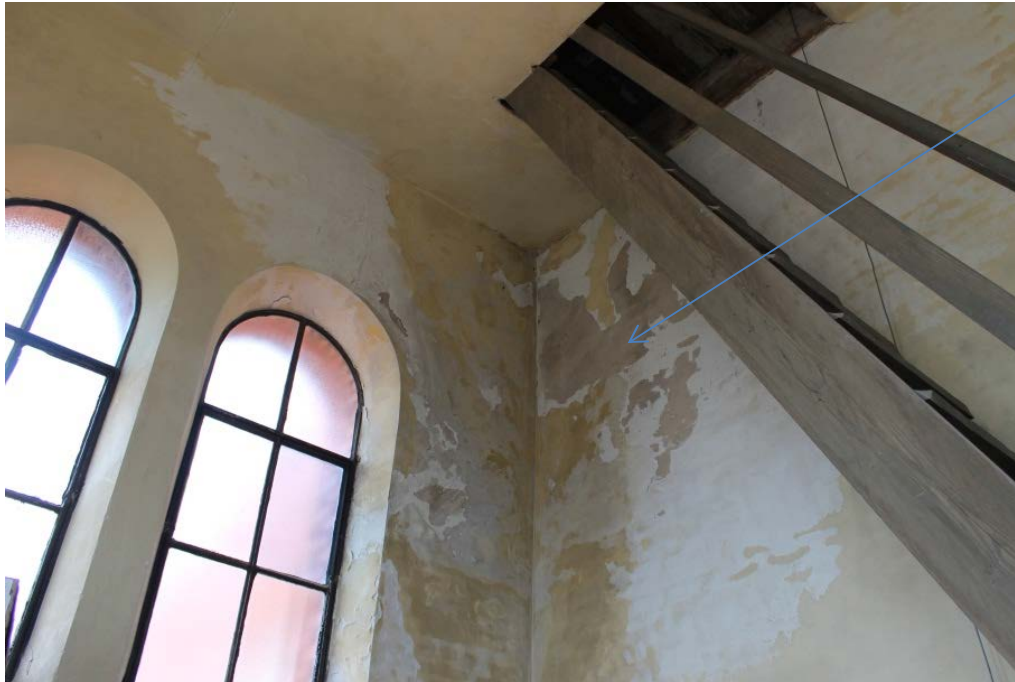
Plaster at bell tower windows & walls spalling due to moisture penetration.

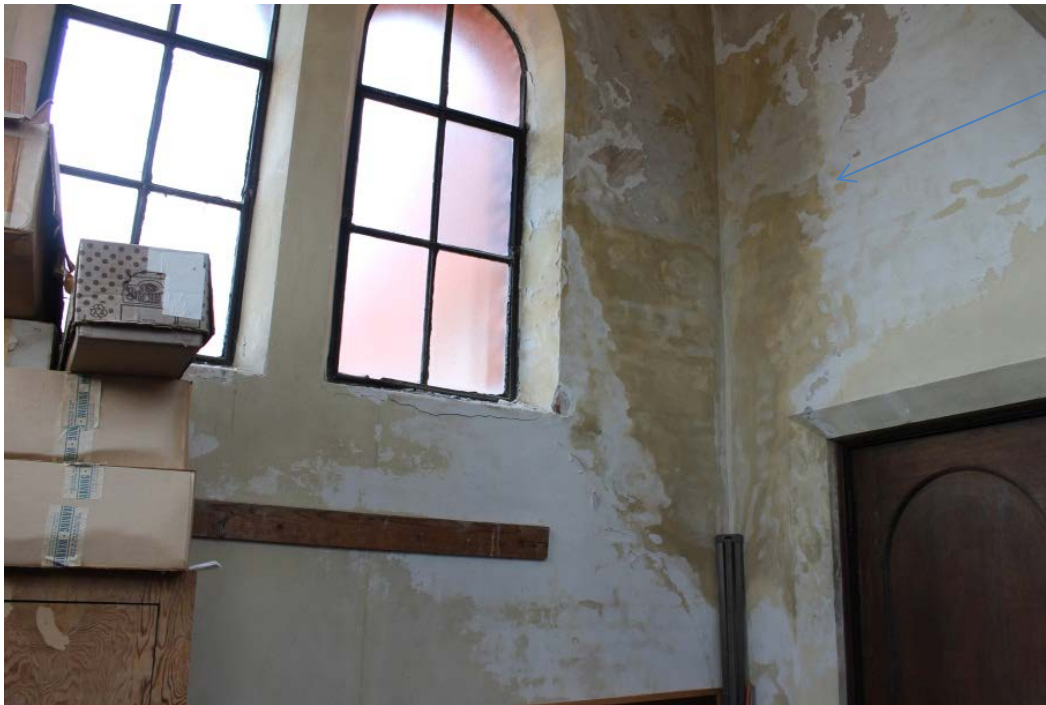
Plaster at bell tower windows & walls spalling due to moisture penetration.

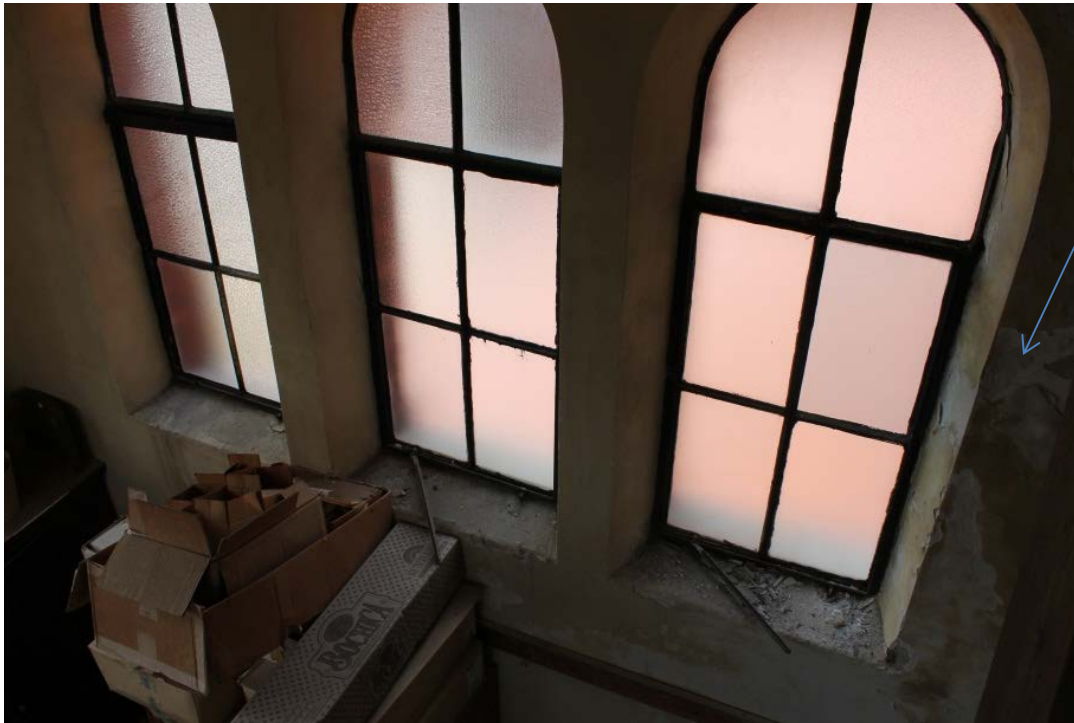
Plaster at
bell tower
windows &
walls
spalling due
to moisture
penetration.

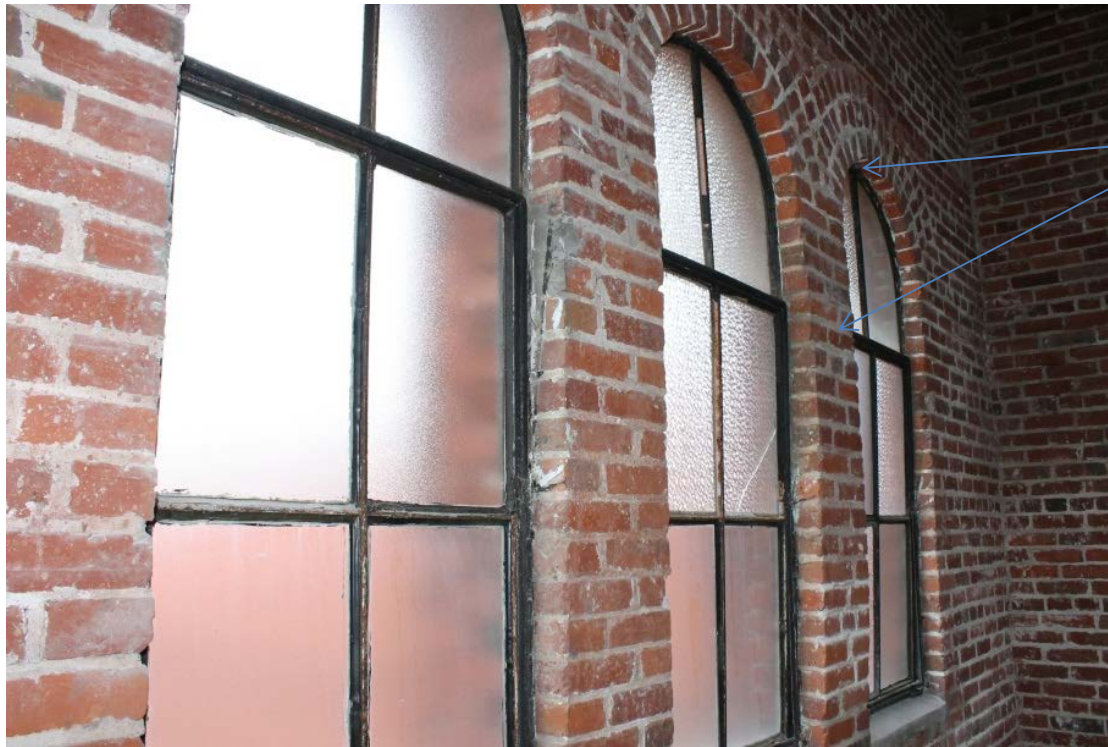
Various types of glass have been utilized over the years to replace broken/damaged glass. Broken glass currently exist.

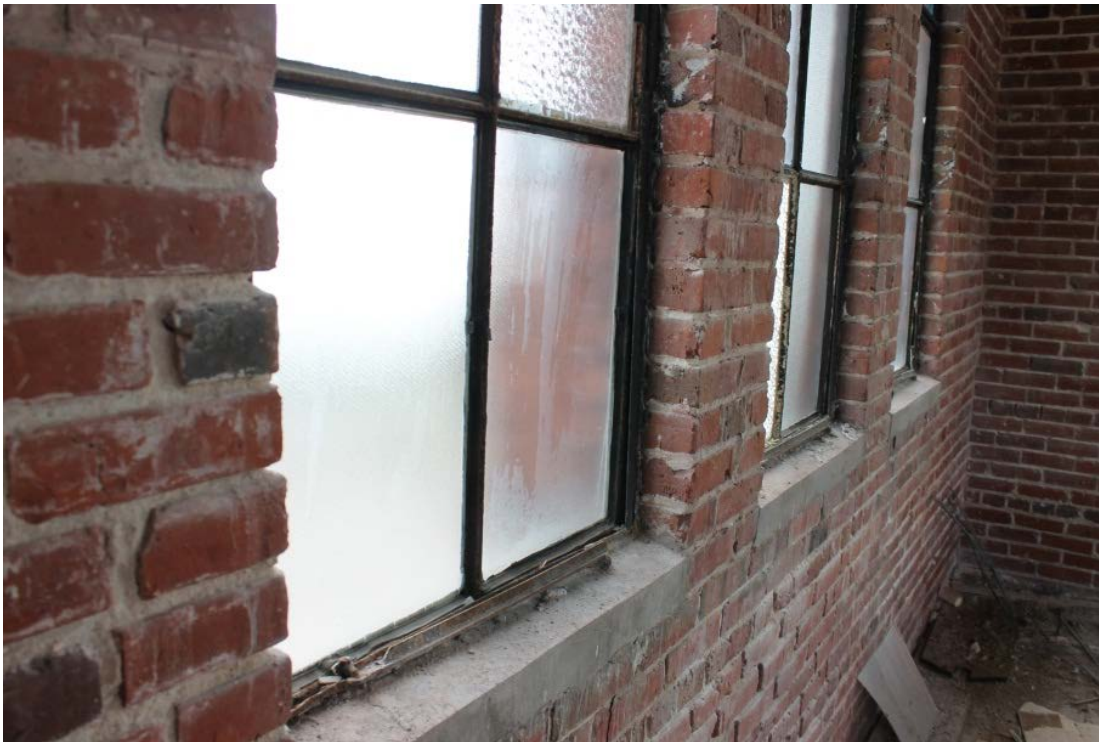
Closer inspection/view of windows in bell tower indicate the need for window glass and window parts restoration/replacement.

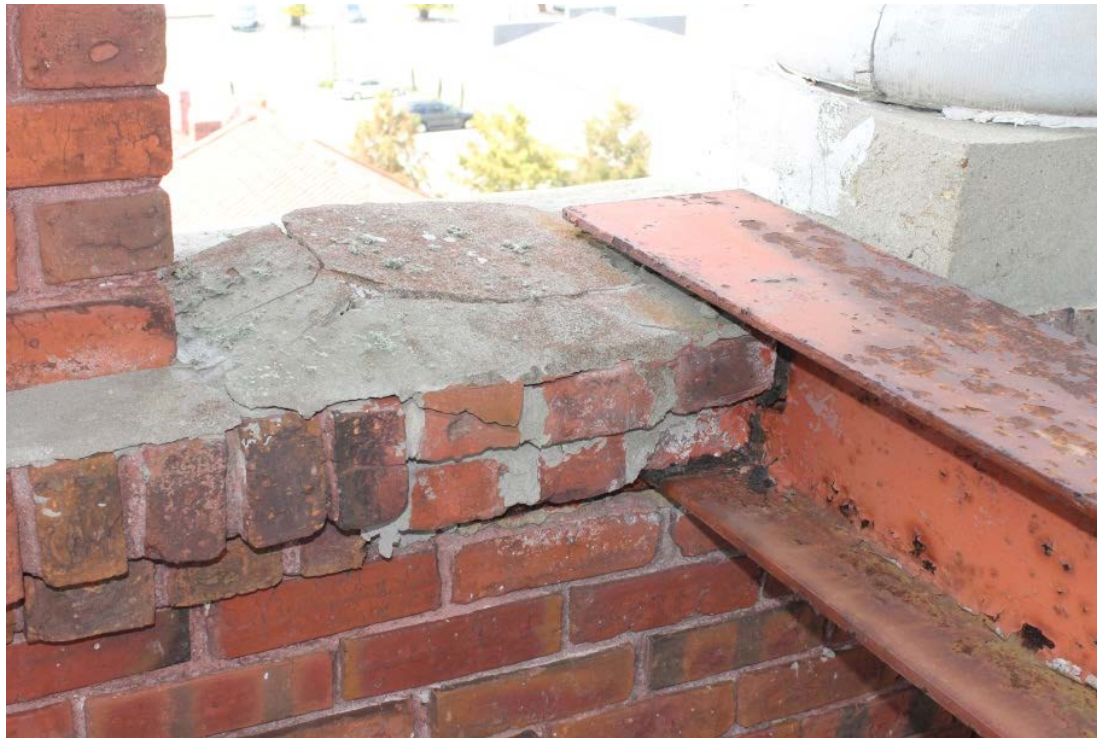
Structural steel bell support which was not part of the original construction was installed in the masonry wall. Damage has resulted from possibly high winds during past storms.

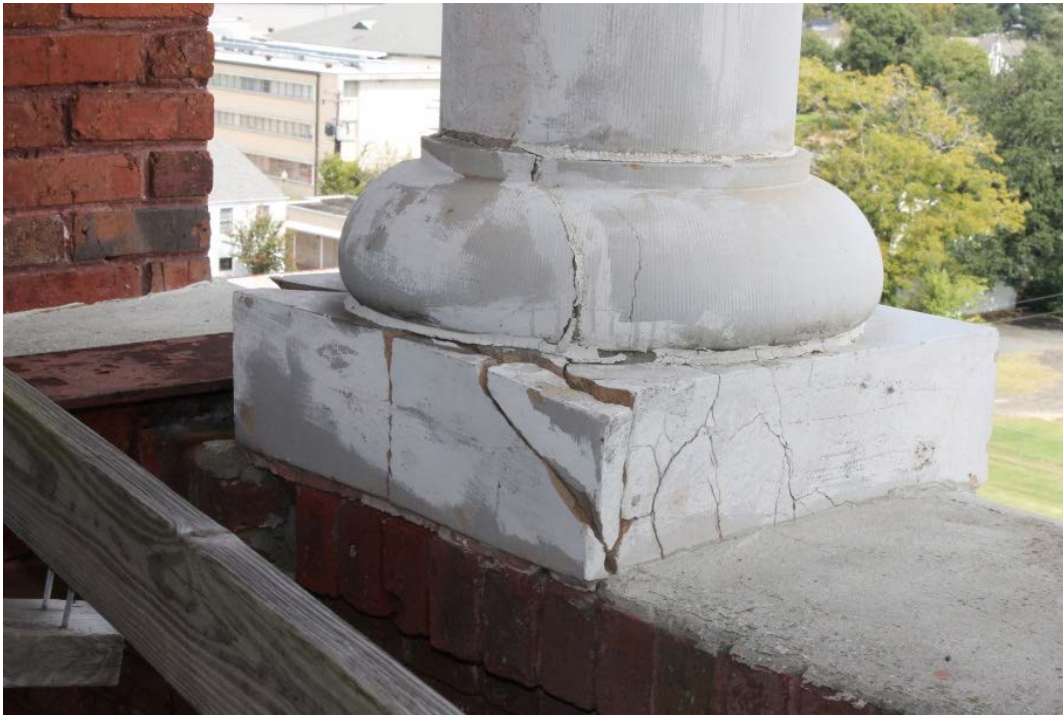
Columns at bell tower damaged in need of repair.

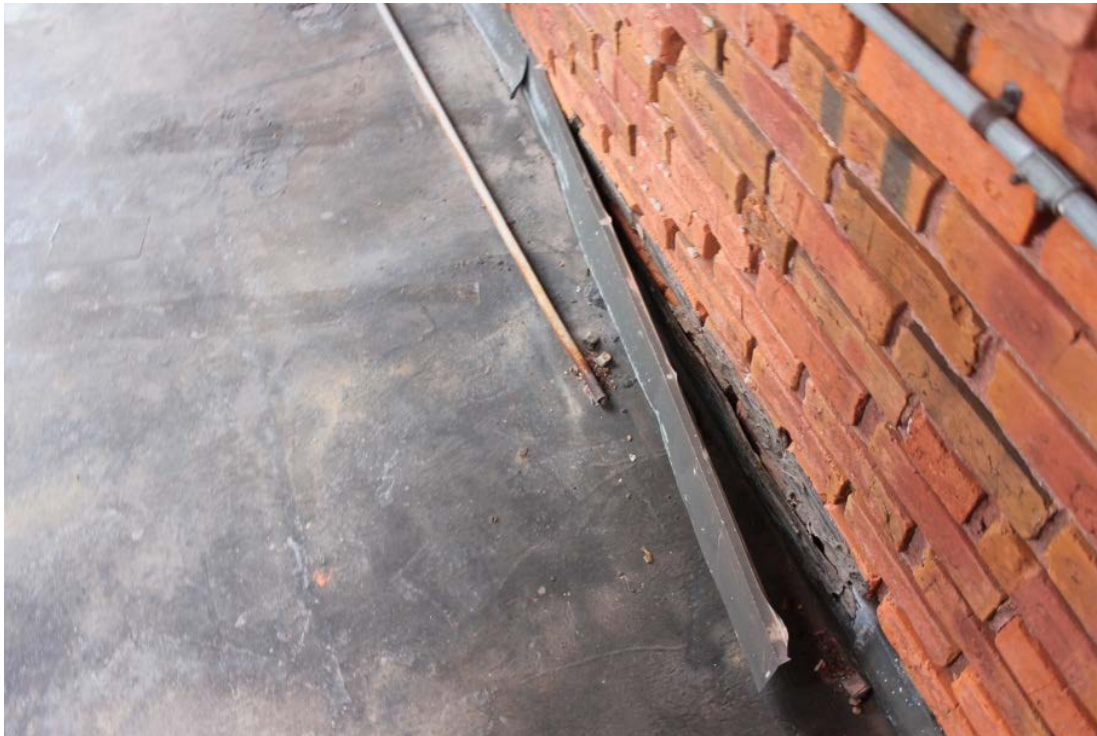
Floor to wall
flashing needs
replacing at bell
tower top level.

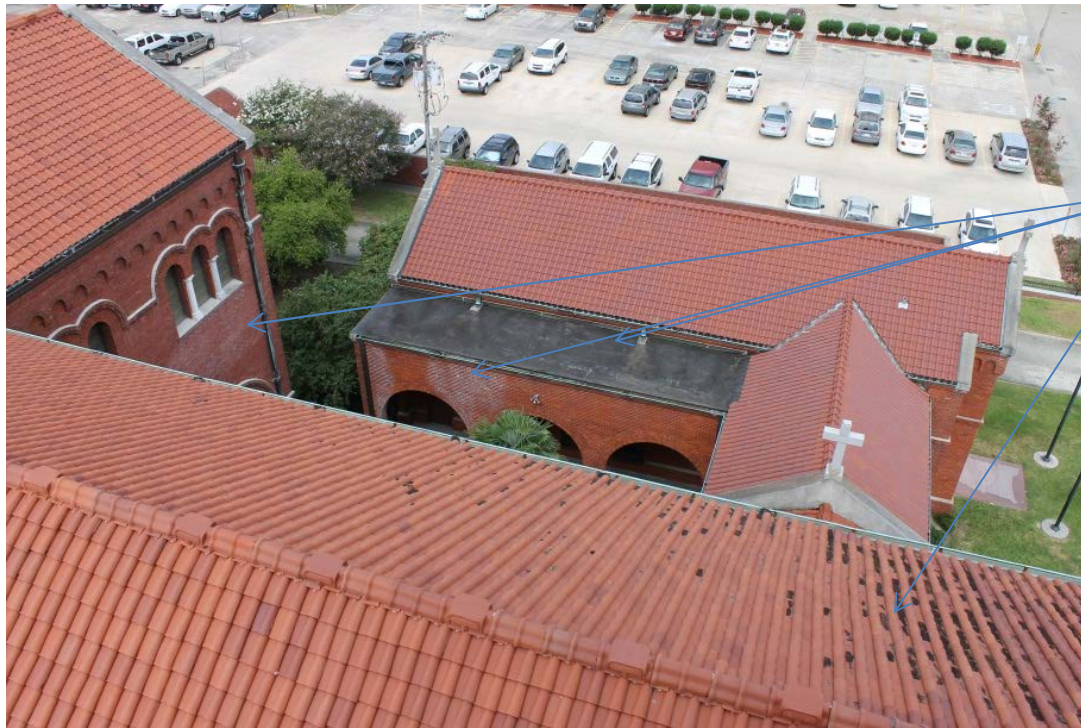
Masonry calcification or sealer/waterproofing. Dirt/debris should be removed from clay tile. Built up roof system needs close inspection along with all flashings on the meeting room addition.

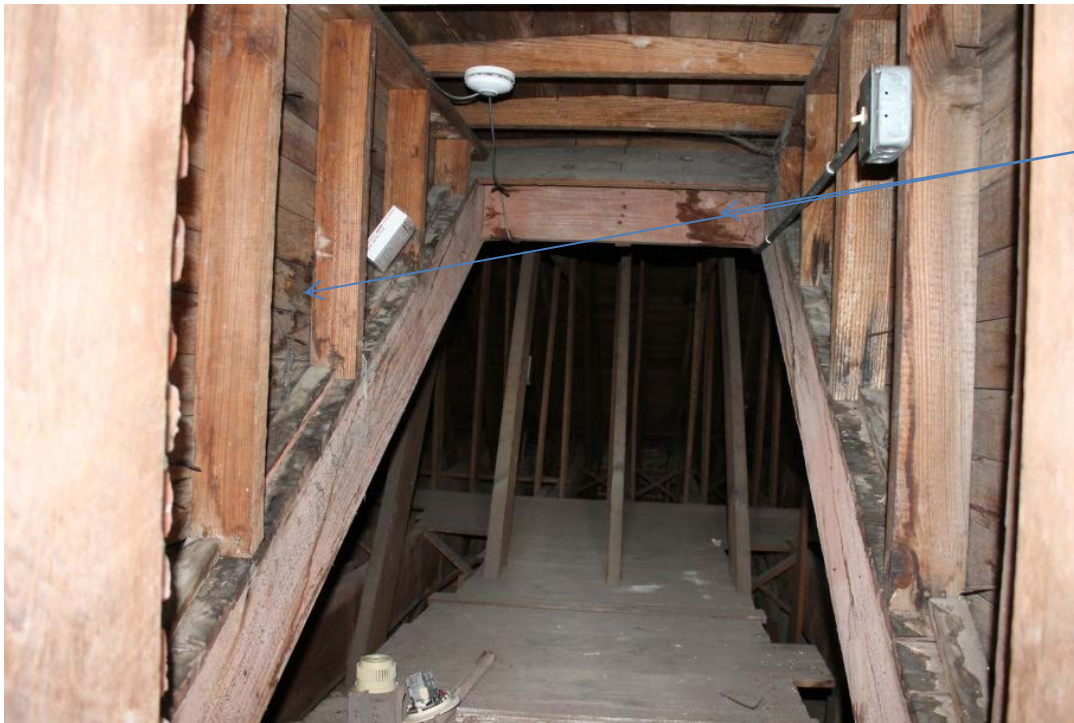
South entry to roof structure from bell tower. Old stain marks from earlier years of rain water leakage.

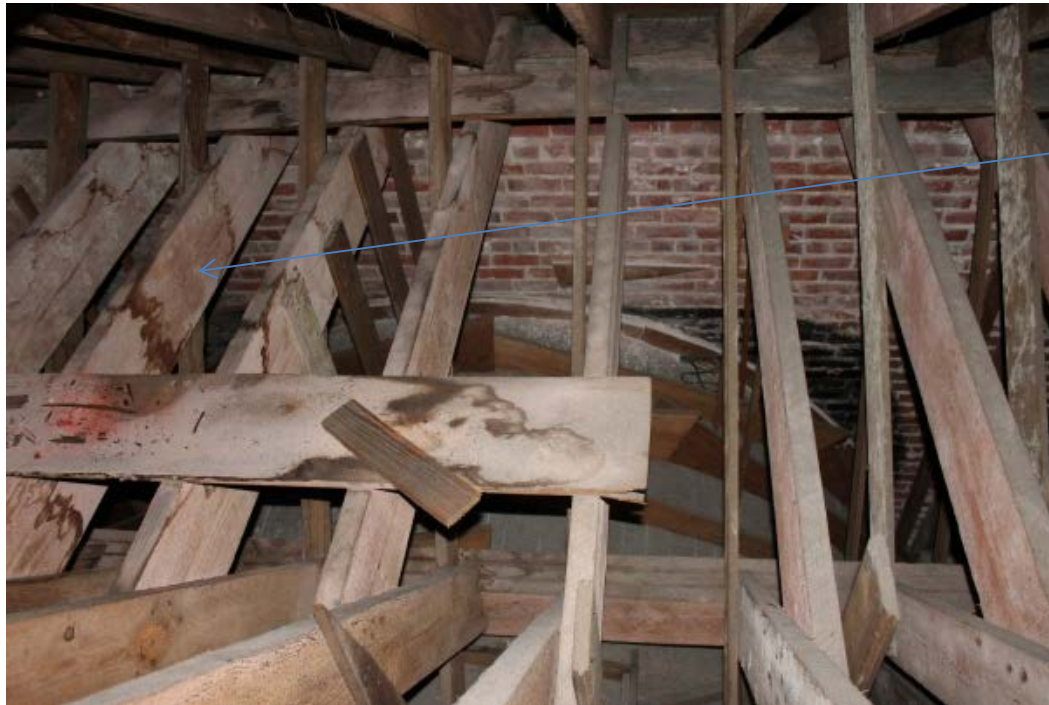
North side of east end of Nave. Old roof leak stains on wood framing members. No issues found.
