REPORT OF CURRENT CONDITIONS

Cathedral of the Immaculate Conception

Lake Charles, Louisiana

01/05/2013

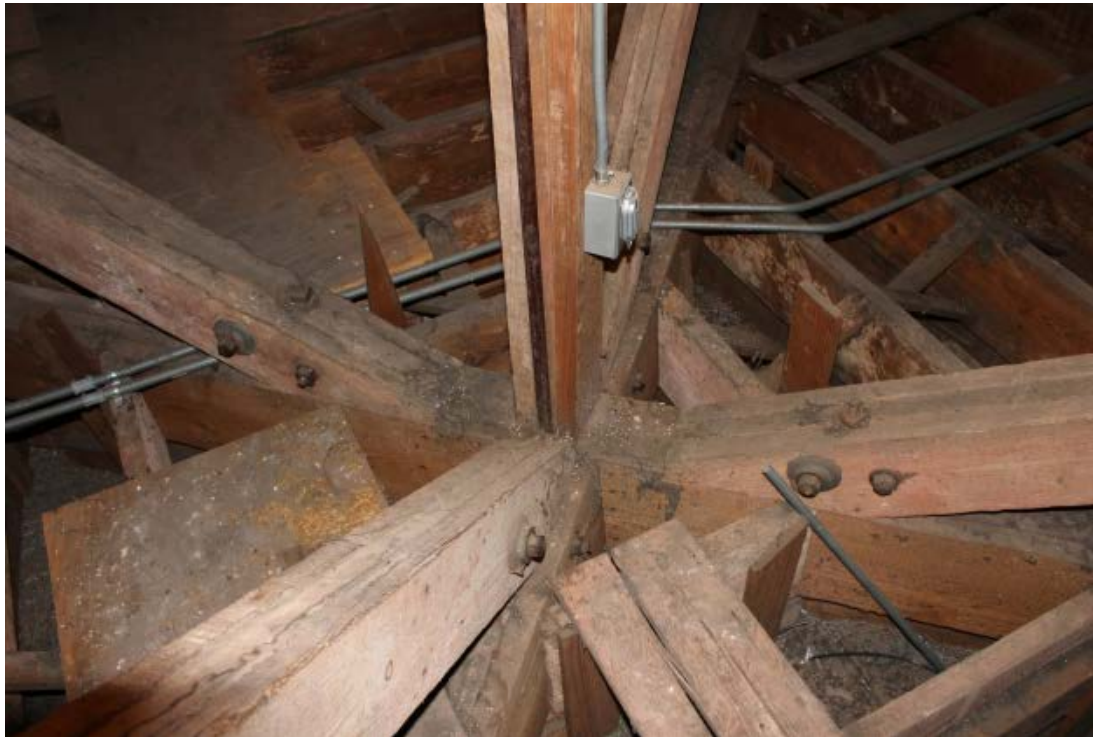
Original roof truss over Apse. All fastenings are steadfast and in good condition. Joints are tight and proper. No signs of decay or insect damage. Electrical was added later.

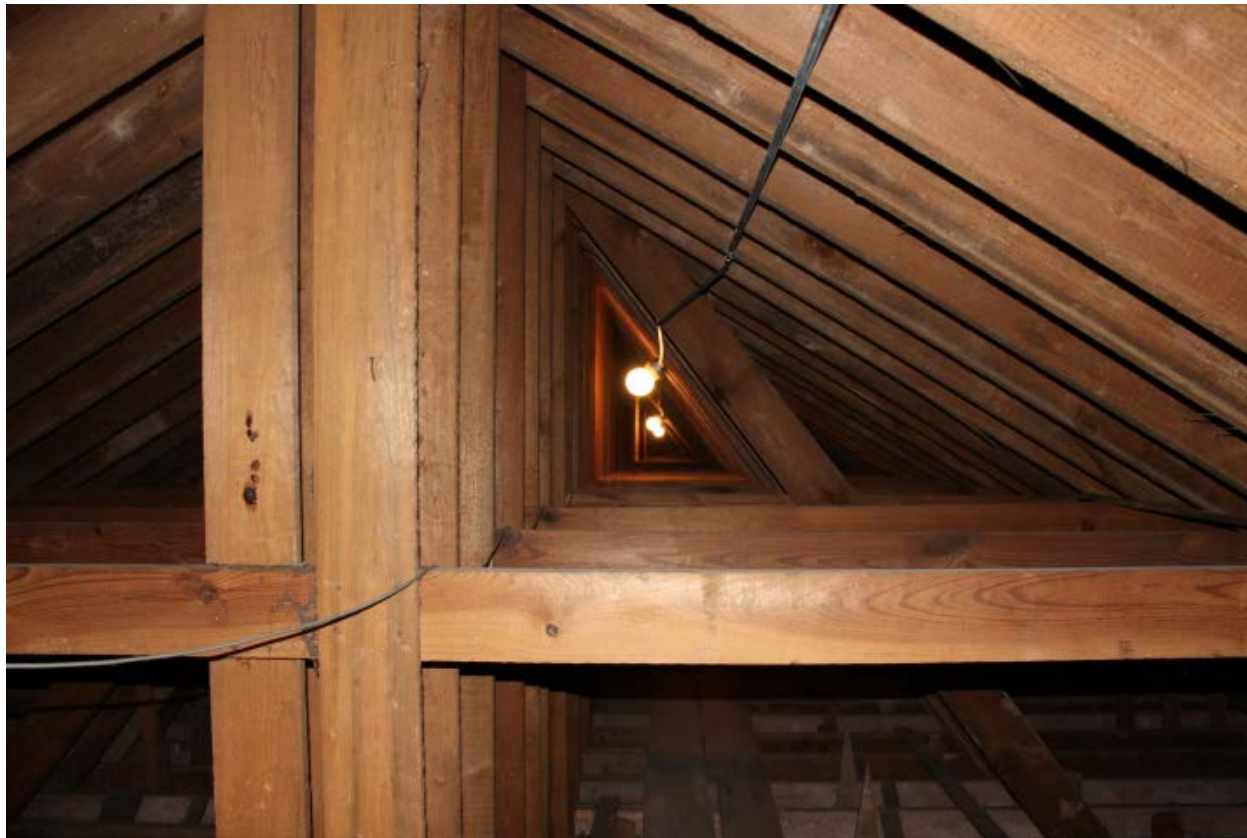
All framing appears to be in good shape. All joinery is tight. No signs of insects or damage.

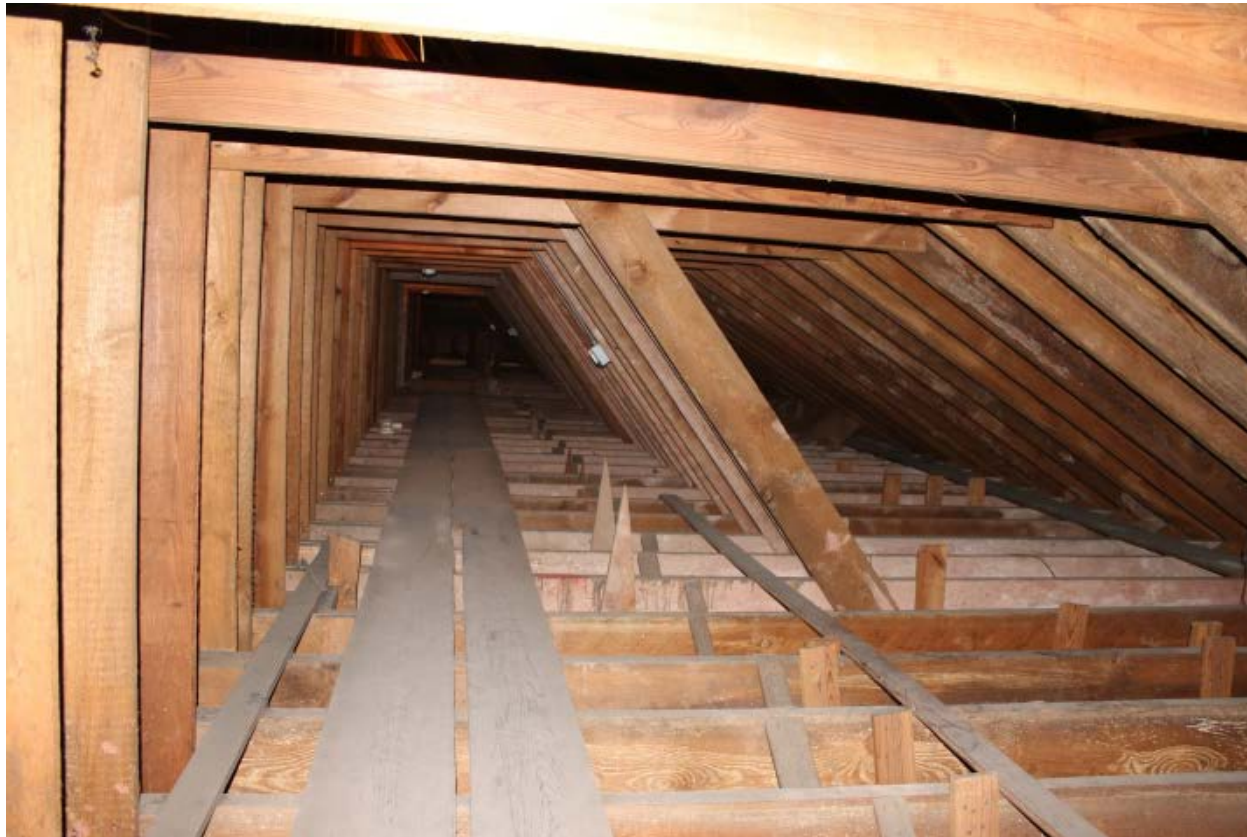
All framing appears to be in good shape. All joinery is tight. No signs of insects or damage.

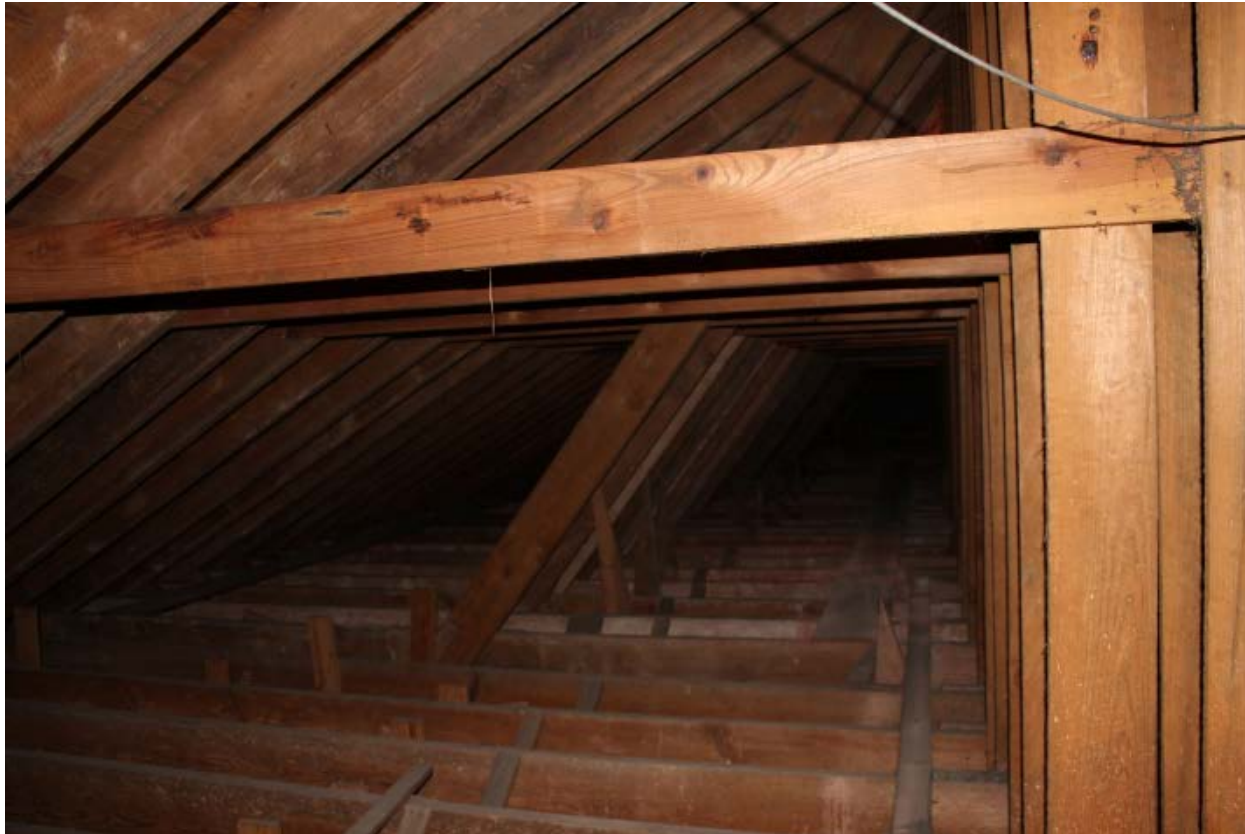
All framing appears to be in good shape. All joinery is tight. No signs of insects or damage.

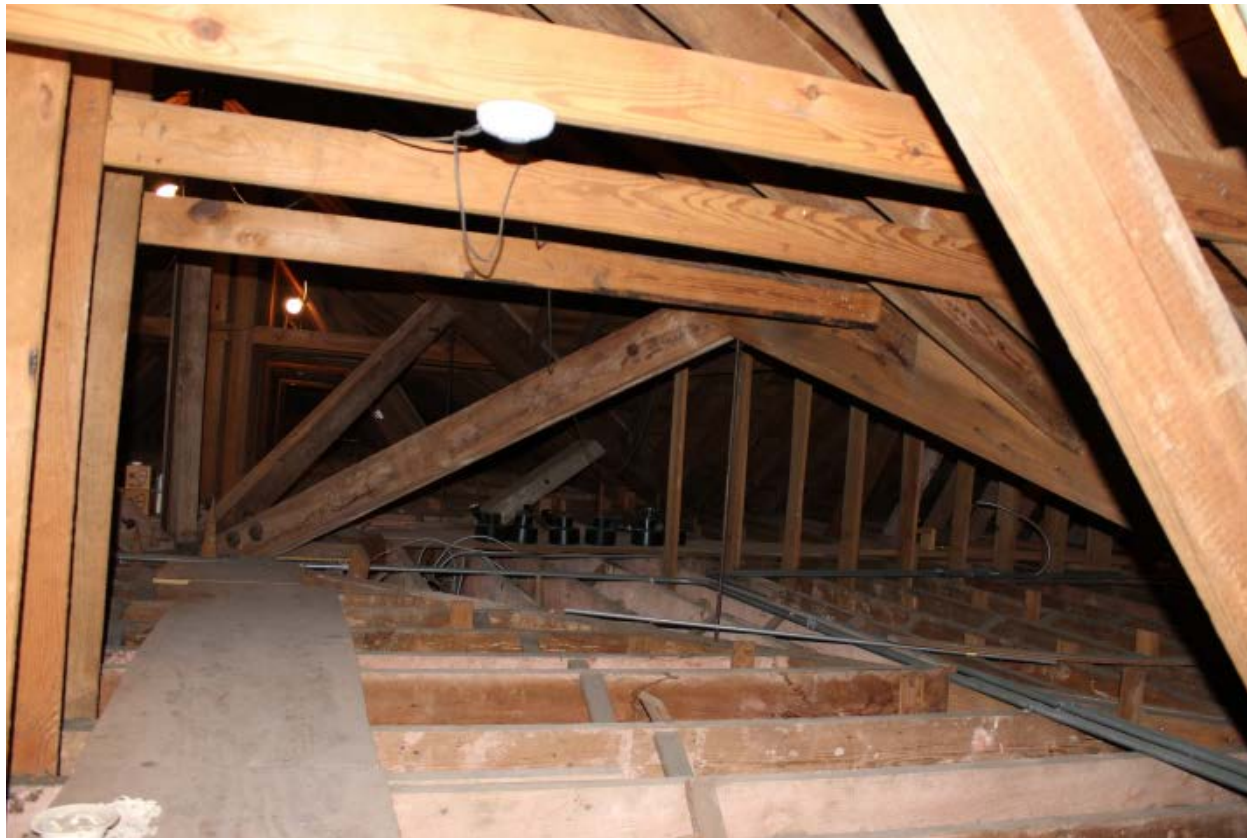
All framing appears to be in good shape. All joinery is tight. No signs of insects or damage.

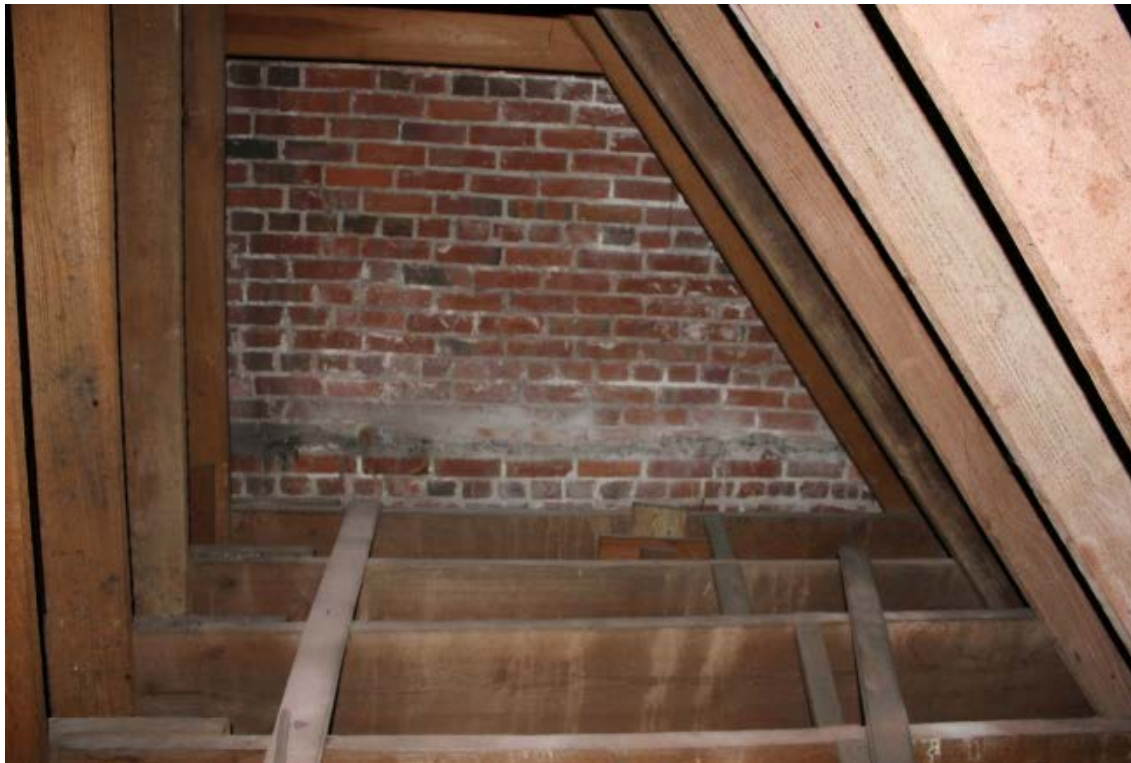
All framing appears to be in good shape. All joinery is tight. No signs of insects or damage.

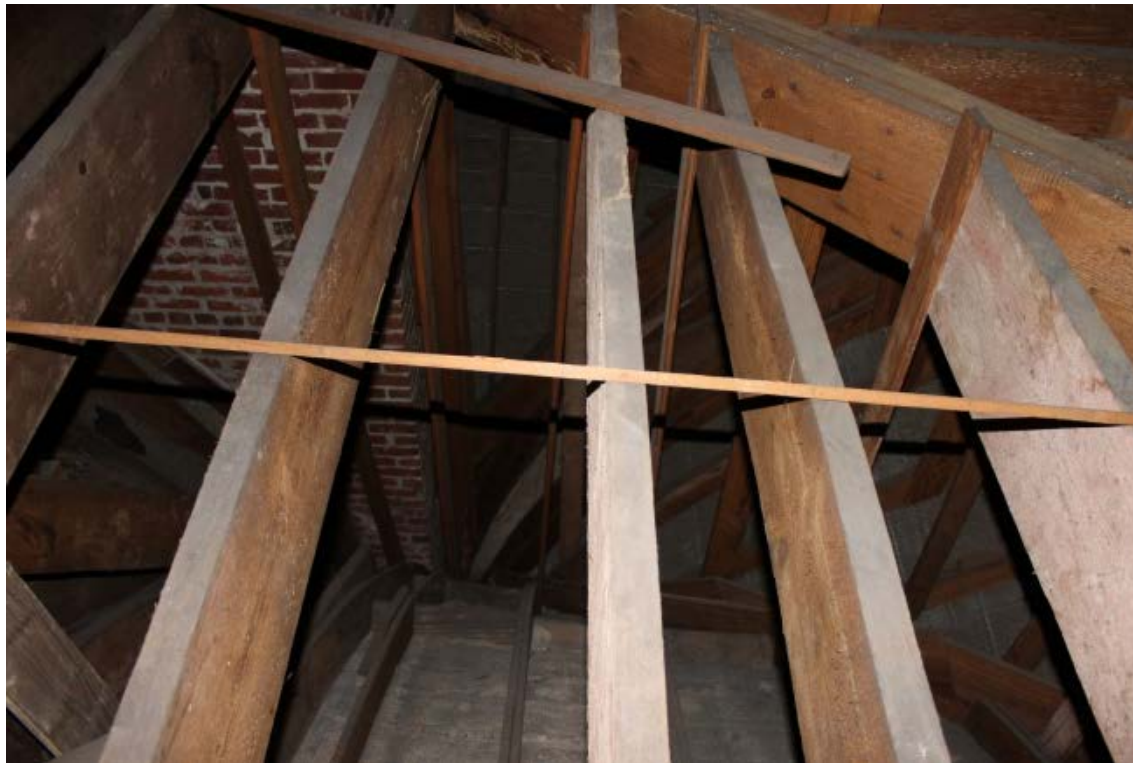
All framing appears to be in good shape. All joinery is tight. No signs of insects or damage.

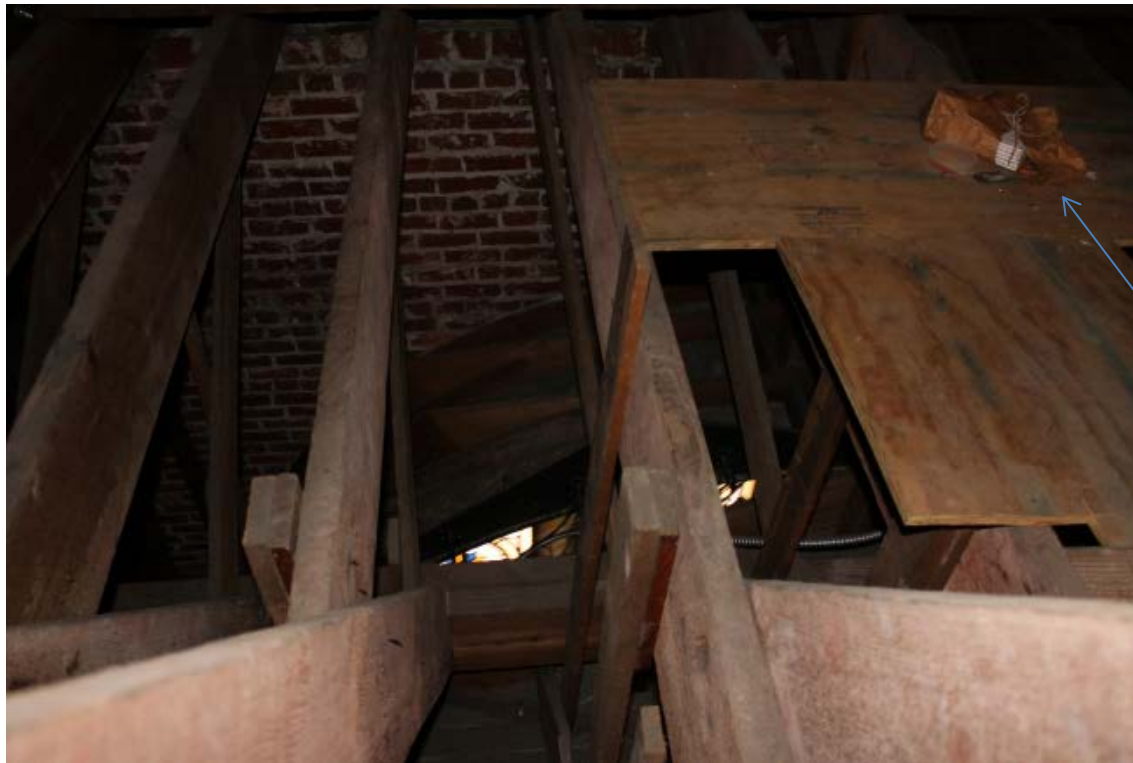
All framing appears to be in good shape. All joinery is tight. No signs of insects or damage.

Construction debris requires removal and should not be left in attic.

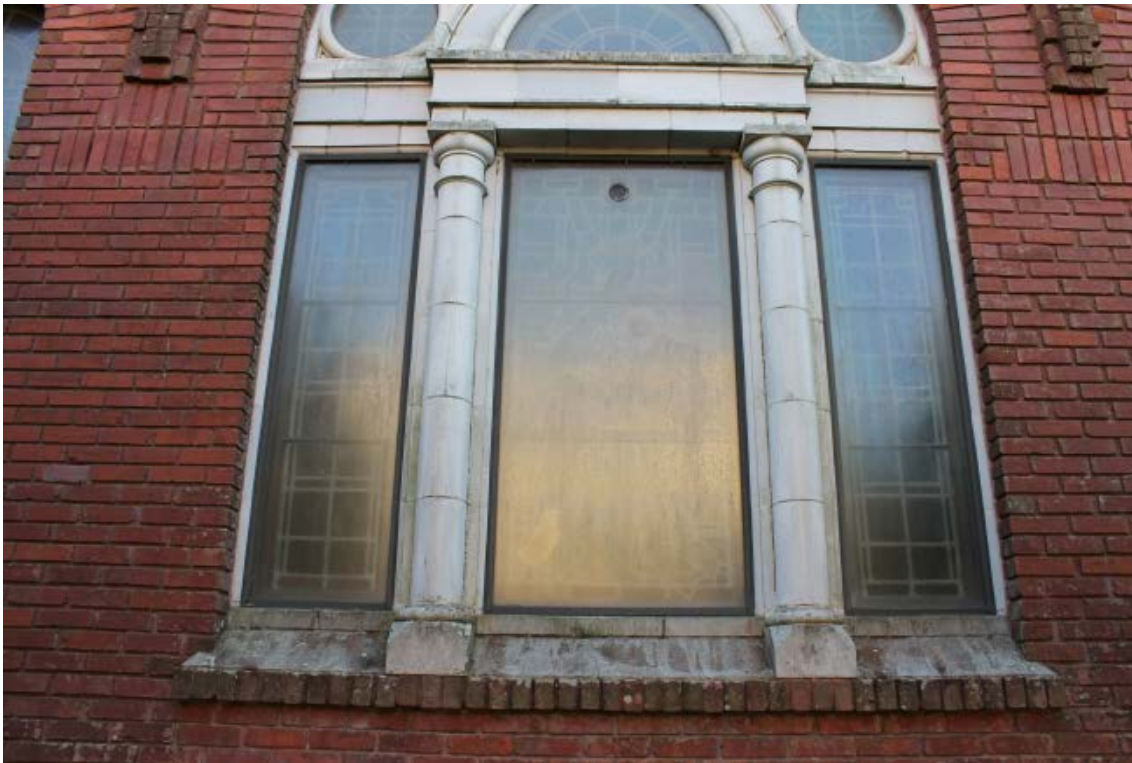
Brick masonry and terra cotta in need of proper cleaning and repointing.

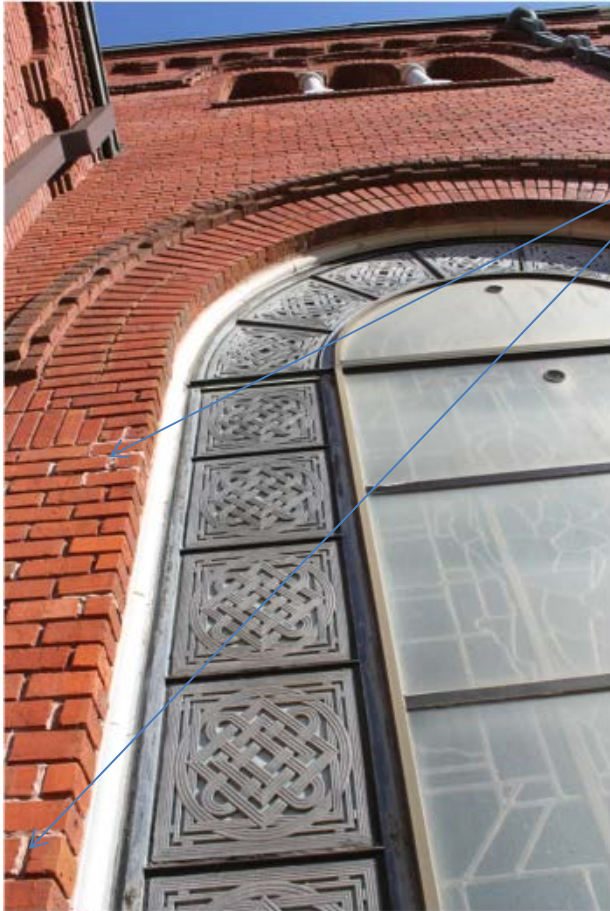
Caulking has been used to replace missing masonry mortar in various locations. This caulking should be removed and replaced with proper mixed masonry mortar and blended to match the existing mortar make up and color. Iron window frames are rusting/corroding and are in need of restoration. A detailed report on each window is required.

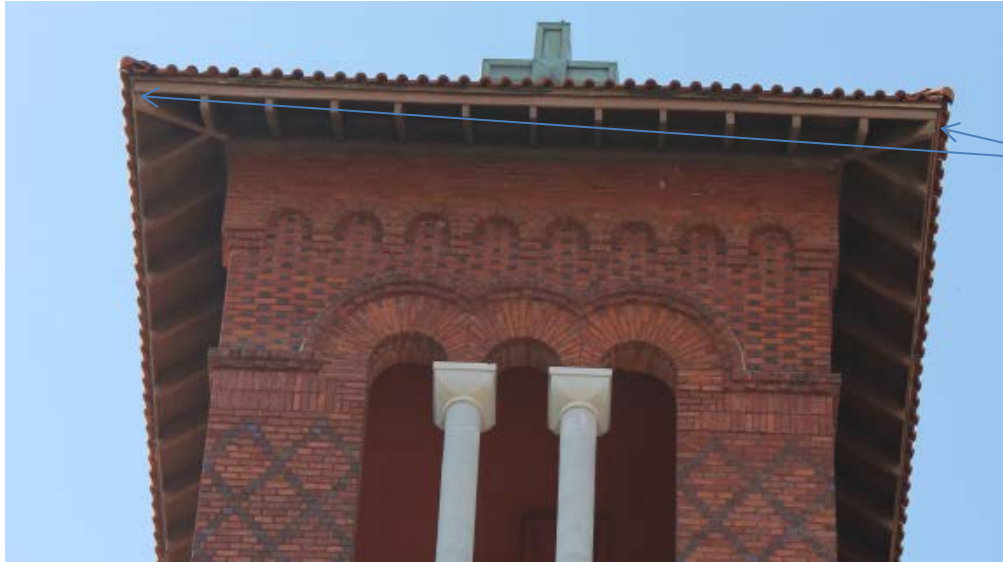
The bell tower roof overhang shows evidence of beginning stages of rot at the four (4) hip rafter tails. These rafter tails are exposed to the elements & can only be reached by means of a crane, so maintenance is not easily performed. After further inspection, it may be found that the rafter tails may need to be repaired. Due to the difficulty (expensive) cost to coat this wood often due to its exposure, extensive consideration and research should be performed to arrive at a means of protection that would both prevent maintenance often and keep within the guidelines of historical preservation.

Wood hip rafters at four corners show signs of rot on ends where they are exposed to direct sun and rain. All overhangs are in need of cleaning and recoating.

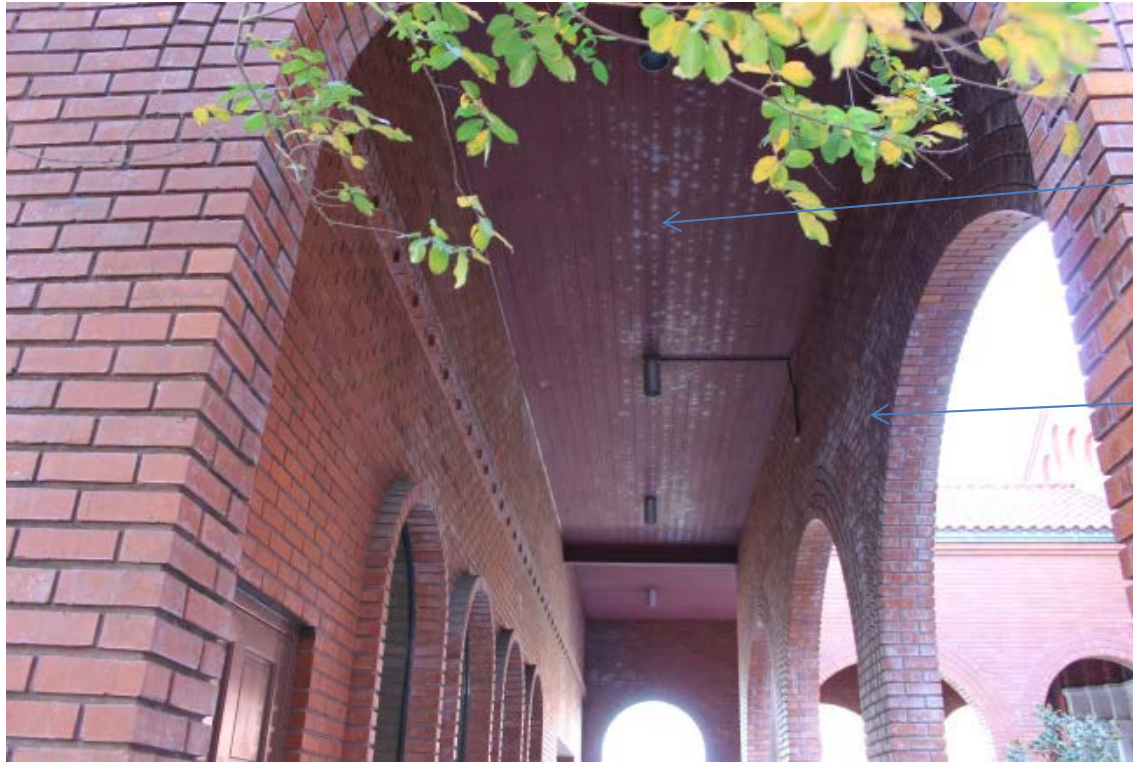
Day chapel ceiling of covered walkway requires cleaning and determination of surface substance.

Masonry shows sign of efflorescence.

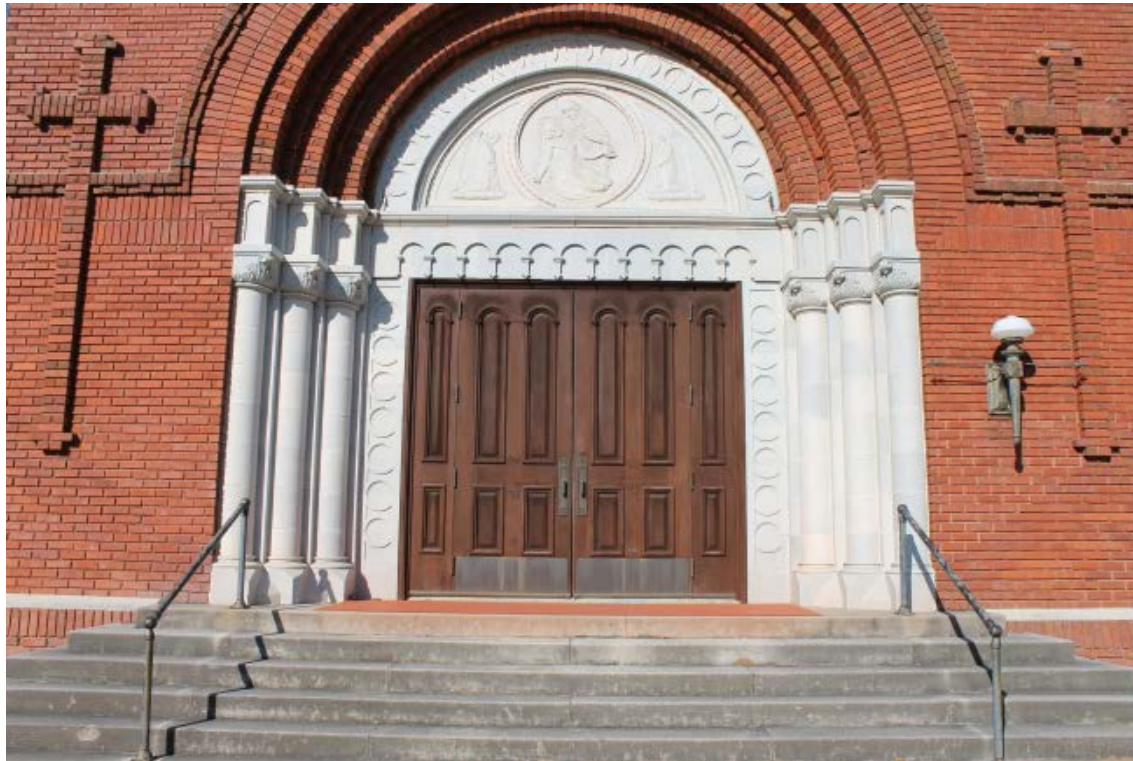
Exterior entry doors at south Transept are in need of cleaning and proper coating, including all perimeter edges.

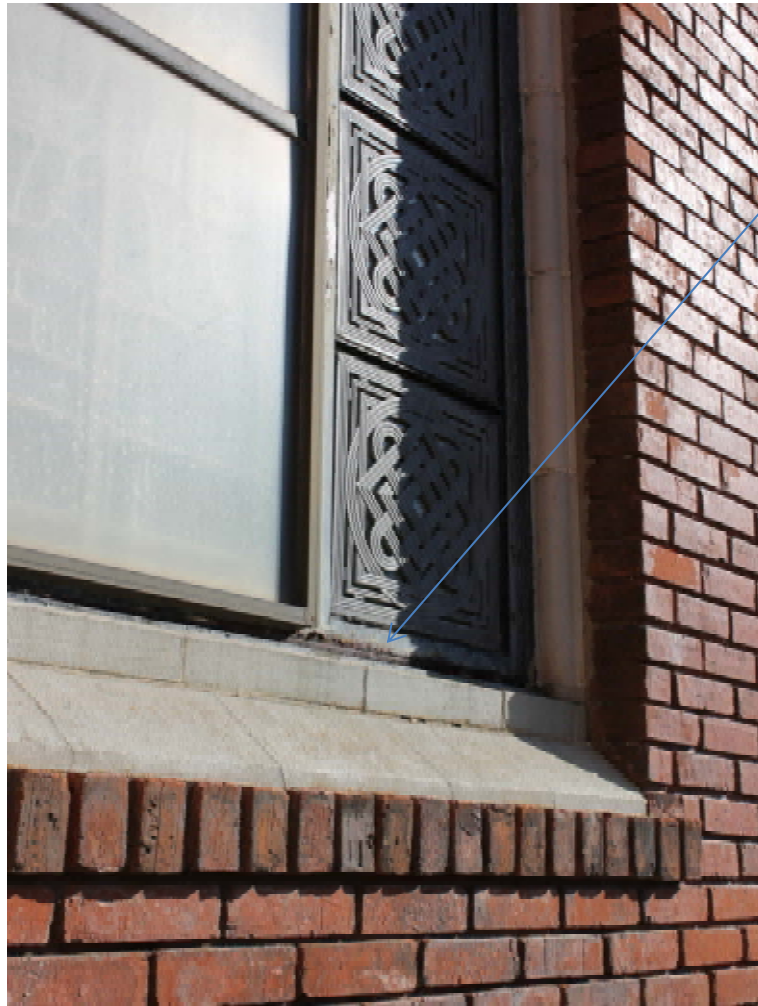
Iron window frame
rusted and
corroded in need of
repair and
refinishing.

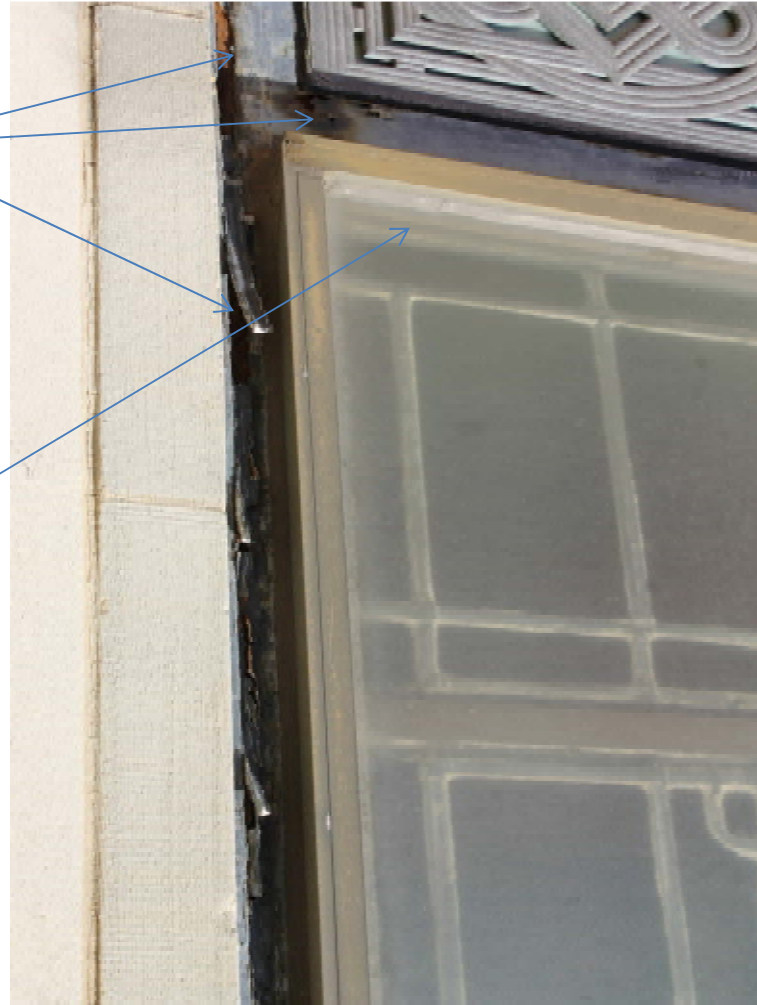
Iron window frame rusting and corroding. In need of restoration and preservation measures.

An investigation and research should be performed further on the protective covers installed to determine how much damage if any has been caused and determine if they should be removed, replaced with a different product etc. Some covers contain vents to allow moisture to exit the space, but some do not.

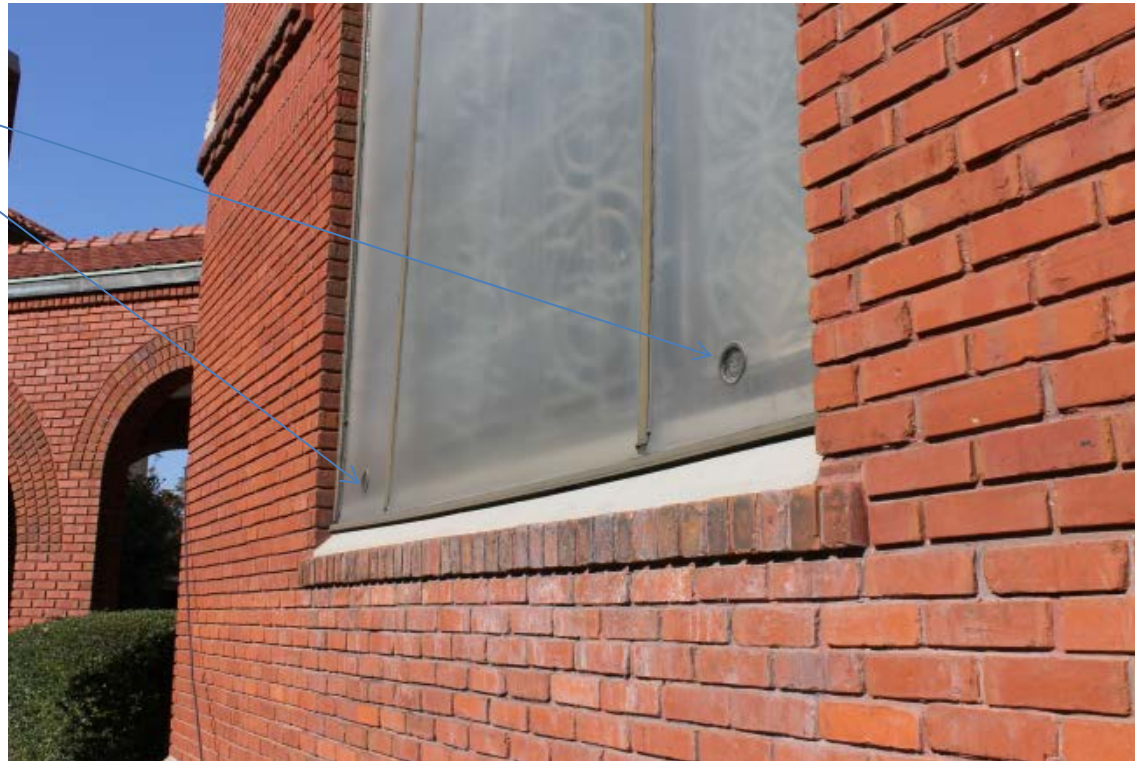
Small vents
installed in
protective
covers.

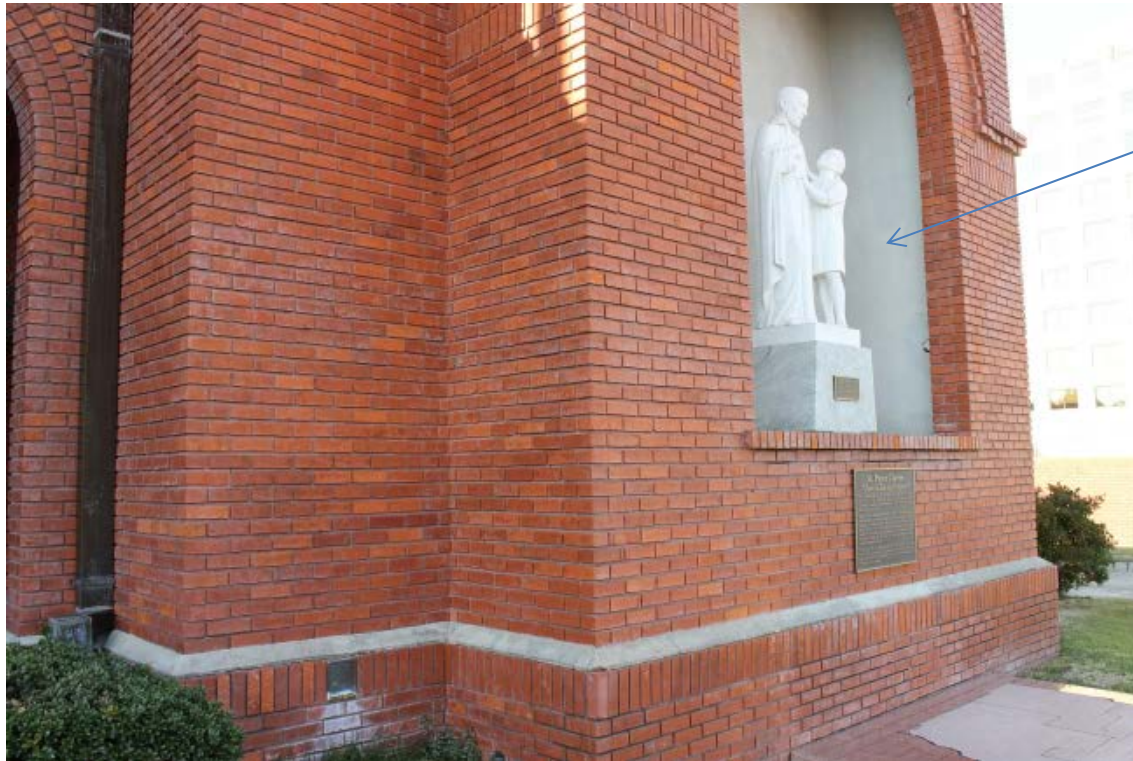
Plaster installed in wall recess at east wall of Day Chapel – originally the Meeting Room Addition constructed in 1972.

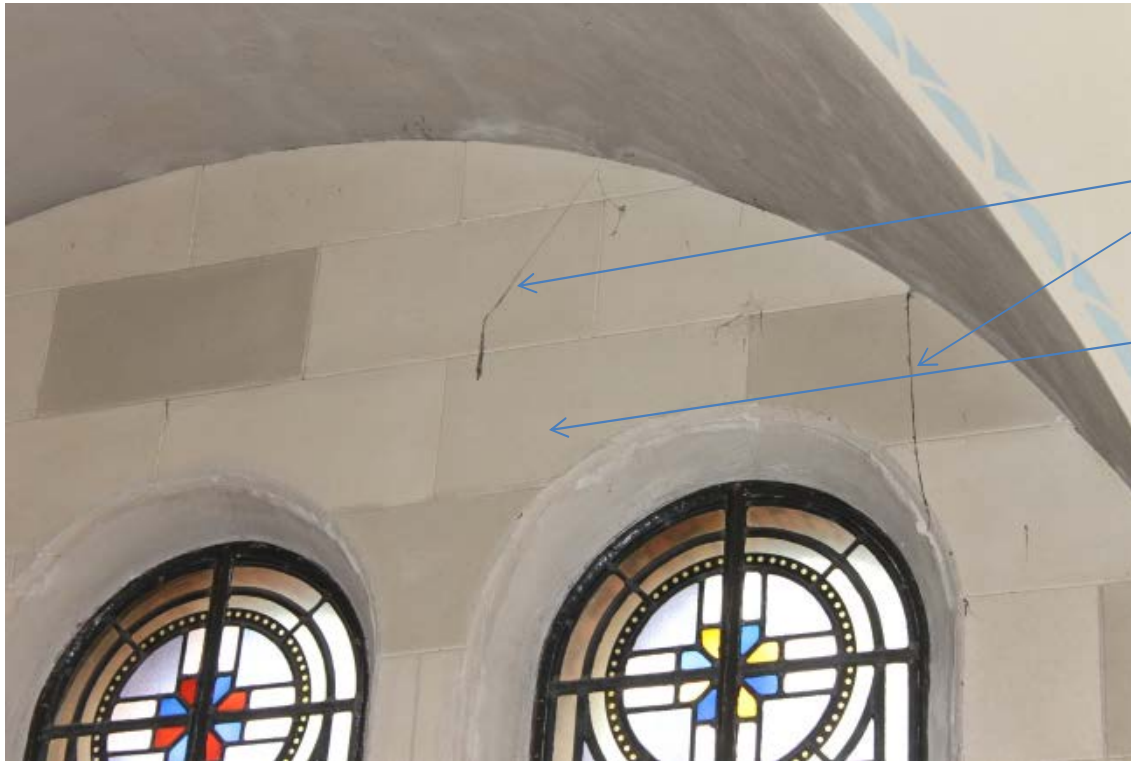
What appears to be insect trails. Further inspection is required. Acoustical sound panels installed over plaster walls after initial construction.
